MODIFICATION OF JRR-2

January 1978

This report gives an outline of some of the main modifications carried out around the Reactor Core on the Research Reactor JRR-2, at the Tokai Research Establishment of JAERI.

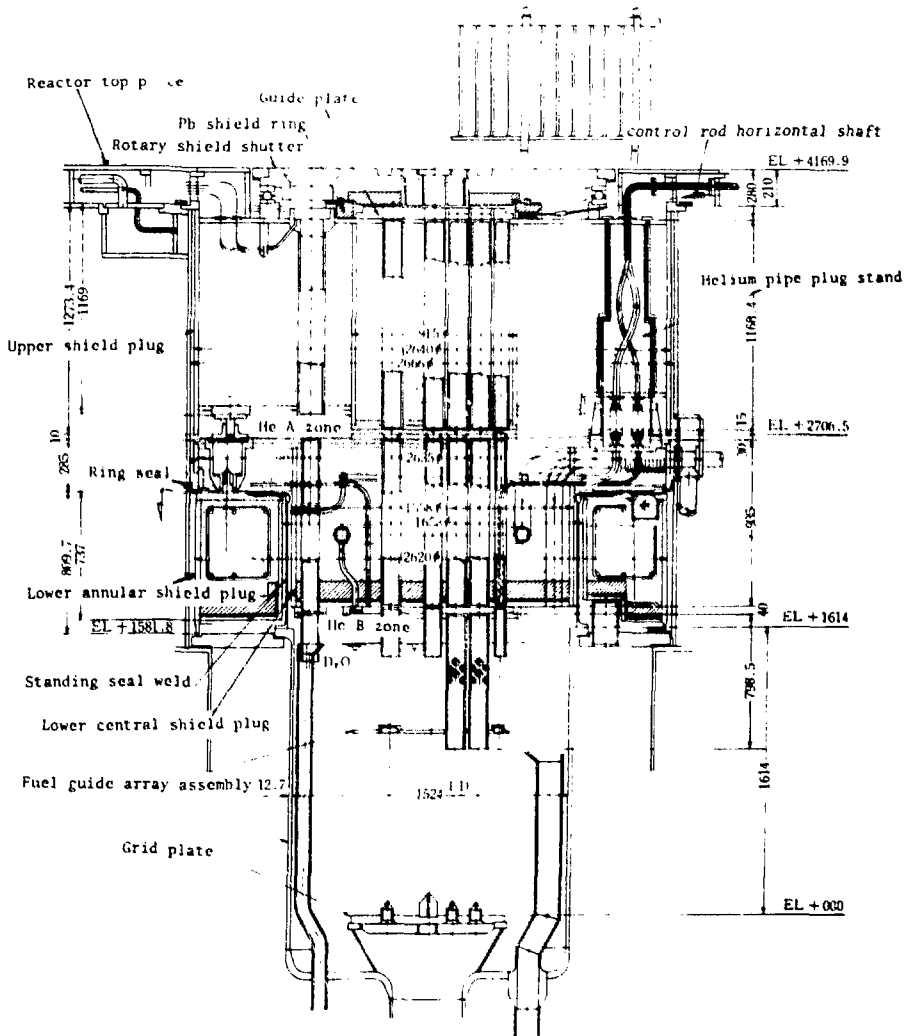
Fig. 1 JRR-2 cross section after modification

Before the modification, the reactor top shield consisted of the lower plug, the upper plug and the rotary plug. These plugs were replaced, because some troubles were observed in the fuel holes of the lower plug etc. The lower plug troubles were caused due to deformation of the rectangular aluminum tubes by corrosion products ($Al_2O_3 \cdot 3D_2O$).

Fig. 1 shows the cross section of JRR-2 reactor top shield after the modification. The modified lower plug consists of the annular shield plug and the central lower shield plug. The shapes of fuel hole in the lower

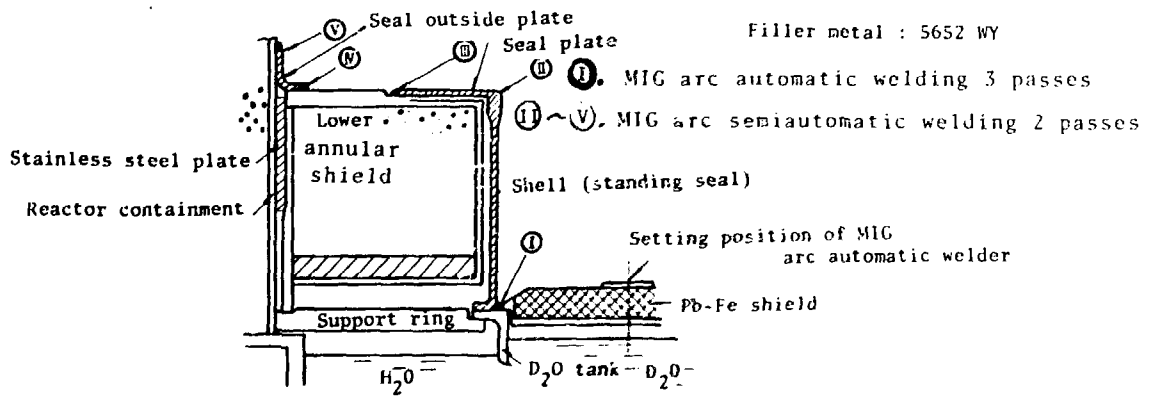
Fig. 2 Standing seal weld.

The heavy water concentration in the thermal shield light water increased gradually since the summer of 1971. Total amount of heavy water leakage into the thermal shield light water system since September 1971 till December 1973 was estimated to be about 520 kg. The repair works were planned to eliminate heavy water leakage trouble and to improve design of the reactor top shield at the same time. The "standing seal weld" for stopping heavy water leakage was carried out in June 1975 after the full size mock-up tests. The standing seal inserted between the lower annulus plug and the lower central plug was welded at the heavy water tank flange as shown in Fig. 1 and Fig. 2.

The three-pass welding at the heavy water tank flange (position No.1) under high radiation level were performed by automatic MIG arc. The other four positions were welded in two passes by semiautomatic MIG arc. Inspection after the welding showed good results, including visual inspection, penetration test and helium leak test. Refer to photo No.1 and 2.

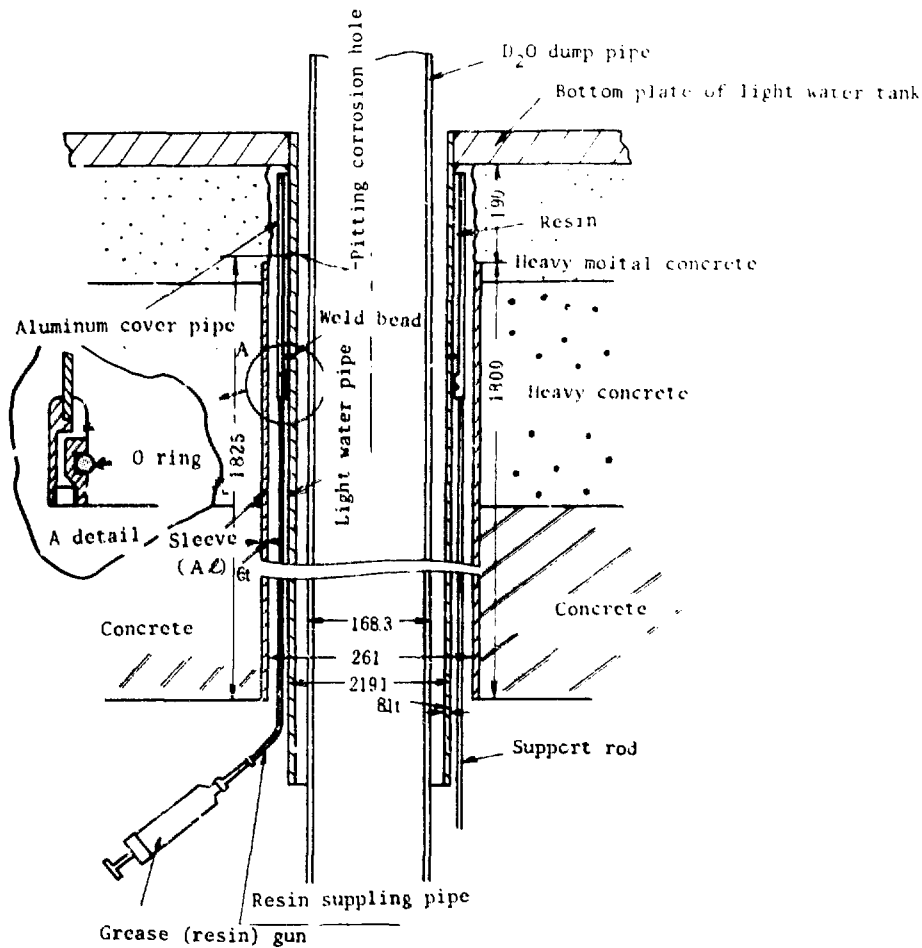
Fig. 12 Repair of light water leakage in stand pipe below the light water tank

Water leakage occurred in November 1975, in pitting corrosion of the aluminum pipe. The location was about 180 mm below the light water tank, along the heavy water dump line. Detailed examination was made with fibre scope and ^{192}Ir radiography.

The cause of the water leakage was presumed to be acidic pitting corrosion by analysis of corrosion products. Corrosion products were mainly chloride, aluminum hydroxide and Bayerite ($\text{Al}_2\text{O}_3 \cdot 3\text{D}_2\text{O}$). About 800 $\mu\text{g/g}$ of chlorine was also detected in the waste materials. The chlorine was supposed to be released by radiation damage of polyvinyl chloride sheets wrapping the aluminum pipe in inferior JRR-2 construction.

The repair works are outlined in Fig. 12. To stop the leakage, resin (Epikote 828) was packed into the gap between the light water pipe and the cover pipe about 350 mm long. The resin is estimated to have a life of about 10 years.
