THE CRACKING OF PRESSURE TUBES IN THE PICKERING REACTOR

Small cracks in 17 of the 390 pressure tubes in Unit 3 of the 2056 MW (electrical) Pickering Generating Station and of 52 tubes in Unit 4, resulted in each of these units being out of service for many months. The cracks originated at areas of extremely high residual tensile stress produced by improper positioning of the rolling tool used during construction to join the pressure tube to its end-fitting. The mechanism of failure was delayed hydrogen cracking.

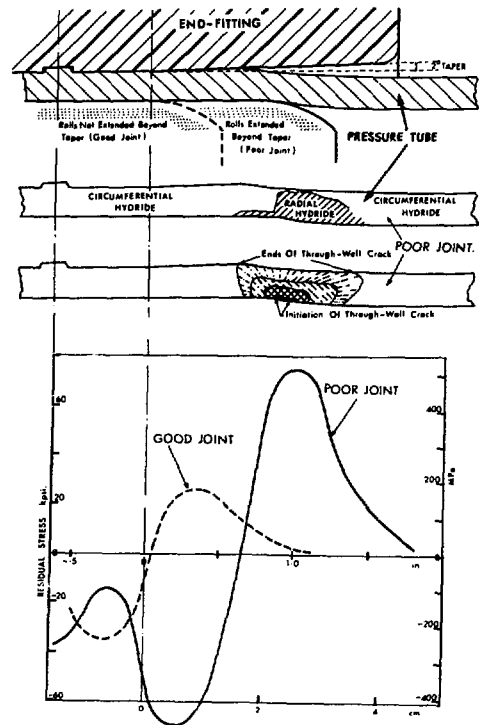
a) Dimensional measurements in the tube and rolled joint showed that the rolling tool had been inserted about 13 mm (0.5 in.) too far into the tube at the 'West' end during the rolling operation. This condition is termed 'over-extended' rolling. The rolling tool had thus been expanding the tube for about 10 to 15 mm (0.4 to 0.6 in.) beyond the hub (the parallel bore of the end fitting), and in a region where the tube has little support. (See position of taper and roll in a poor joint, Figure 5.) The joints at the 'East' end of the reactor were not as over-extended as those at the 'West' end.

b) The cracks were about 13 to 20 mm (0.5 to 0.8 in.) long and were just inboard of the rolled joints, where the tube is flared out during the roll forming process. The crack initiation point was close to the innermost point of contact of the rollers (Figure 5). The cracks had either propagated through the tube wall or had propagated almost through the wall with only a thin web on the outside remaining.

e) Radial hydrides (i.e. zirconium hydride platelets in the radial-longitudinal plane) existed in the same circumferential plane as the cracks (Figure 5). The orientation of zirconium hydrides within the pressure tube is normally circumferential. Circumferential hydrides will reorient when cooled under high tensile stress.

Figure 5 - Pickering rolled joint showing:

- (a) relative position of rolling tool during installation.
- (b) position of radial hydrides and cracks in a poor (over-extended) joint, and
- (c) residual stress distribution on the inner wall of a good and poor joint.

- b) the position of the cracks, radial hydrides, and peak residual transverse tensile stresses, all coincided (Figure 5).
- c) properly rolled joints have residual transverse tensile stresses on the inner wall of about 145 to 300 MPa (20,000 to 48,000 psi), and the zone of residual stress is closer to the end fitting.

An important step in avoiding delayed hydrogen cracking is to reduce the residual hoop stresses during the rolling process. By avoiding 'over-extended' rolling, residual stresses are reduced by one-half. Two further methods of improvement have been proven. One is by reducing the clearance between pressure tube and the hub of the end fitting to close to zero (heating the hub and cooling the tube to produce a shrink fit). The other is to leave the initial clearances unchanged and then stress relieve by heating the flared area after rolling. With these improvements residual stresses can be reduced to about 100 MPa (14,500 psi) or less. A number of improvements have also been incorporated in assuring good and uniform quality during fabrication of the tubes to further reduce the material susceptibility to delayed hydrogen cracking.
