**DAMAGE AND FAILURE OF UNIRRADIATED AND IRRADIATED  
FUEL RODS TESTED UNDER FILM BOILING CONDITIONS**

A. S. Mehner, R. R. Hobbins, S. L. Seiffert,  
P. E. MacDonald, R. K. McCardell

EG&G Idaho, Inc.  
Idaho Falls, Idaho 83401

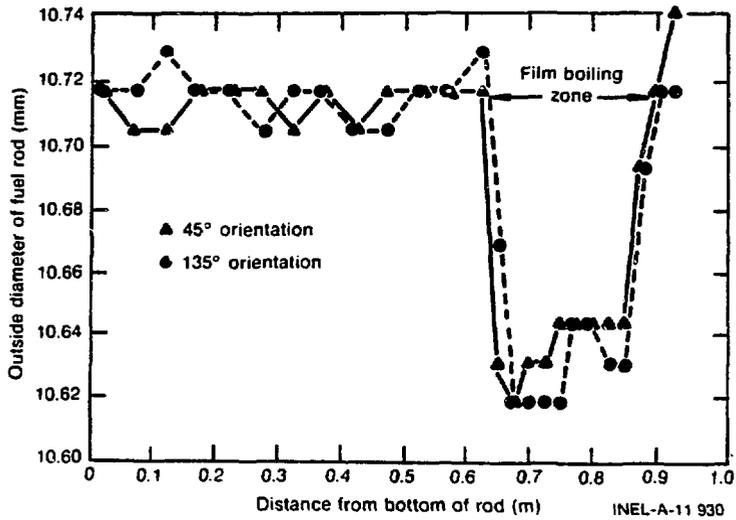
Fig. 3 Cladding outside diameter of Rod UTA-0006, Test PCM 8-1 RF, showing reduction in diameter within the film boiling zone of an irradiated fuel rod.

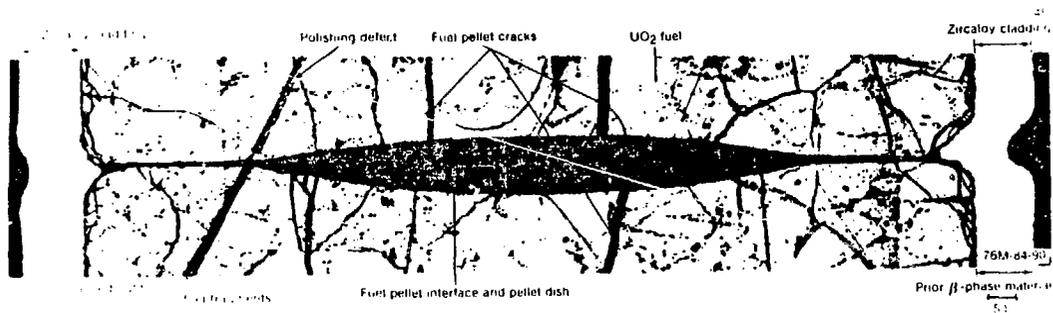
Fig. 4 Example of cladding flow into a pellet-to-pellet gap in Rod UTA-0007, Test PCM-2A.

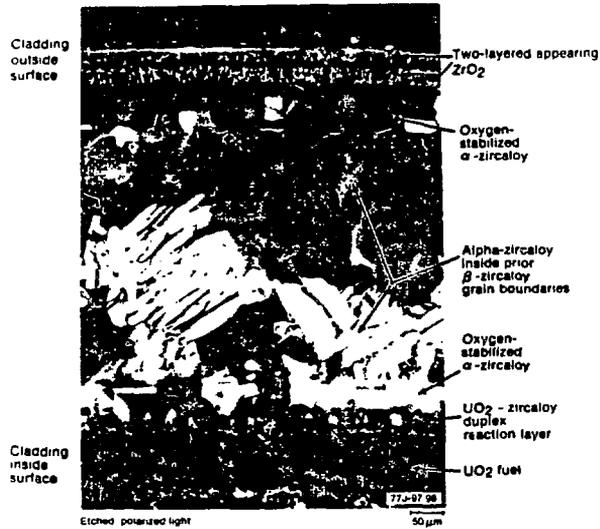
As a result of the high cladding temperatures, the cladding reacts with the coolant to produce the characteristic oxide and oxygen-stabilized alpha layers at the outer surface of the cladding, as shown in Figure 5. These reaction layers are brittle and degrade the ductility of the cladding, leading to fuel rod failures as will be discussed later. The formation and extent of these reaction layers on the PBF test fuel rods appear to be consistent and

Fig. 5 Typical cladding microstructure in region of film boiling zone on Rod IE-020, Test IE-5.

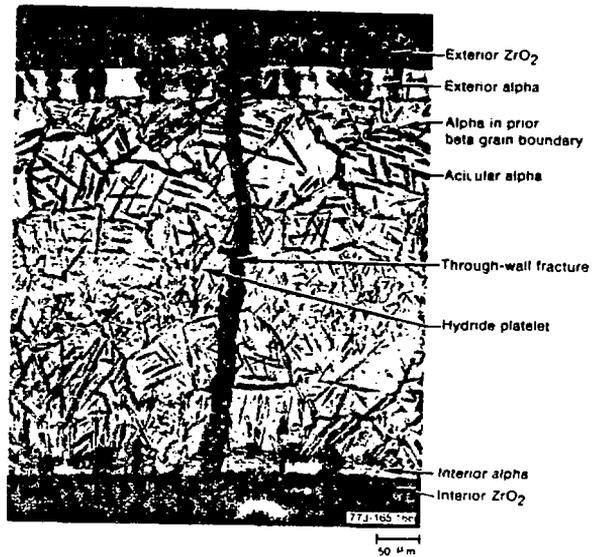
Seiffert and Hobbins [13] have analyzed the PBF results to determine the effects of hydrogen pickup on cladding microstructure in the film boiling zone. A small amount of hydrogen pickup occurred in the film boiling zones of rods which were intact prior to and during film boiling operations. Hydrides were generally dispersed in the cladding wall and no adverse effects on cladding ductility or fuel rod behavior were detected. However, three rods which were operated in film boiling with failed cladding were embrittled at room temperature to a greater extent than intact rods oxidized under similar conditions. This embrittlement appears to be associated with enhanced hydrogen absorption arising from stagnant steam conditions inside the failed rods, and with hydrogen modification of the prior-beta material as shown in Figure 7. Hydrogen concentrations as low as 300 ppm in cladding with this type of microstructure appear to significantly affect the room temperature ductility of both previously unirradiated and irradiated cladding.

Fig. 7 Cladding microstructure from Rod IE-019, Test IE-5, showing hydride effects that result in room temperature embrittlement.

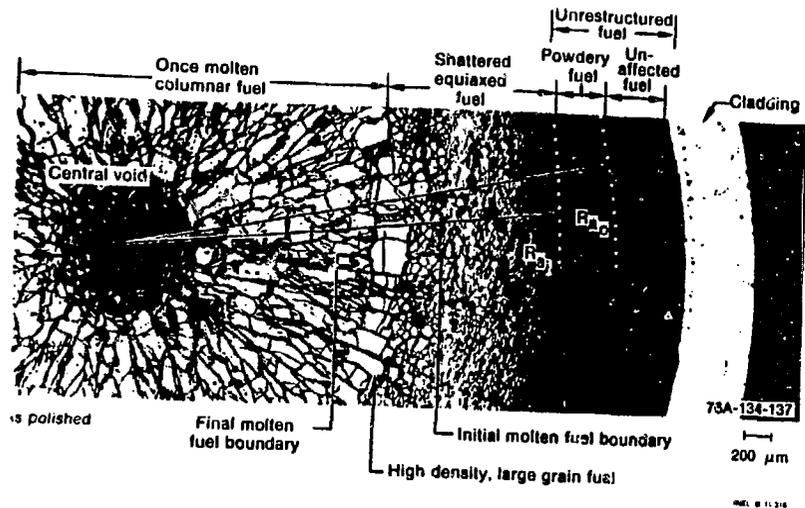
Grain boundary separation has been observed in fuel from the film boiling zone of both unirradiated and irradiated fuel rods, a typical example of which is shown in Figure 8. The shattered fuel is in a powdered condition and has sometimes washed out of failed fuel rods. Cronenberg and Yackle [14] have examined this phenomenon and attribute it to the fuel temperature being above the equicohesive temperature of about 1900 K, at which grain boundary strength is less than the grain strength in  $UO_2$ . The calculated thermal stresses during the quench from film boiling operation are considerably higher than the grain boundary strength; thus, fracture occurs along the grain boundaries. The radial extent of the region of grain boundary fracture increases with increasing temperatures above 1900 K.

Fig. 8 Transverse section showing typical fuel microstructure and grain boundary shattering across a fuel pellet from the film boiling zone of a previously unirradiated fuel rod, Rod IE-001, IE Scoping Test 1.

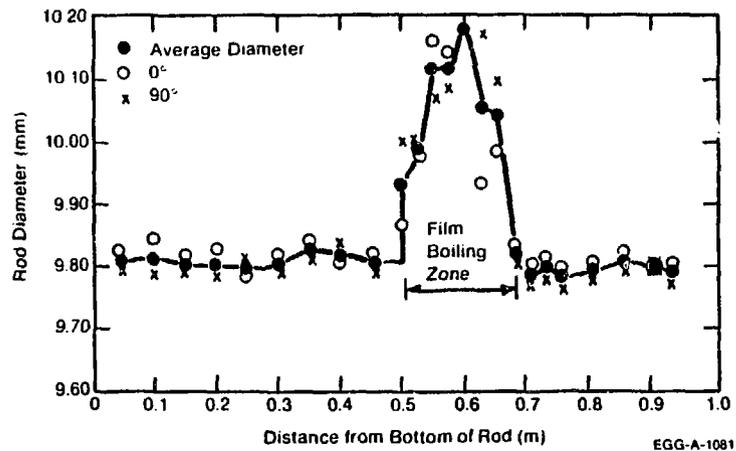
Fuel rod swelling has been observed in the film boiling zones of both previously unirradiated and, as shown in Figure 9, previously irradiated fuel rods. In unirradiated rods the swelling was caused by pellet thermal expansion and pellet volume expansion due to fuel melting. The swelling in irradiated rods was generally greater (3 to 4%), compared with unirradiated rods (< 1%). Mehner et al [15] have analyzed this phenomenon and conclude that only about half of the swelling is due to pellet thermal expansion and pellet volume expansion due to fuel melting. The remaining expansion is attributed primarily to fission gas effects. A small part of the expansion was attributed to fission-gas bubble migration to grain boundaries. However, the major contribution was concluded to be caused by fission gas bubbles trapped in the molten fuel. The molten fuel appears to act as an effective containment for the gases, sealing cracks and preventing escape of the gases to the rod plenum. The fission gas bubbles expand due to changes in surface tension and agglomeration, thereby pressurizing the molten fuel core. As bubbles continue to agglomerate, significant hydrostatic pressures may build up and cause fuel rod swelling and molten-fuel extrusion as shown in Figure 10. These fission gas effects produced no significant adverse behavior in test rods with burnups up to 17 000 MWd/t.

Fig. 9 Posttest diametral measurements showing diameter increase in the film boiling zone of a previously irradiated fuel rod, Rod IE-010, Test IE-1.

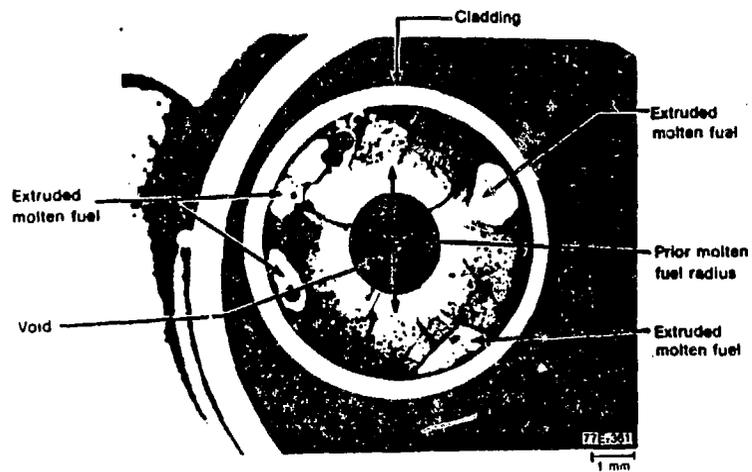
Rods have been operated in film boiling with up to 80% of the pellet radius molten. The molten fuel is generally contained at the center of the pellet; however, molten fuel extrusion into pellet interfaces, gaps in the fuel column (Figure 11) and radial cracks in the outer layer of the fuel pellet (Figure 10) has been observed. El-Genk [16] has modeled the case of molten fuel extrusion into a radial crack in a fuel pellet. The extent of extrusion was concluded to depend primarily on the pressure difference between the central molten zone and the fuel-cladding gap, the length and width of the crack, the molten fuel temperature, and the crack surface temperature.

Fig. 10 Molten fuel extrusion in an irradiated fuel rod, Rod IE-016, Test IE-3.

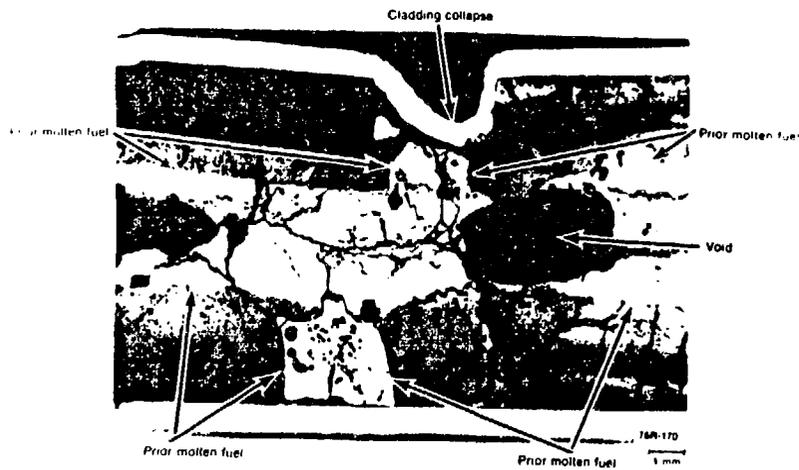
Fig. 11 Longitudinal section showing molten fuel extrusion in the film boiling zone of a previously irradiated fuel rod, Rod IE-009, Test IE-1.

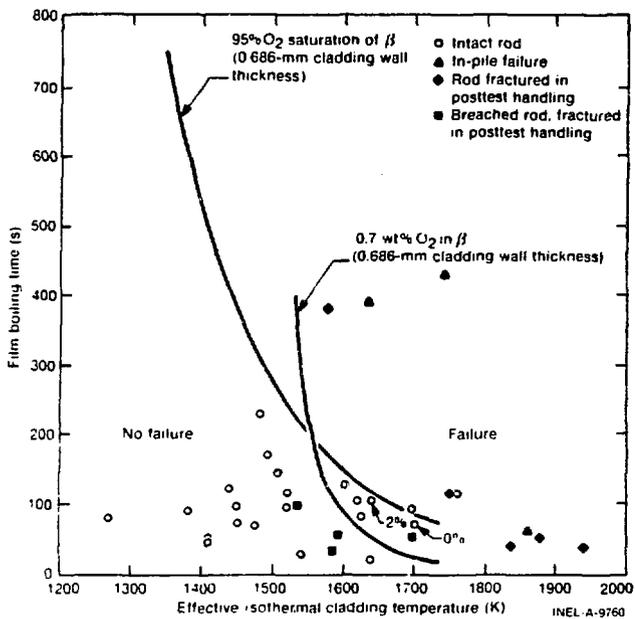
Seiffert and Hobbins [13] and Hobbins et al [21] have assessed the effects of oxygen embrittlement on rod failure during the quench from film boiling operation and during posttest handling in transport and in the hot cells. Rod failure due to oxygen embrittlement was found to be consistent with room temperature embrittlement criteria based on oxygen content in the beta zircaloy, as reported by Pawel [22], rather than embrittlement criteria based on the fractional thickness of transformed beta-phase or equivalent cladding reacted.

The cladding on rods that failed (breached) prior to or during film boiling was embrittled to a greater extent than intact rods oxidized under similar conditions and fractured during posttest handling (see Figure 12). This additional embrittlement appeared to be associated with enhanced hydrogen absorption from the stagnant steam inside the breached rods. The hydrogen appears to affect the prior beta-phase material, resulting in room temperature embrittlement with cladding hydrogen concentrations as low as about 300 ppm.

Fig. 12 Failure criteria for intact fuel rods tested under PCM conditions.

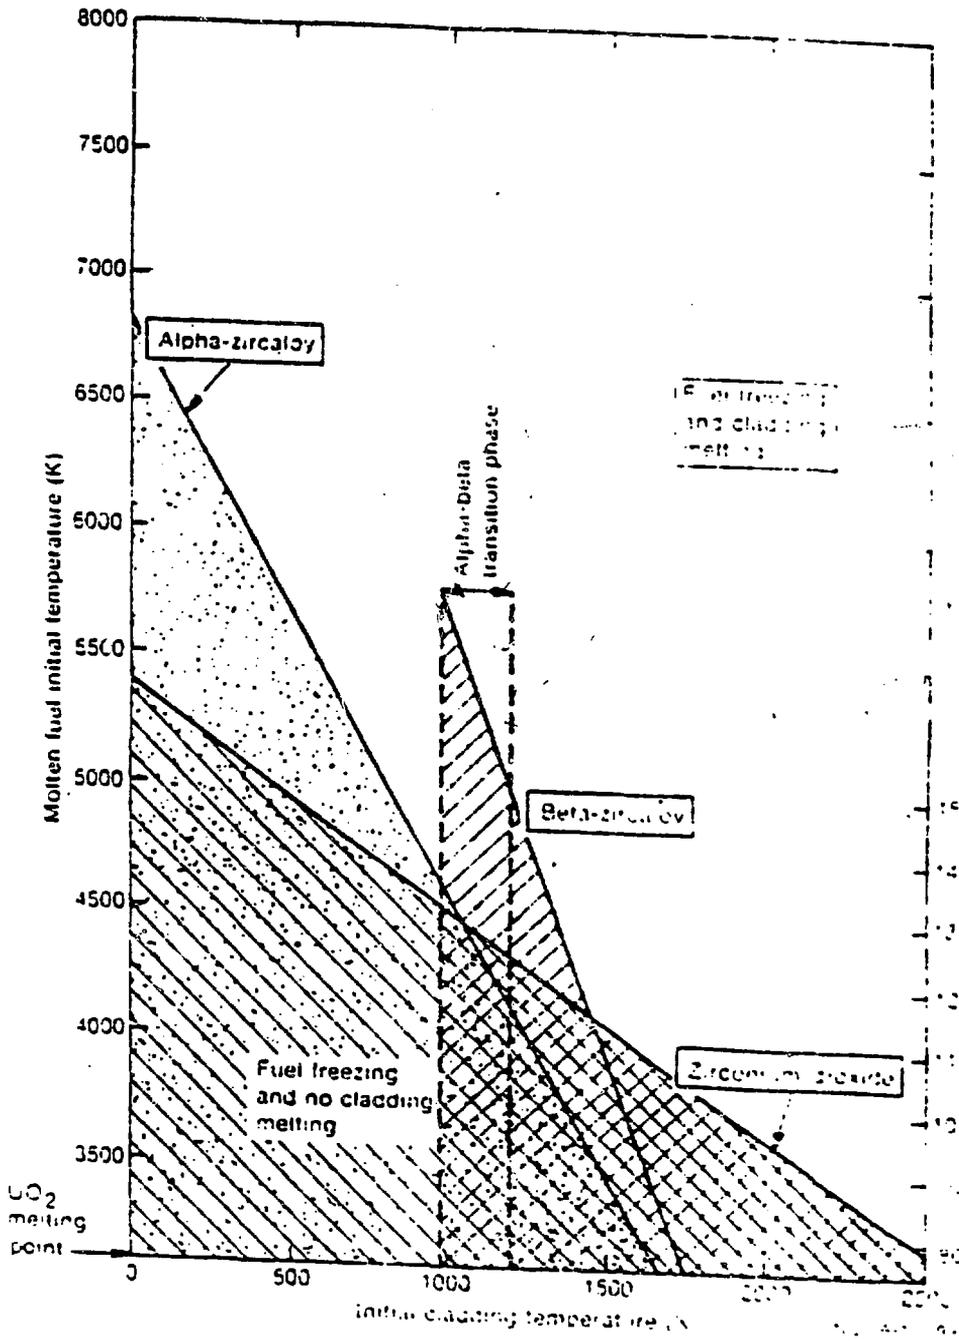
EI-Genk [16] has assessed the conditions for melting of zircaloy cladding upon being contacted by extruded molten fuel. Cladding melting at its inner surface; i.e., potential for cladding failure upon being contacted by extruded molten fuel, depends on the temperatures of the cladding and extruded molten fuel and the metallurgical composition at the inner surface of the cladding (alpha zircaloy, beta zircaloy, or  $ZrO_2$ ). The conditions for molten fuel freezing and simultaneous cladding melting are shown in Figure 13. As would be predicted from EI-Genk's analysis, cladding melting has not occurred in the PBF tests where molten fuel has contacted the cladding. The absence of cladding melting was concluded to be due to the temperatures of the molten fuel and the cladding being below the level required to initiate cladding melting.

Fig. 13 Initial temperatures map for initially molten  $UO_2$  contacting initially solid zircaloy cladding.
