As part of LLNL's program on radionuclide migration through fractured rock, major geologic discontinuities have been mapped and characterized at the 420 m level in the Climax Stock, adjacent to LLNL's Spent Fuel Test. Persistence or continuity of features was the principal sampling criterion, and ninety major fractures and faults were mapped in the main access and tail drifts. Although the purpose and nature of this study was different from previous fracture surveys in the Climax Stock, the results are generally consistent in that three predominant fracture sets are identified: NW strike/vertical, NE strike/vertical, NW strike/subhorizontal. The frequency of major features in the main access drift is somewhat higher than in the tail drift. Those mapped in the main access drift are generally braided, stepped, or en echelon, while those in the tail drift appear to be more distinct and planar. Several of the fractures in the tail drift lie in the NE/vertical set, while most form an entirely different set oriented N5E/55NW. Sub-horizontal fractures were common to both drifts. An area of seepage associated with some of these low-angle features was mapped in the main access drift.

The f

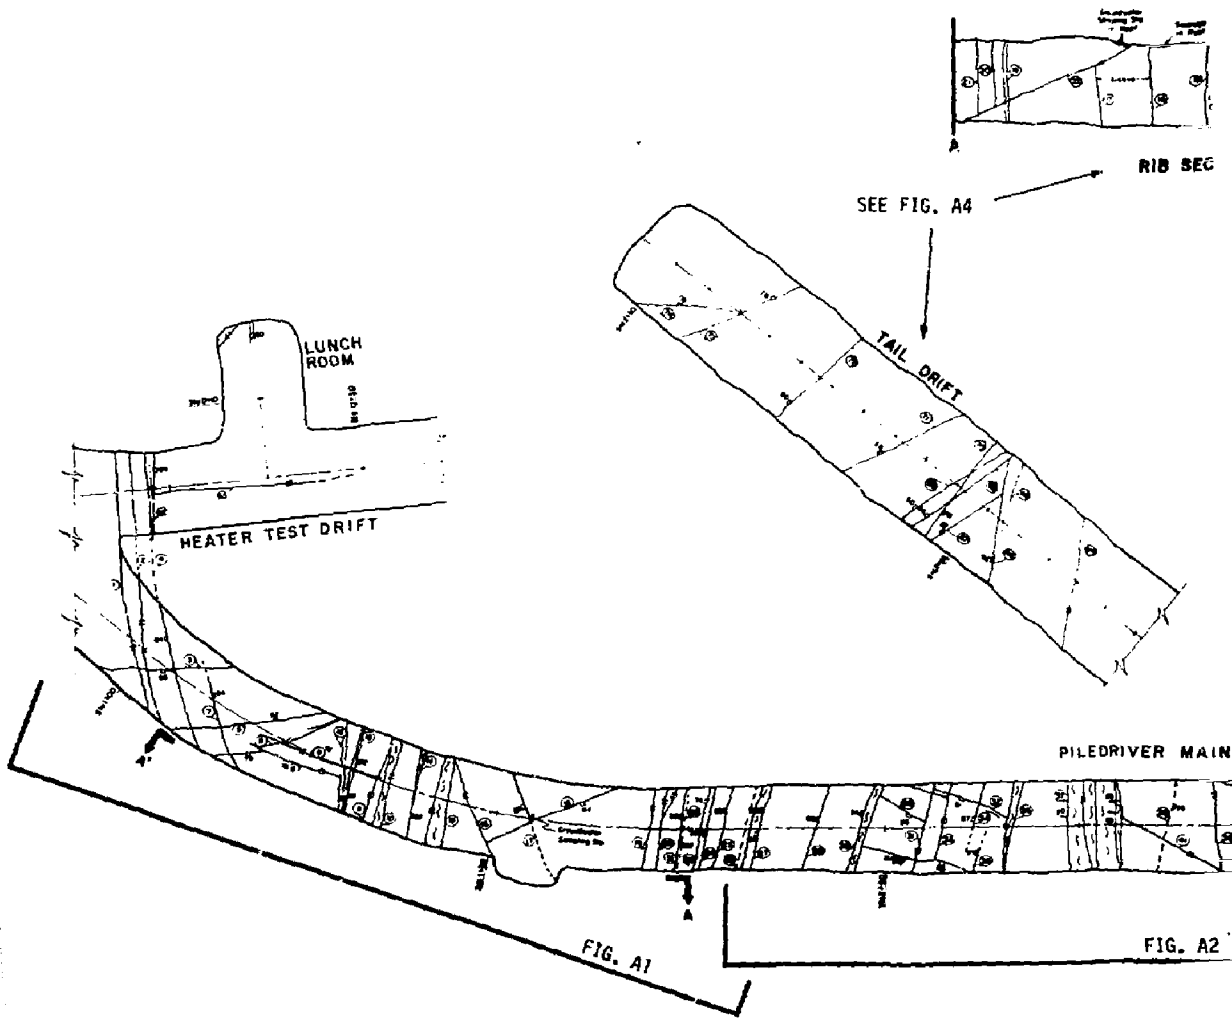
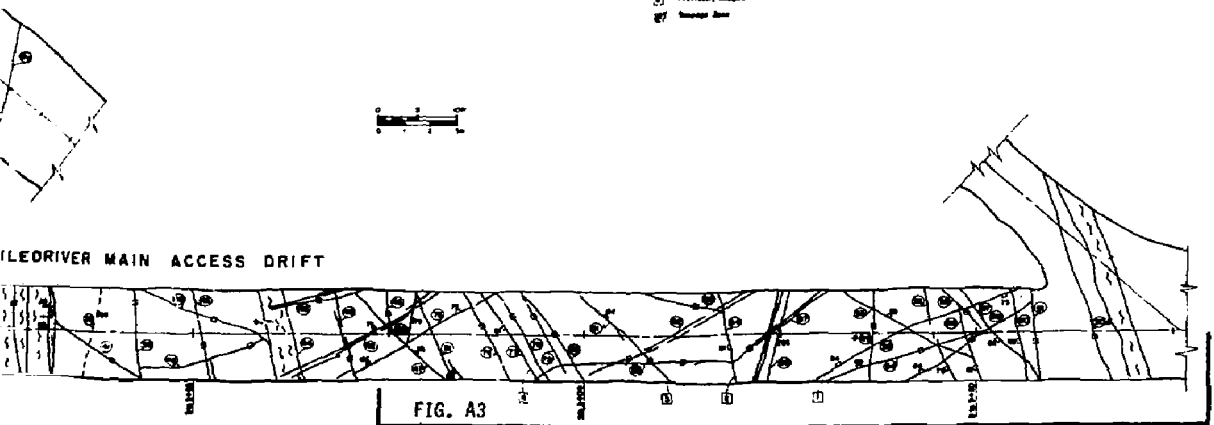
Fig. 5. Floor map of major discontinuities in Tail and Main Access Drifts at 420m level of Climax Stock, NTS.

Results of the mapping are summarized by Fig. 5, which has been reduced from its original 1:60 scale. In order to provide maps suitable for future field work, enlargements of the composite portions indicated in Fig. 5 are given at a scale of 1:120 in Appendix A. A total of ninety features were sampled in the heater test alcove, access drift, and tail drift; and each is described in Appendix B according to its assigned number. Fig. 6 is an equal-area contour diagram of poles to the ninety fractures. Comparing this with the previous results reported for the Climax Stock in Fig. 3, there is general agreement in the predominant fracture or fault orientations. There appears to be some dissimilarity, however, in results for the tail and main access drifts, which is discussed further below.

In many places, the northeast-dipping, low-angle features are observed to truncate high angle fractures. Examples of this can be found in the rib map (Section AA') of Fig. 5. Evidence of faulting along the low-angle fractures is absent, and therefore would be an unlikely cause for the truncation. Our tentative explanation is that the low-angle discontinuities, either open or healed at the time, effectively blocked the propagation of the later high-angle fractures. Our data on such a relationship is indeed limited, and further detailed mapping would be needed to substantiate this explanation.

We would recommend that the major fault zones in the access drift near stations 1+35, 1+80, 2+30, 2+60 and 3+65 be avoided for the type of single-fracture work under the current work plan. However, faults are very important hydrologic features and these would be excellent sites for studying flow through them. In terms of an underground repository of nuclear waste, highly fractured zones will require special attention when encountered, and development of techniques for characterizing their transport properties could be accomplished in the Climax Stock.

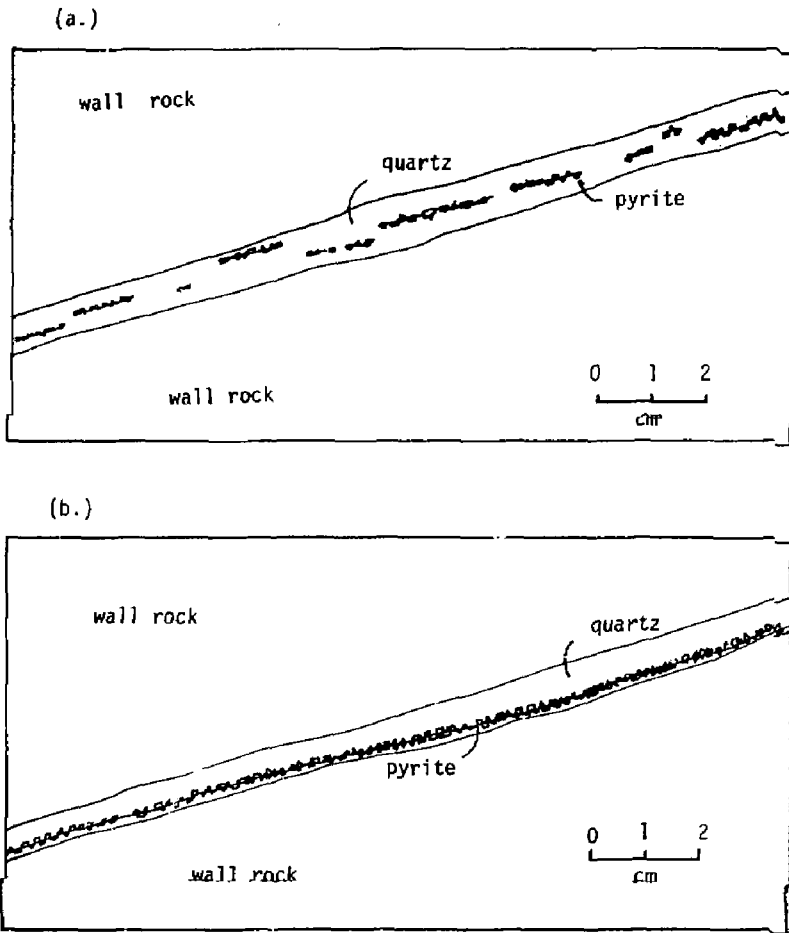
A third set of discontinuities was observed in the access drift with a mean orientation of N35W/25NE. This sub-horizontal set is apparently pervasive in the Climax Stock, according to the data in Fig. 3. Most of these features are planar and healed by quartz up to 10 mm thick. They typically contain pyrite in either continuous veinlets or discontinuous stringers. As sketched in Fig. 8, they tend to break or be open where the pyrite is continuous. Some of these low-angle fractures in the vicinity of Sta. 1+50 (Section A-A' of Fig. 5) are apparently open and seeping groundwater. Collection of groundwater in this area is in progress as part of the geochemical characterization task (Isherwood, et al., 1980). An additional low-angle fracture with an orientation of N38E/52NW and several high-angle fractures are also seeping water; however, it is not clear which of these features is the dominant flow path.

Fig. 8. (a) Low-angle healed fracture with discontinuous pyrite stringers. (b) Low-angle healed fracture with pyrite as a continuous layer. Open breaks or fissures tend to be along the continuous portions of the pyrite.

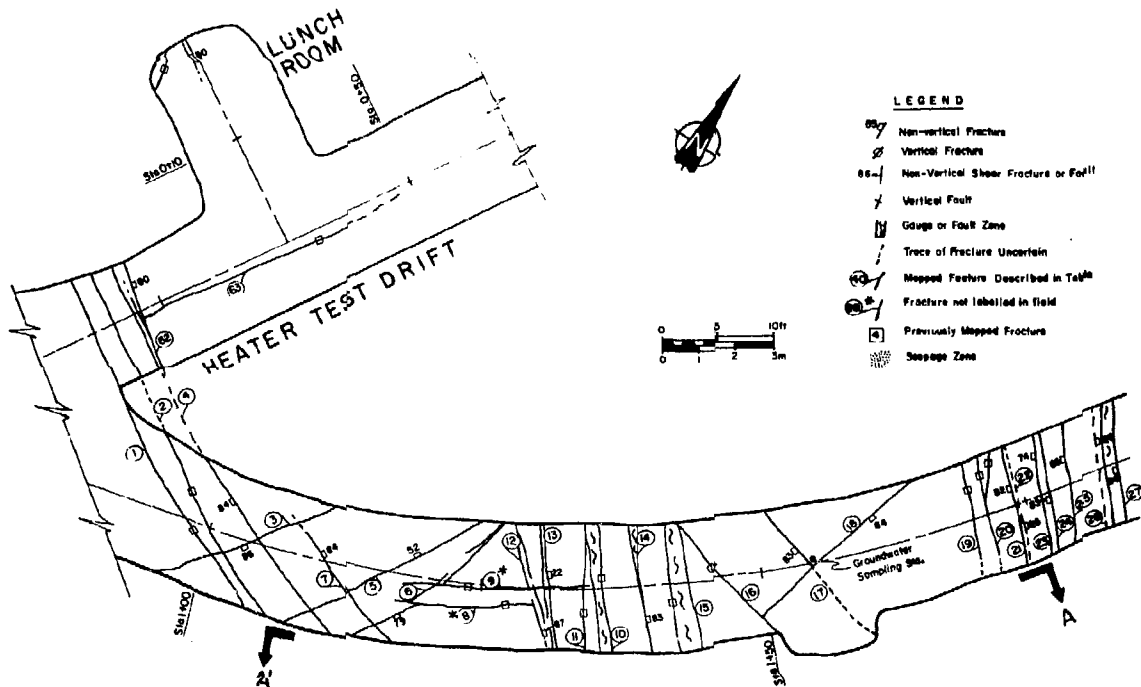
Fig. A1. Floor map of Heater Test Drift and Main Access Drift from station 0+90 to 1+85.

Along the access drift from station 1+10 to station 1+85 water can be seen seeping from low-angle discontinuities. In order to show the relation of the wet and dry features in this area, an additional map of part of the southwest rib was prepared. This appears as section A-A' on the fracture map which is discussed in the following section.

In terms of potential fracture sites for radionuclide migration tests, several areas appear promising. First, in the main access drift there are several features near the heater test drift that could probably be intercepted at some suitable distance from the drift by horizontal boreholes. As members of the main set (N50W/90) in the drift, at least four fractures could be intersected by a pair of 8 m boreholes. On the base map these are numbered 1

through 4. (They should not be confused with fractures currently being studied in the Radionuclide Migration Program.) Also in this area, a major low-angle, water bearing fracture (number 5) could be intercepted with a slant-drilled borehole. This would provide an opportunity to develop testing capabilities for non-vertical fractures, if the need arises in the future.

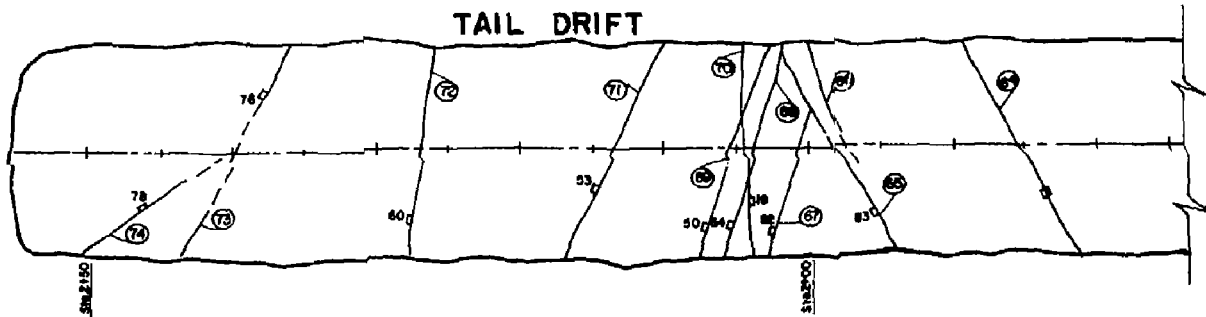
Fig. 4. Tail Drift floor map and south rib map in vicinity of station 1+50.

Far fewer major fractures were found in the tail drift than in the main access drift. Only eleven were identified over a distance of about 30 meters (frequency = 0.37 fracture/m), whereas the main access drift yielded a frequency of 79/85 m = 0.93 fracture/m. Three of the major fractures fall into the NW-striking, high-angle set, and one belongs to the low-angle NE-dipping set of the Stock (Fig. 9). The remaining seven fractures have a mean orientation of about N5E/50NW, which lies outside the major NE-striking set described earlier. However, Wilder and Patrick (1980) report the latter as the dominant joint orientation in the tail drift, which would indicate that none of those joints apparently met the continuity or persistence criteria for our mapping. Orientation of the drift with respect to the NE-striking set would be of lesser importance in causing this bias.

The nature of the major NE-striking fractures in the tail drift appears to be somewhat different than that noted in the access drift. Their traces are typically more planar; and although the mineralization is similar (calcite, iron oxides, and chlorite), it is somewhat thicker at 5 to 20 mm.

A second pair of candidate fractures is in the tail drift, oriented NSOE/vertical. These fractures may be more conductive than desirable for the migration experiments; however, the relatively few number of major intersecting fractures in the drift makes this area attractive for single-fracture flow studies.
