**HUMAN FACTORS ENGINEERING
CONTROL-ROOM-DESIGN REVIEW/AUDIT REPORT;**

**PALO VERDE NUCLEAR GENERATING STATION,
ARIZONA PUBLIC SERVICE COMPANY**

Jack W. Savage
David A. Lappa
Lawrence Livermore National Laboratory

October 9, 1981

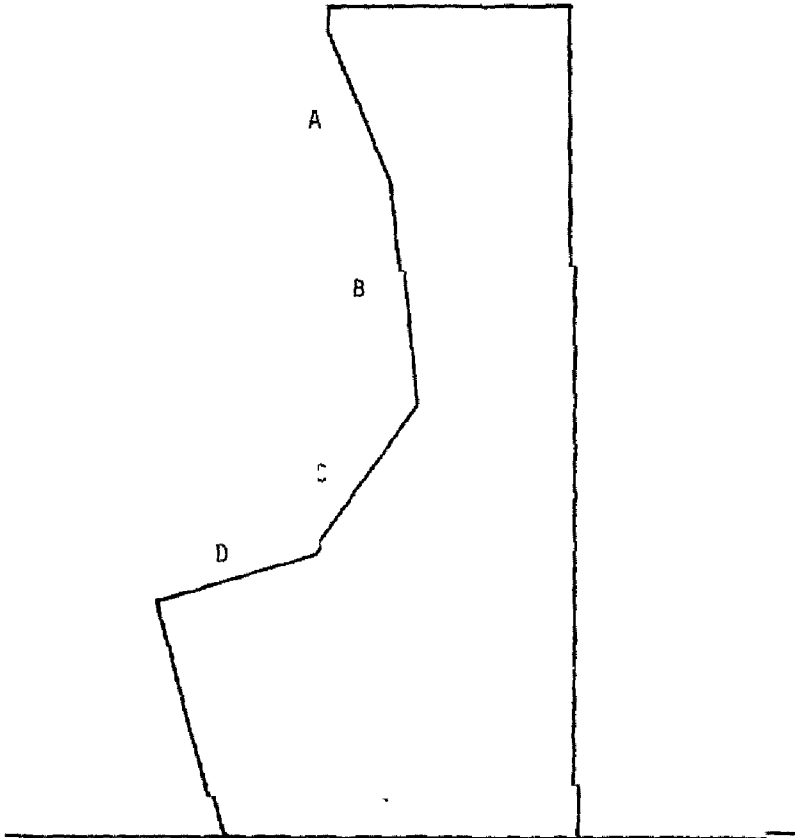
FIG. 1. Identification letters of the four control board surfaces.
