COMMITTEE'S REPORT ON RUTHENIUM FALL-OUT INCIDENT

Subject: COMMITTEE'S REPORT ON RUTHENIUM FALL-OUT INCIDENT

REPORT OF THE COMMITTEE ON THE RUTHENIUM FALL-OUT INCIDENT

November 11-12, 1959

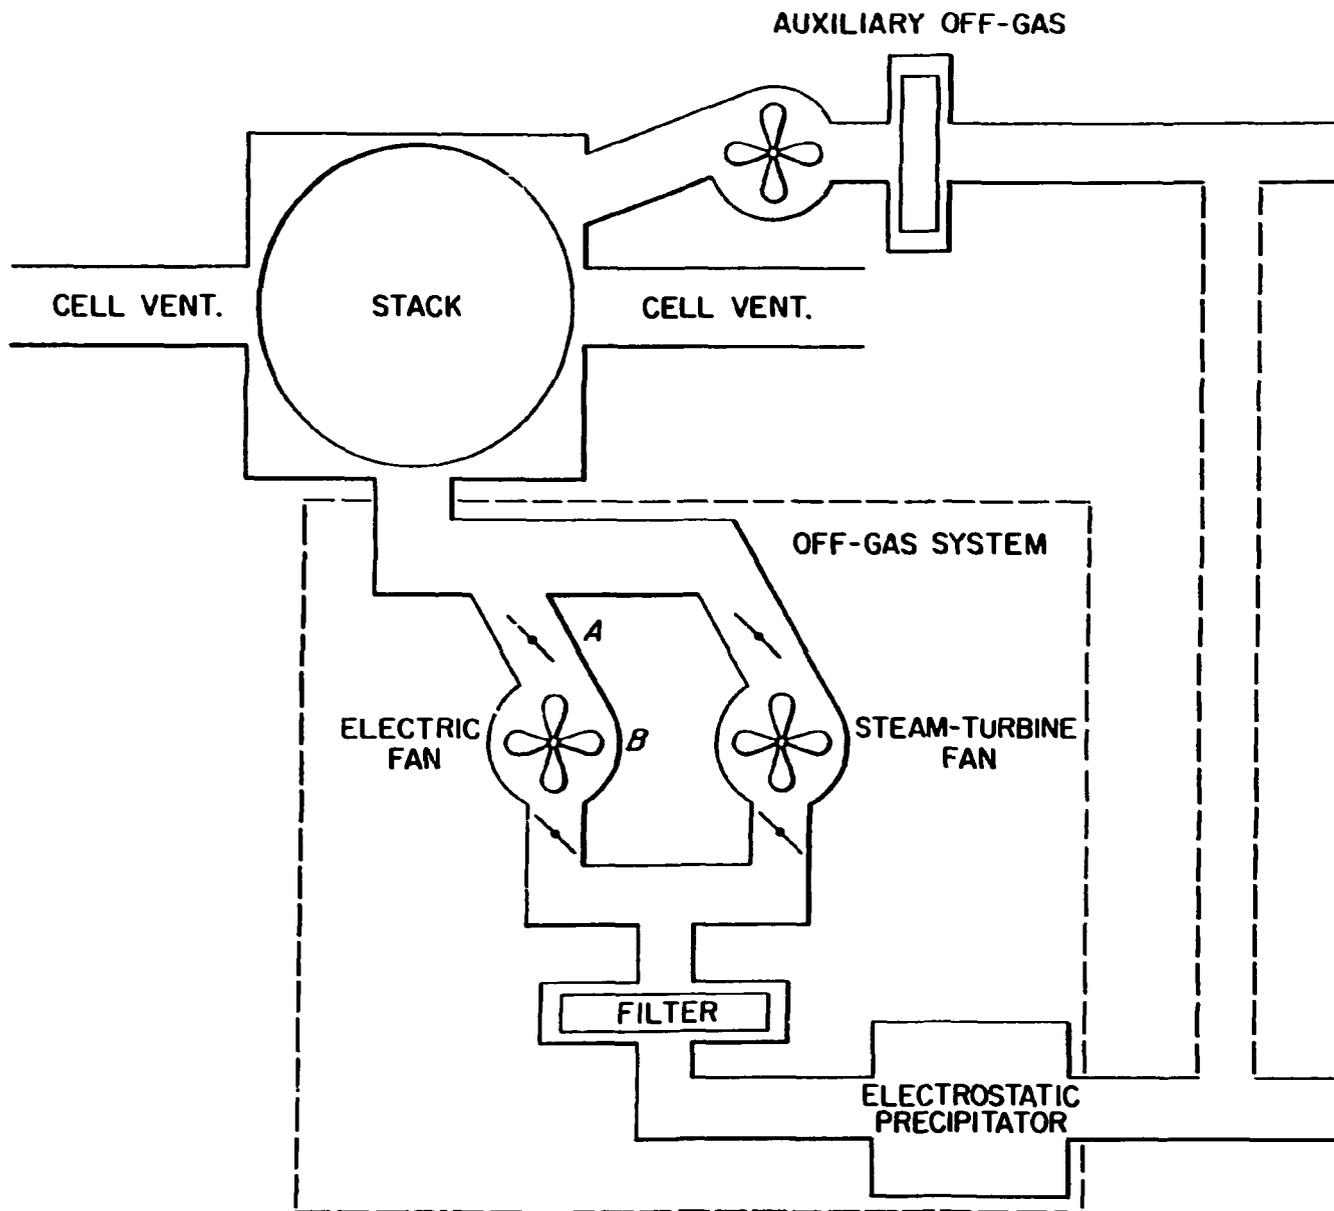
An appreciation of the physical layout of the gaseous waste disposal system associated with the brick stack is essential to an understanding of the circumstances leading to the incident. A schematic sketch of the off-gas system is shown in Fig. 1. The first element requiring maintenance was the exhaust damper or valve of the electric fan (indicated by A). The second maintenance problem was one of the bearings of the electric fan itself (indicated by B). Hence on two occasions there was opportunity for mechanical vibration and shock to detach particles on the duct walls of this fan. Not shown on the diagram (Fig. 1) is the stack monitoring arrangement. This consists of a gas stream collected from 40 feet above ground level in the stack and conducted by a small diameter pipe (~ 1 to 1 1/2" diameter) to a collection filter located near ground level. The filter is normally checked daily. An experimental filter-monitor, checked weekly, has been attached to this same sample line during the past several months.

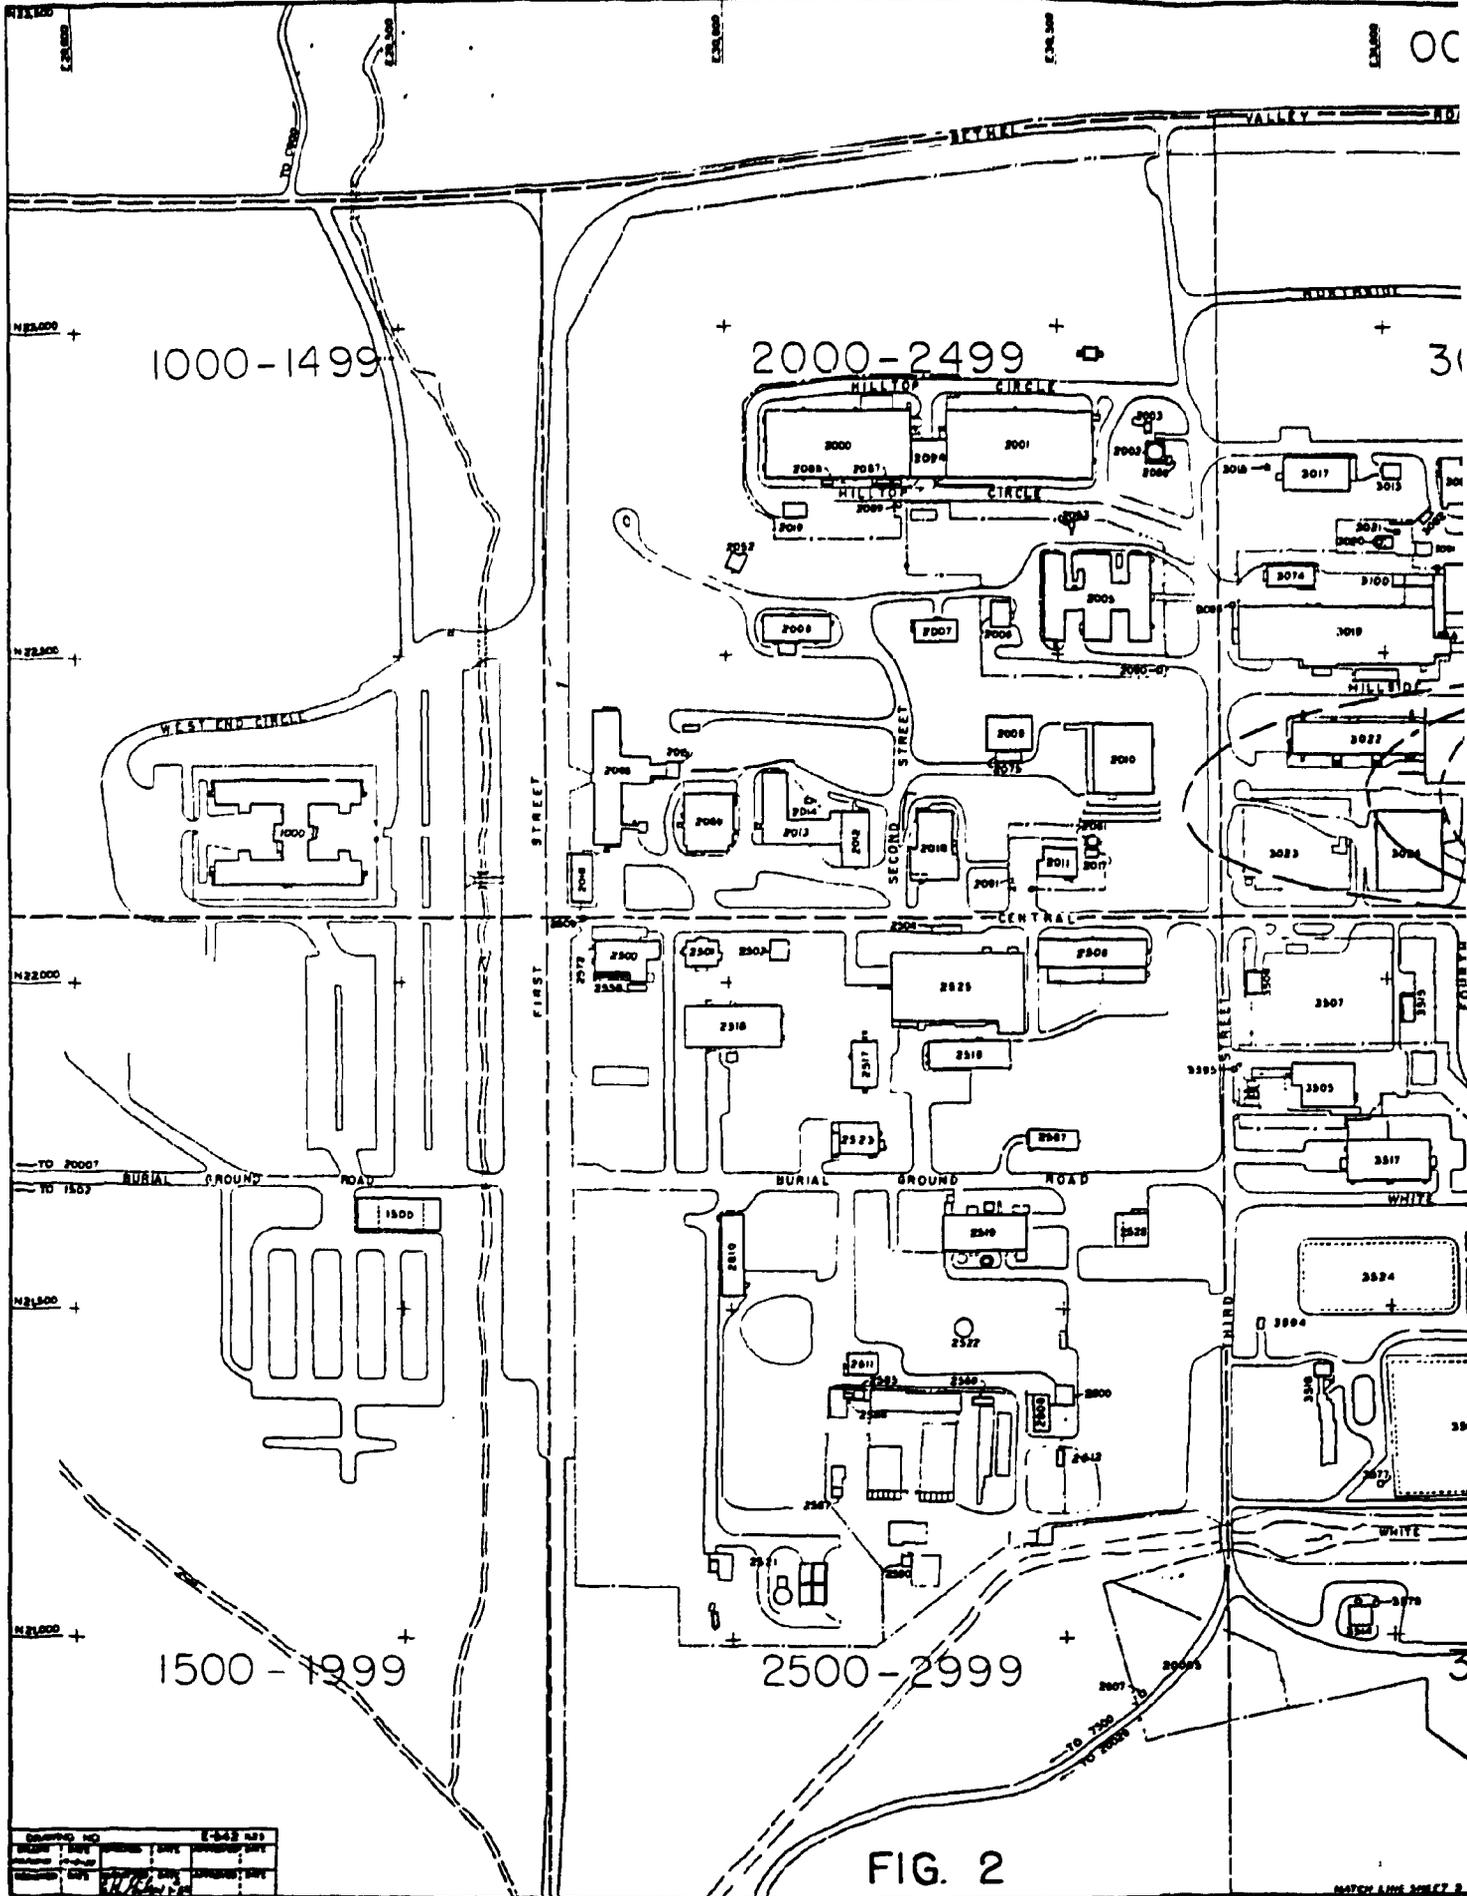
FIG. 2

Numbers associated with contour lines represent a rough average of readings in $\mu\text{r}/\text{hr}$ taken with a G.M. survey meter at grass top level in the areas indicated. Some isolated spots of intensity higher than shown could be found throughout the contaminated area.

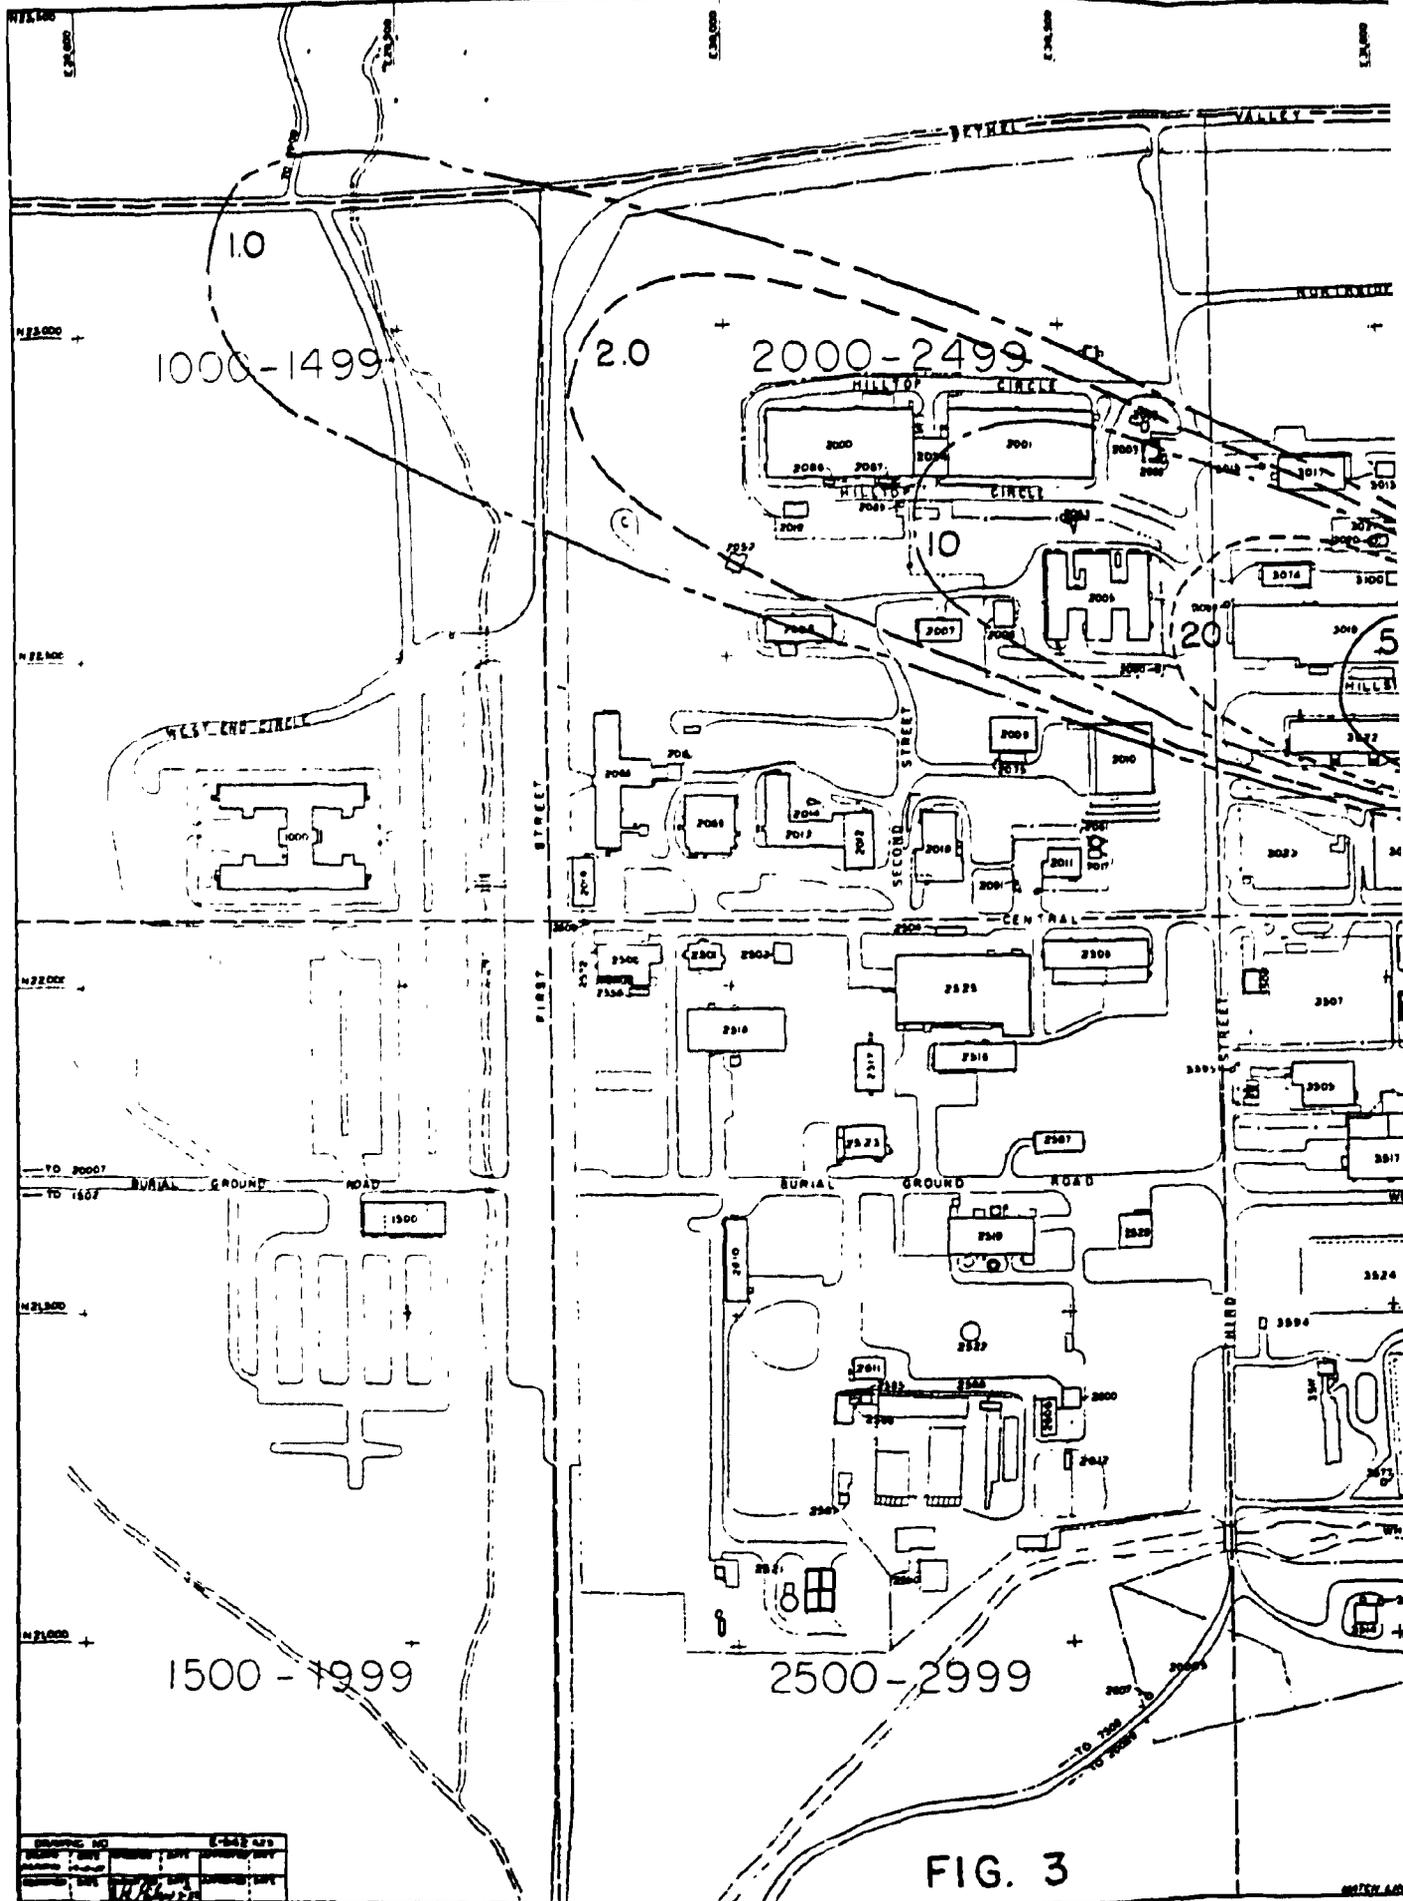
FIG. 3

Numbers associated with contour lines represent a rough average of readings in $\mu\text{r/hr}$ taken with a G.M. survey meter at grass top level in the areas indicated. Some isolated spots of intensity higher than shown could be found throughout the contaminated area.

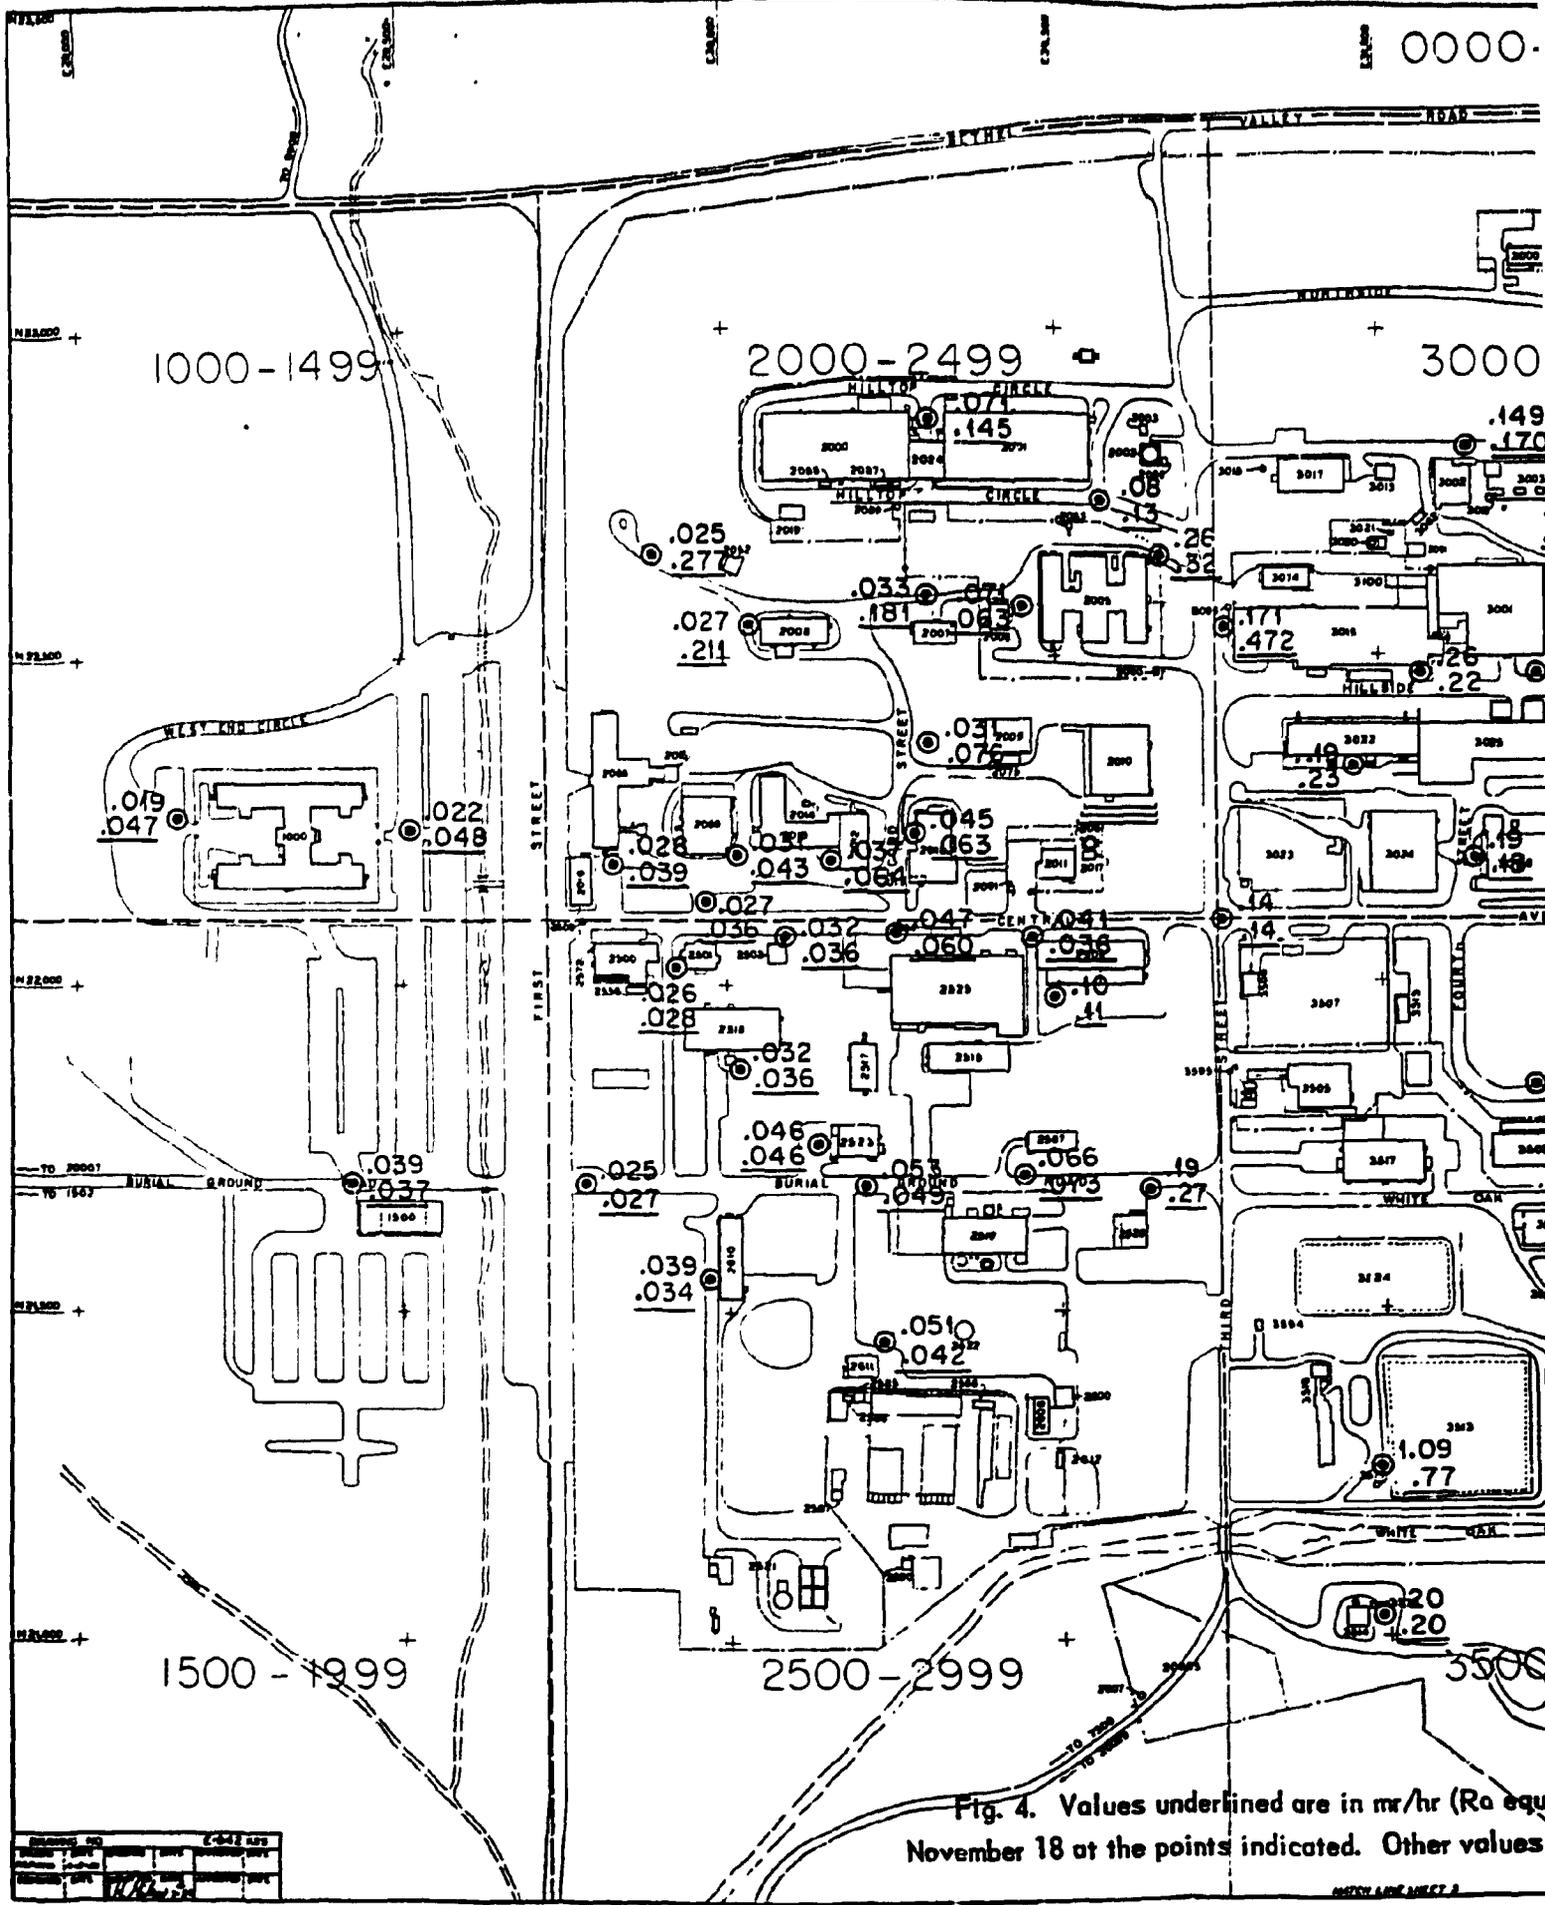
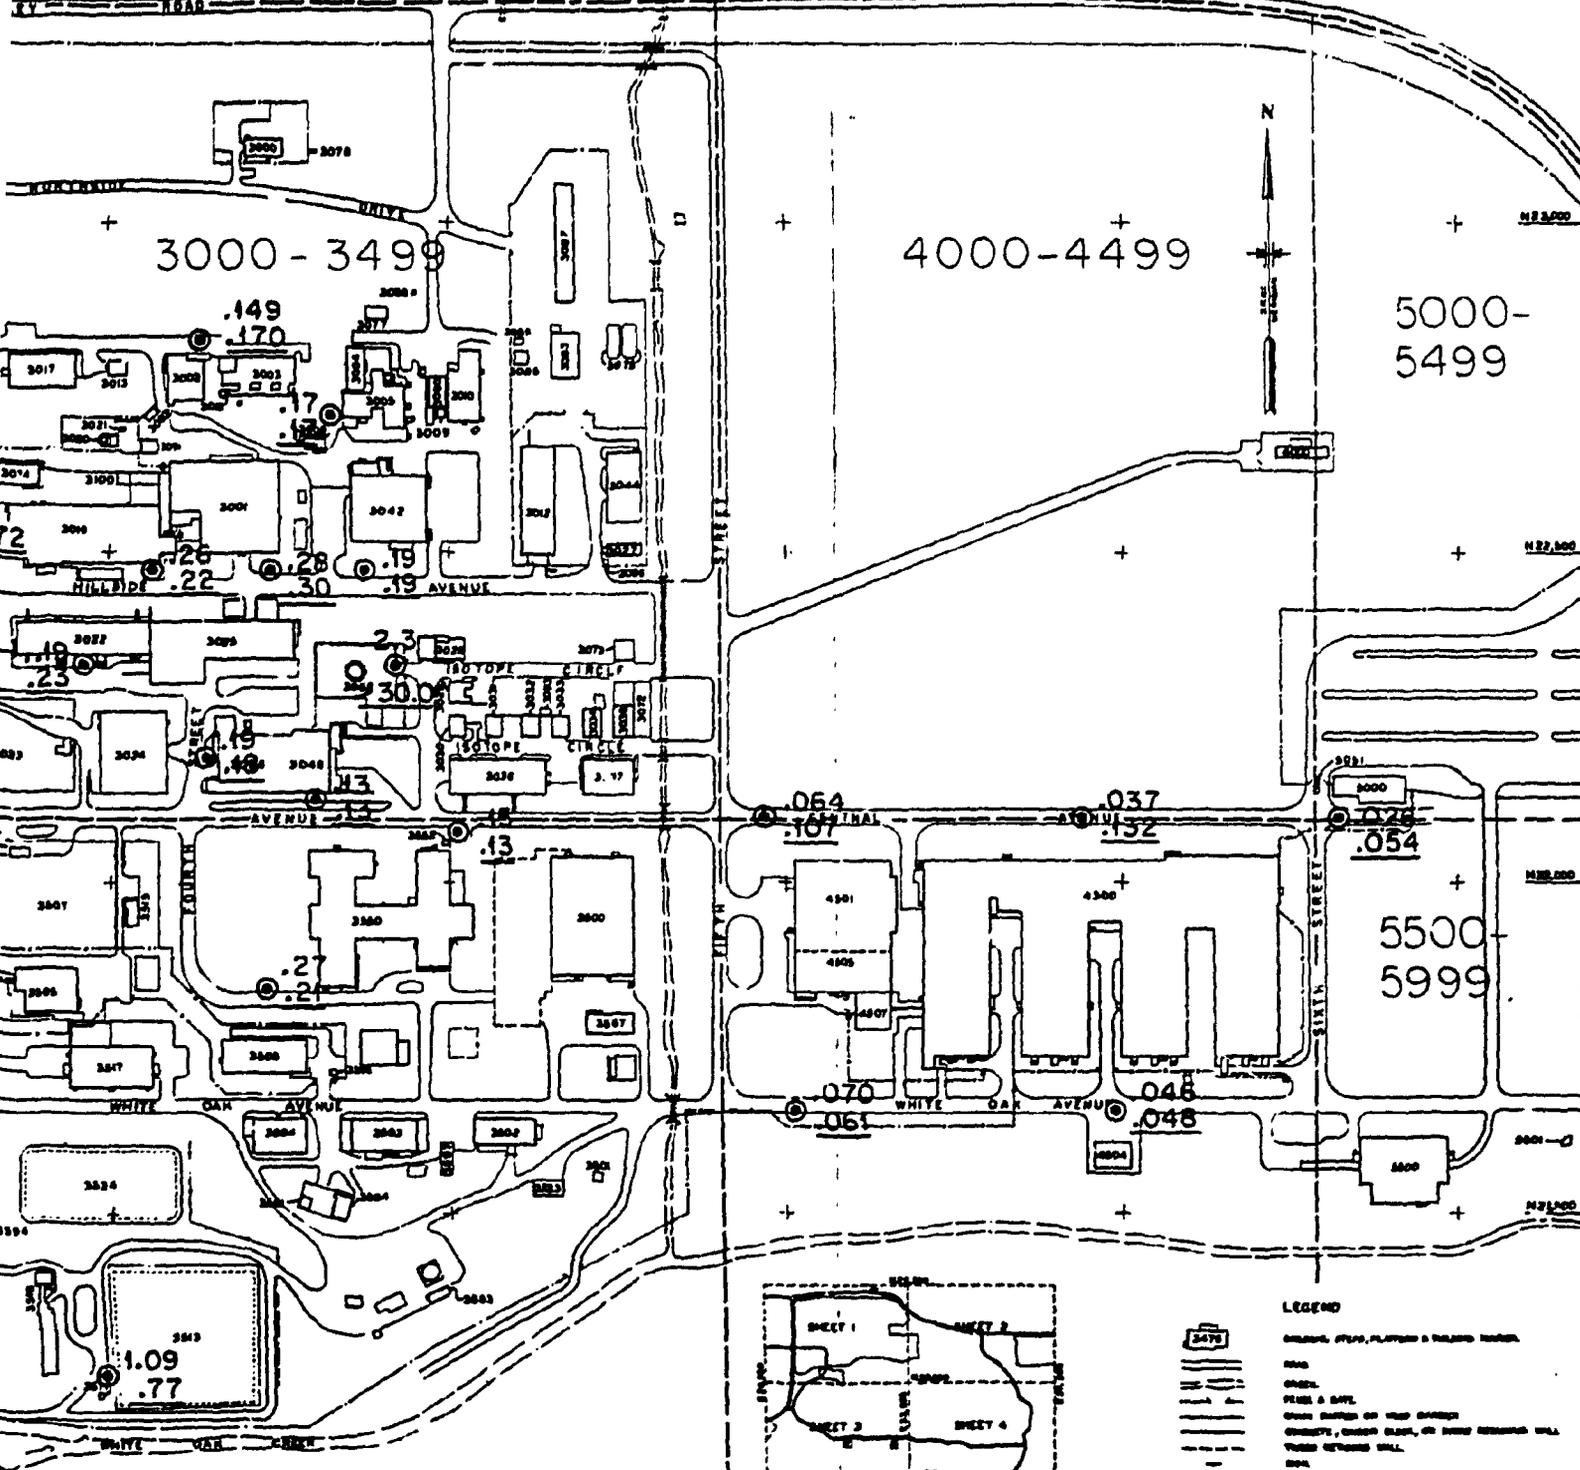
Figure 4 shows a survey map of the Laboratory area with radiation levels before and after the fallout (October 29th and November 18th) indicated at various points. These values were obtained by J. S. Sprain of the Health Physics Division in the regular monthly area survey program. Readings were taken with a G.M. survey meter at a height of ~ 3 ft above the road surface from a fixed position at the rear of a panel truck. The counter is calibrated in units of mr/hr with a radium source. The mr/hr readings given in Figure 4 should be regarded as nominal only since an unknown fraction of the reading is due to beta radiation.

This map shows that clean-up operations on roads and sidewalks have been effective in reducing radiation levels to values approaching those which existed before the accident, with a few exceptions.

are in m/hr (Ra equivalent) and were obtained on
indicated. Other values were found on October 29
