ANL-82-86

FAILURE ANALYSIS OF CRACKED HEAD SPRAY PIPING  
FROM THE DRESDEN UNIT 2  
BOILING WATER REACTOR\*

D. R. Diercks and G. M. Dragel

July 1983

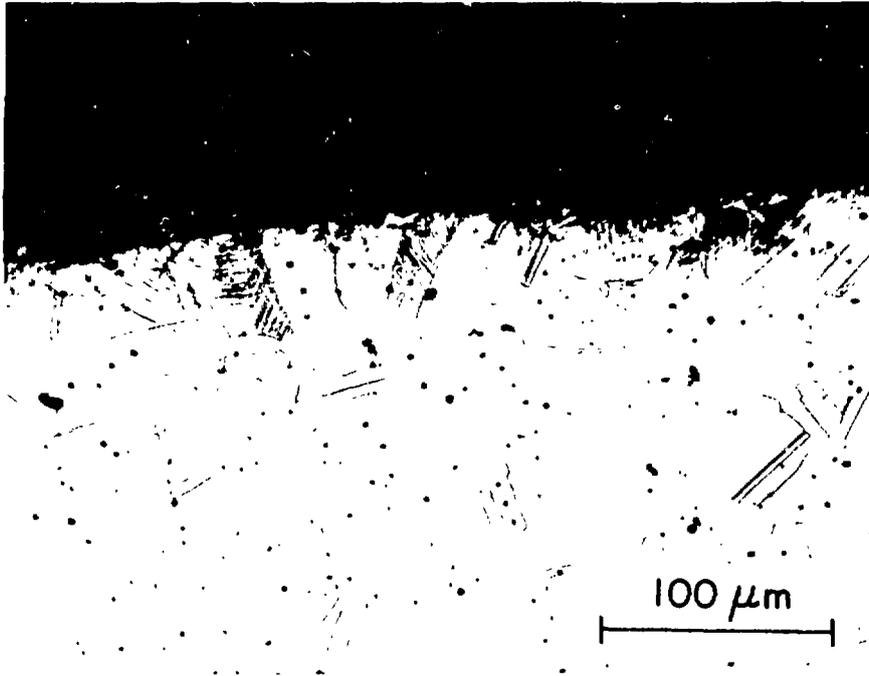
Figure 5 shows the microstructure present under the helical stripe at the outer surface. No cracking is present at this location, but the slip bands seen in the austenite grains near the surface indicate that this region was cold worked. The deformation is relatively light, however, and extends no more than a few grains into the interior of the specimen. Similar deformation was seen at locations on the outer surface away from the stripe, but it was generally not as extensive.

Fig. 5. Microstructure Under Helical Stripe on Outside Surface of Piping.

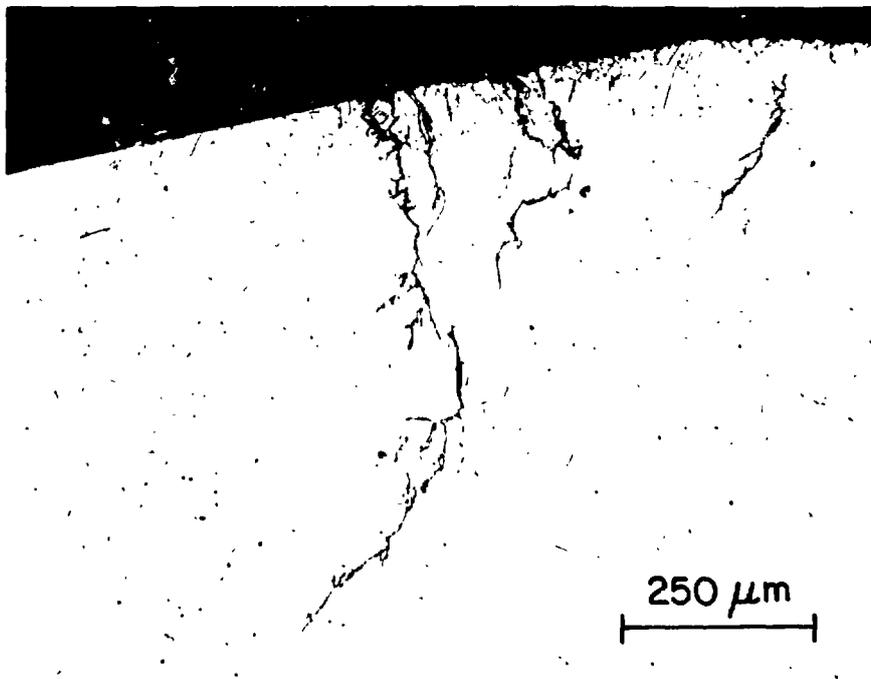
The appearance of several cracks that do not extend through the pipe wall and one crack that does extend through the wall, present on the outer surface of the head spray line, is shown in Figs. 6-9. The cracks are all transgranular, tend to be highly branched, and in some cases (see Fig. 9) have associated surface pitting. All of the cracks observed, including the leaking cracks, appear to have originated at the outer surface of the piping. The microstructural features associated with the cracking strongly suggest chloride-induced stress corrosion cracking as the cause of failure.

Fig. 6. Section through Transgranular Cracking on Outer Surface of Piping.

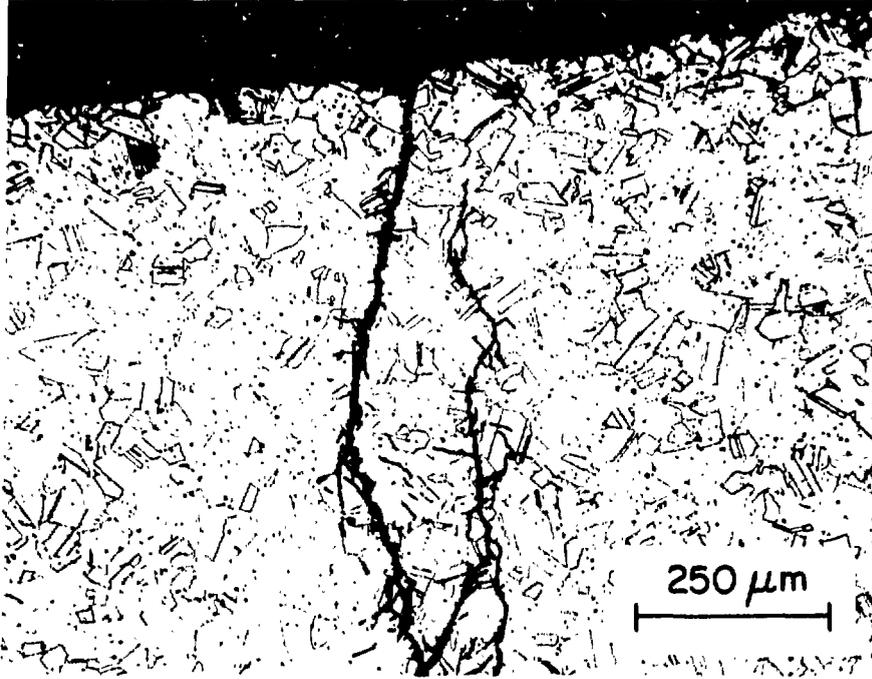
Fig. 7. Transgranular Cracking on Outer Surface of Piping.

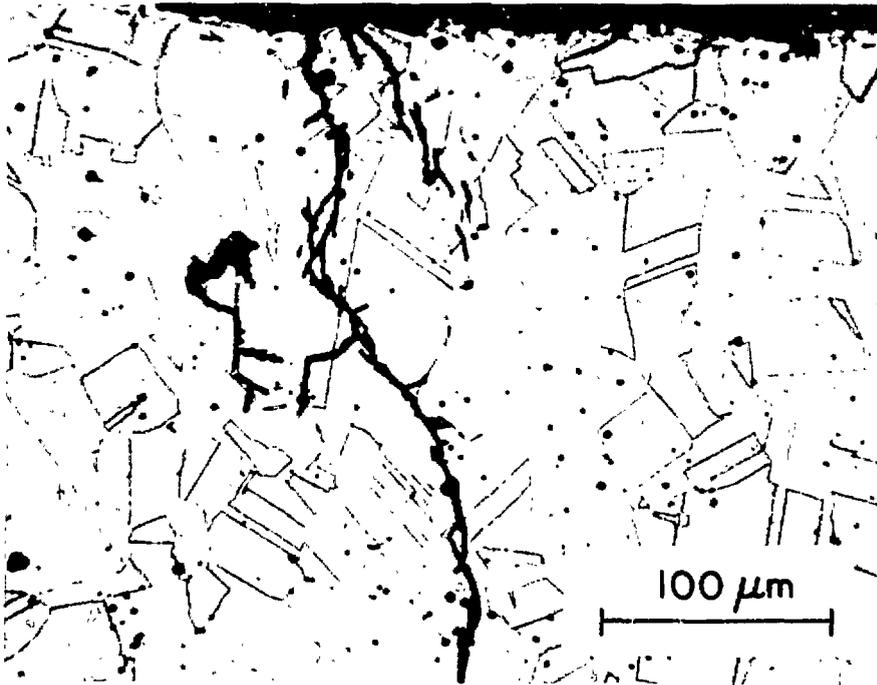
Fig. 8. Higher Magnification View of Cracking on Outer Surface of Piping.

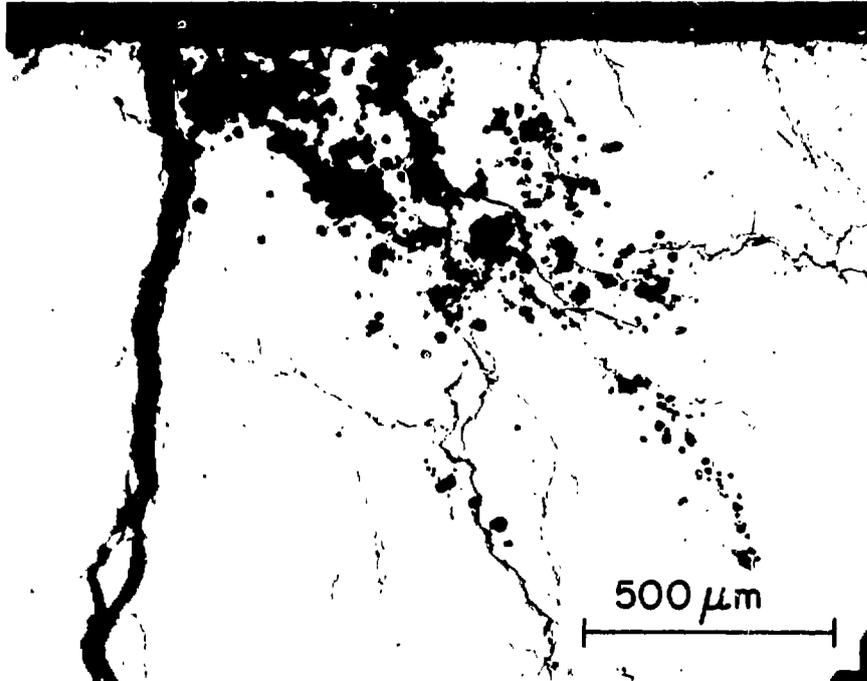
Fig. 9. Surface Pitting and Cracking on Outer Surface of Piping. The wide crack at left penetrated through the wall of the piping.

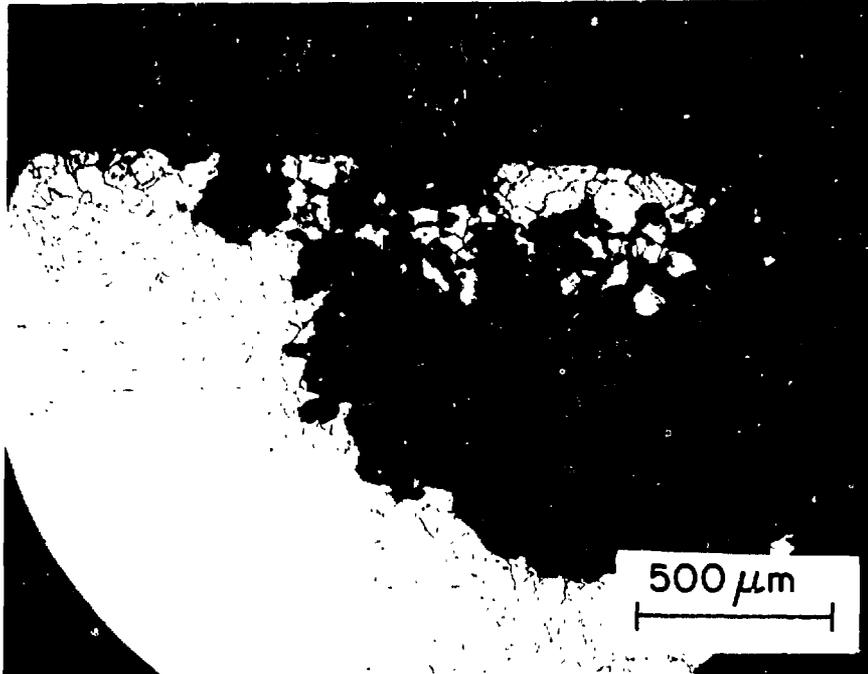
A profile through one of the surface pits is shown in Fig. 10 at low magnification. Unlike the pitting seen in Fig. 9, no cracking is associated with the relatively large, isolated pit. However, the extensive undercutting and the interconnected "cavern" appearance again suggest the presence of chlorides at the outer pipe surface.

Fig. 10. Profile through Surface Pit on Outside Surface of Failed Piping.

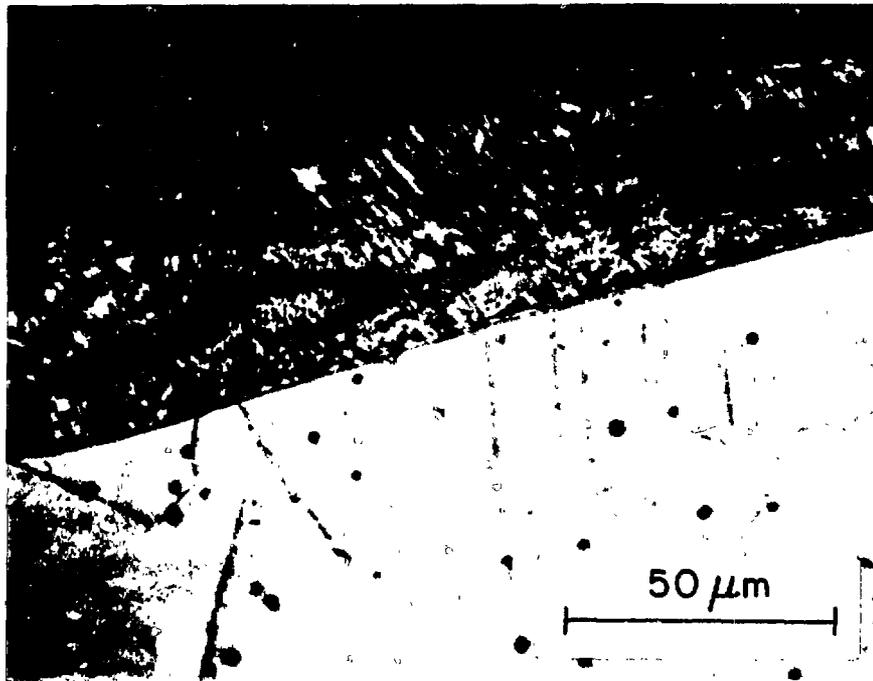
One microstructural feature observed but not satisfactorily explained can be seen at the surface of the specimen shown in Fig. 6, immediately to the left of the longest crack. This dark etching surface layer is shown in more detail in Fig. 11. This feature was seen on only one of the specimens and extended for a distance of several millimeters on the outer surface. It did not appear to be directly associated with either the helical stripe on the outer surface or with the cracking. Although the needle-like appearance of this surface feature is somewhat suggestive of a martensitic structure, its exact nature and cause remain unexplained.

Fig. 11. High-magnification View of Dark Etching Surface Layer Present on a Portion of One Failed Piping Sample.

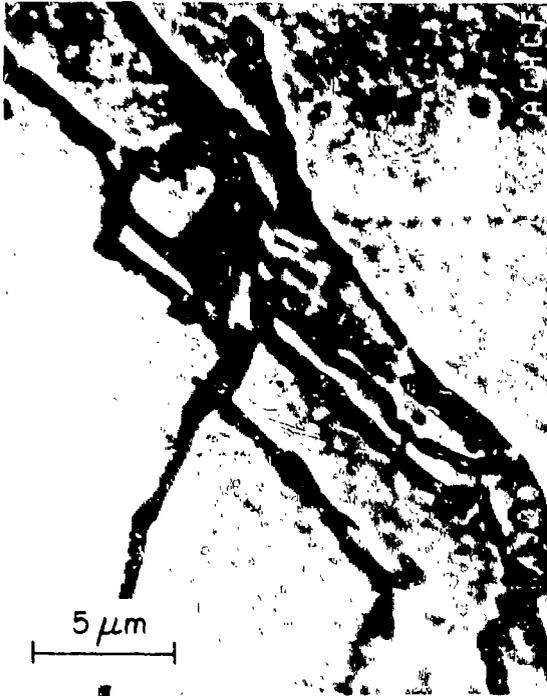
Selected cracked regions of the piping were examined in the scanning Auger microprobe in an attempt to identify the corrosion product present. Typical results are shown in Fig. 12. The cracked region shown in the Auger electron image of Fig. 12a was mapped for the selected elements Fe, Cr, and O, by adjusting the Auger electron detector to detect electrons only at the appropriate energy intervals. The results clearly indicate a relatively high oxygen concentration in the corrosion product present in the crack, and also indicate Fe and Cr to be somewhat depleted. The Cl concentration was below the detection capabilities of the instrument.

Fig. 12. Scanning Auger Microprobe Auger Electron Image (a) and Fe, Cr, and O Elemental Maps (b)-(d) At and Near Transgranular Crack in Piping.

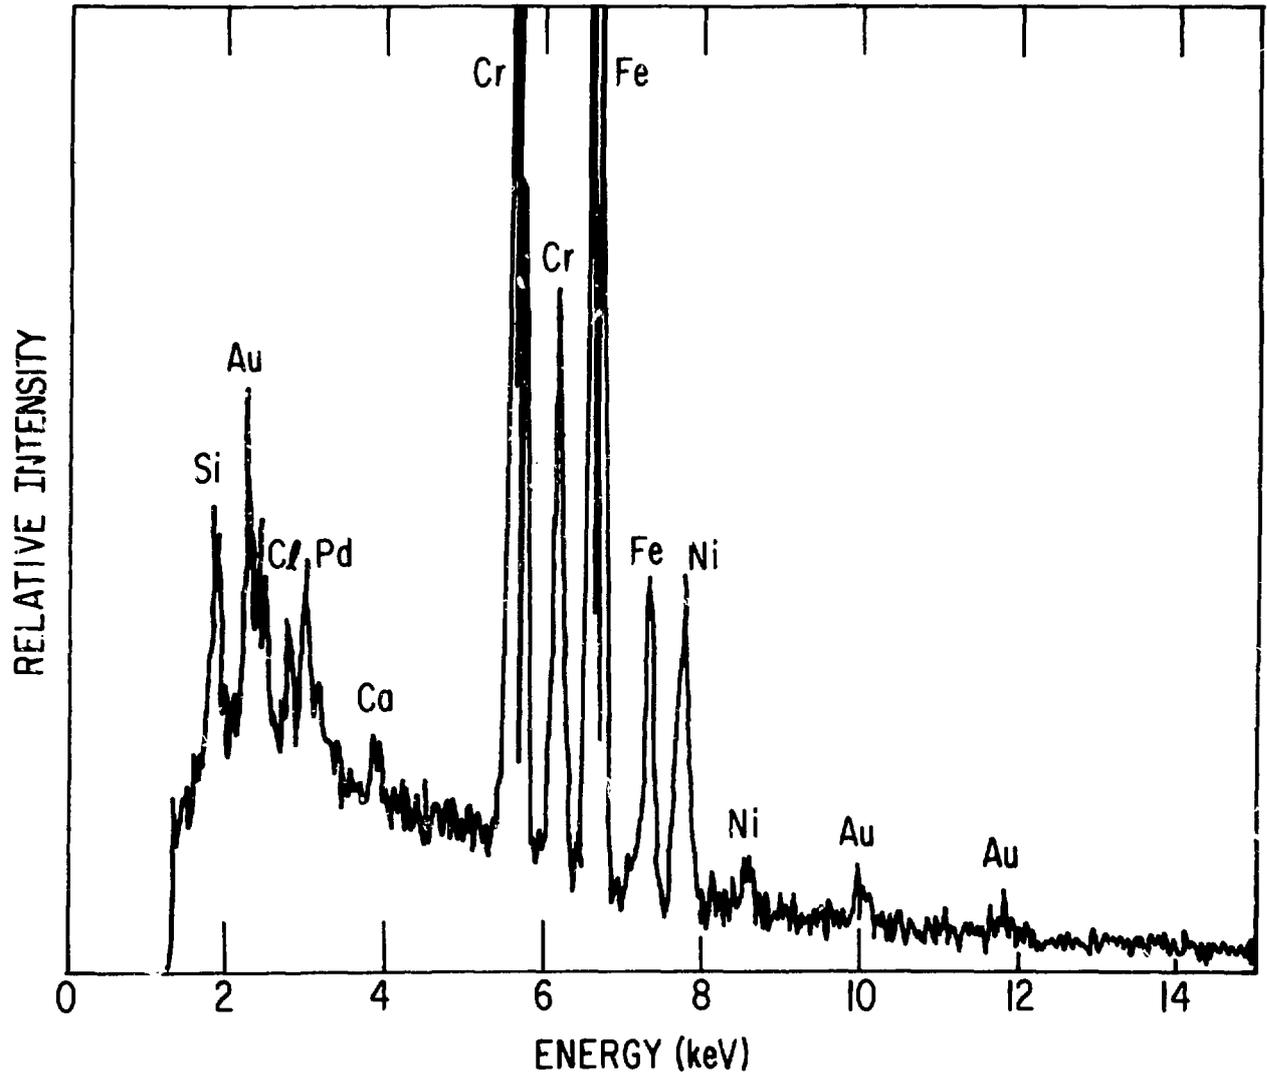
The spectrum from the corrosion product in the crack (Fig. 13) shows strong Fe, Cr, and Ni peaks, as expected, and also Si, an impurity in the alloy, and Au and Pd, which were applied to the mounted sample as a thin coating to provide electrical conductivity across the bakelite mounting material. Of particular interest, however, is the presence of well-defined peaks at about 2.6 keV, corresponding to the energy of characteristic Cl K $\alpha$  radiation, and 3.7 keV, corresponding to the energy of characteristic Ca K $\alpha$  radiation. These same two peaks are absent from the x-ray spectrum obtained from the piping material away from the crack (Fig. 14), even though the x-ray count time was even longer in the latter case. Hence, the presence of Cl (<1 wt %) in the cracks is clearly indicated.

Fig. 13. SEM X-ray Spectrum Obtained from Corrosion Product in Crack in Failed Piping.

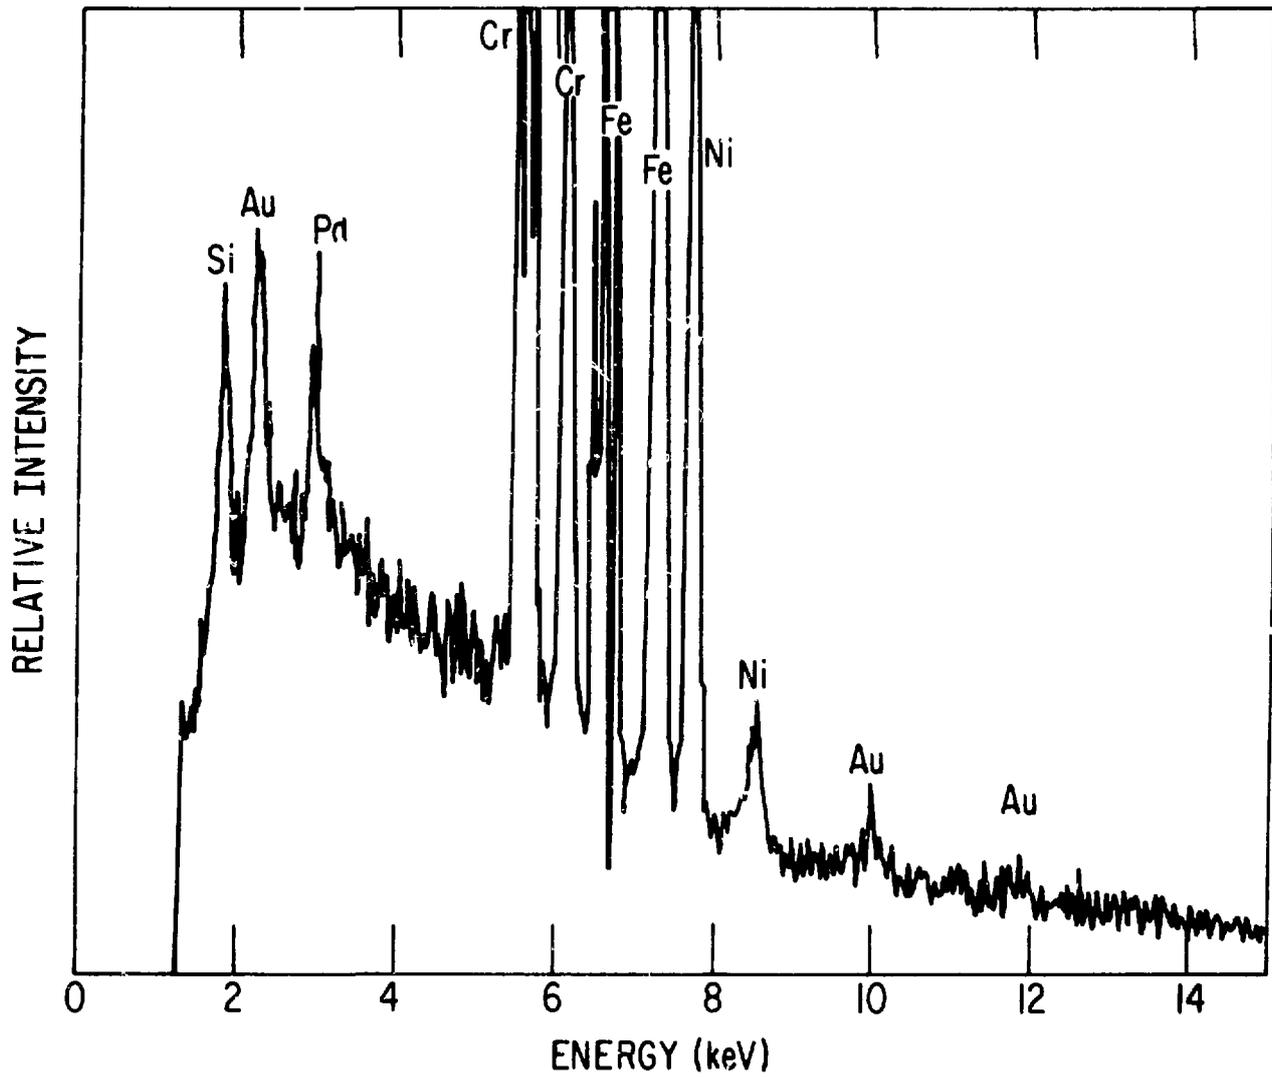
Fig. 14. SEM X-ray Spectrum Obtained from Base Metal Away from Cracking in Failed Piping.
