**CANDU-PHW  
Fuel Channel  
Replacement Experience**

by J.T. Dunn, B.K. Kakaria  
Atomic Energy of Canada Limited;  
J. Graham, A.H. Jackman  
Ontario Hydro

Presented to the IAEA  
Specialists' Meeting in  
Riso, Denmark

AECL-7538

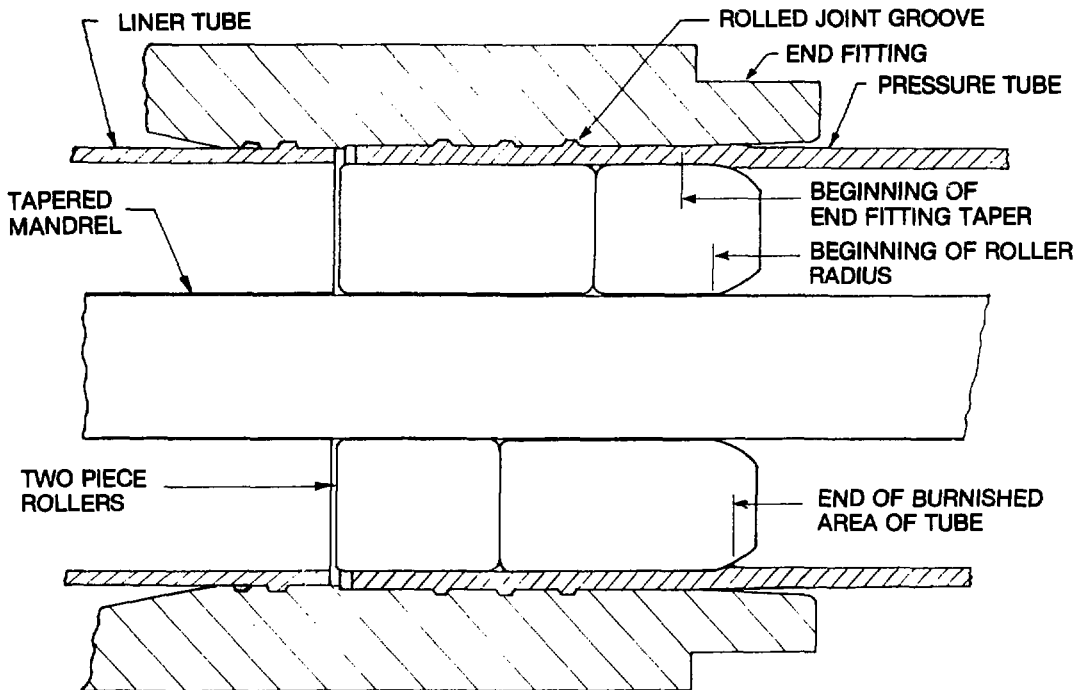
**FIGURE 3 CROSS SECTION OF A PRESSURE TUBE ROLLED JOINT  
DURING ROLL EXPANDING**

Figure 3 shows the cross-section of a rolled joint. Three grooves are machined in the end fitting bore, and

the pressure tube is inserted into the end fitting covering the grooves. A tube expander is introduced into the pressure tube through the end fitting and the tube is roll-expanded into the end fitting. The pressure tube wall thickness is reduced by 12-15% and the grooves in the end fitting are partially filled with the pressure tube material. The axial strength and leak-tightness of the rolled joints were established by extreme qualification testing, and have proved very satisfactory in operation.

The improper rolling was caused by over insertion of rollers, by approximately 13 mm, expanding the pressure tube beyond the end of the supporting surface on

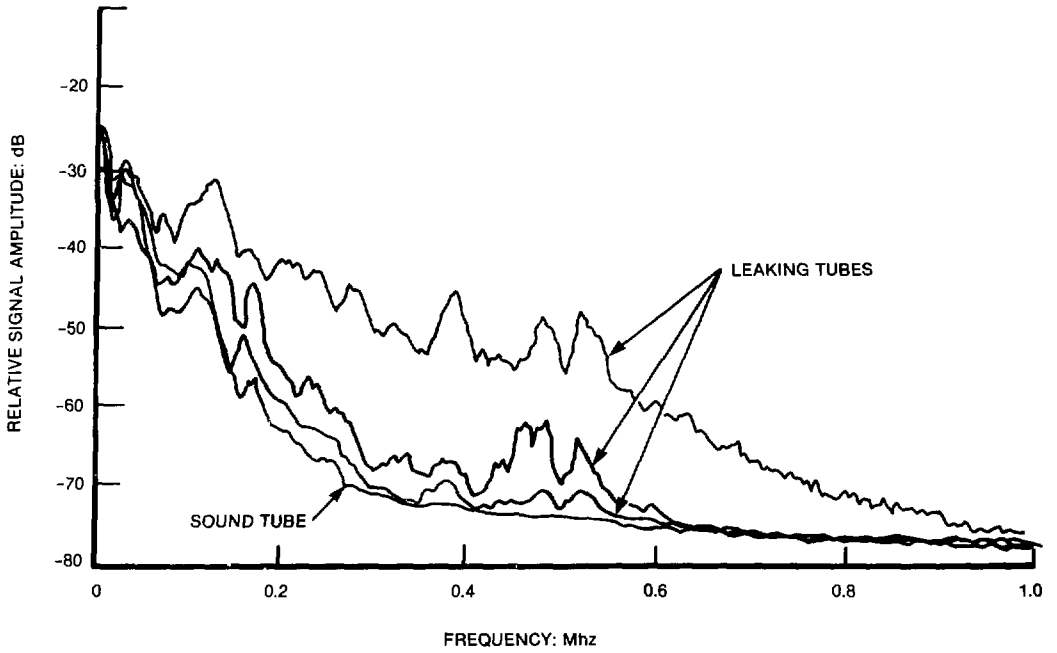
**FIGURE 5 CHARACTERISTIC ACOUSTIC EMISSION FREQUENCY SPECTRA**

Alternative methods of leak detection were investigated and the one that proved best was acoustic emission where the noise emitted by the leaking water could be detected, Figure 5. This method was used when further leakage in Unit 3 was confirmed and sixteen leaking channels were identified.

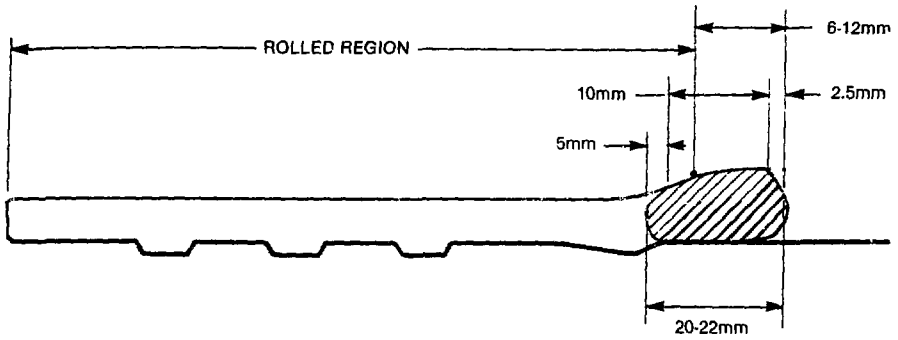
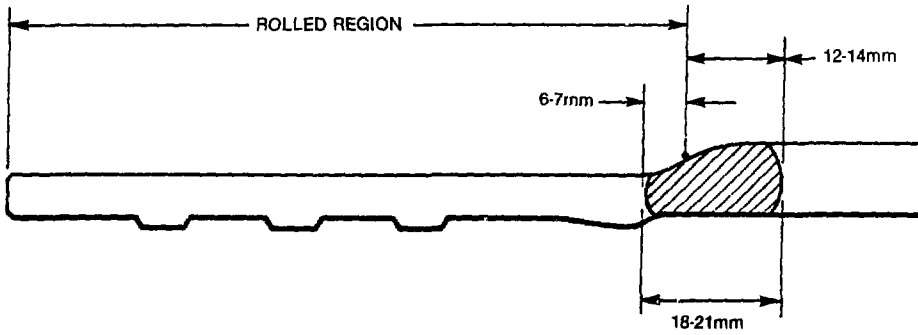
FIGURE 8 DIMENSIONS AND LOCATION OF DEFECT IN PRESSURE TUBE

The examination of the leaking Bruce Unit 2 pressure tube has led to the conclusion that the crack is similar to that seen at Pickering (Figure 8), and initiated during the two years between rolling and stress relief. At the time of stress relief this crack was about 0.3 mm deep permitting it to propagate during reactor shutdowns by delayed hydride cracking during the reactor shutdowns.

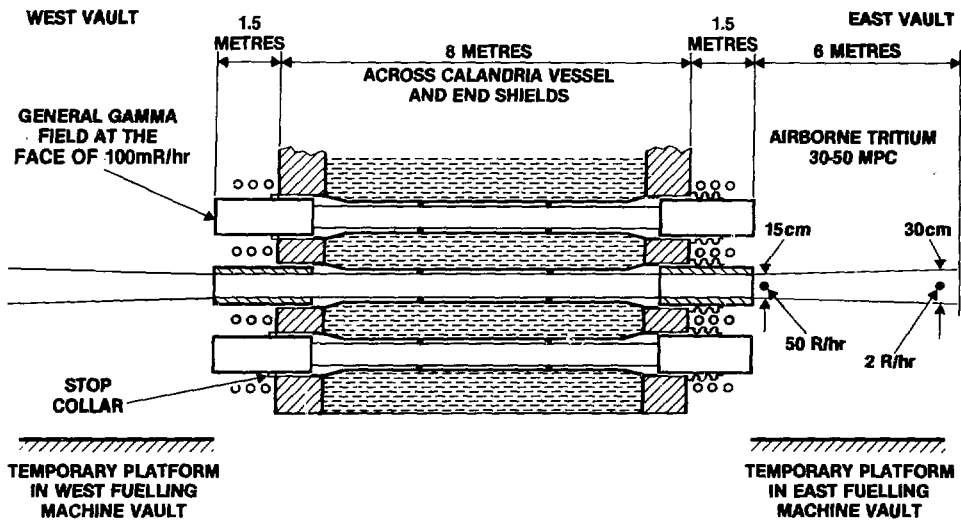
**FIGURE 12 RADIATION BEAM IN THE FUELLING MACHINE VAULTS WITH SHIELDING PLUGS REMOVED FROM THE CHANNEL**

Prior to the start of on-reactor fuel channel replacement operations it was necessary to prepare the vault. Since the fuelling machine bridge is only about 1 m wide, it was necessary to mount working platforms on both bridges. These were relatively light structures, designed to support personnel and light equipment with local reinforcing to transfer the weight of the shielding flasks to the bridge structure. Access facilities between the working platforms and vault floor was relatively straightforward since the fuel channel to be replaced was located only slightly above the floor level. Relatively low general fields (100 mR/hour) did not necessitate the use of personnel shielding cabinets, Figure 12.

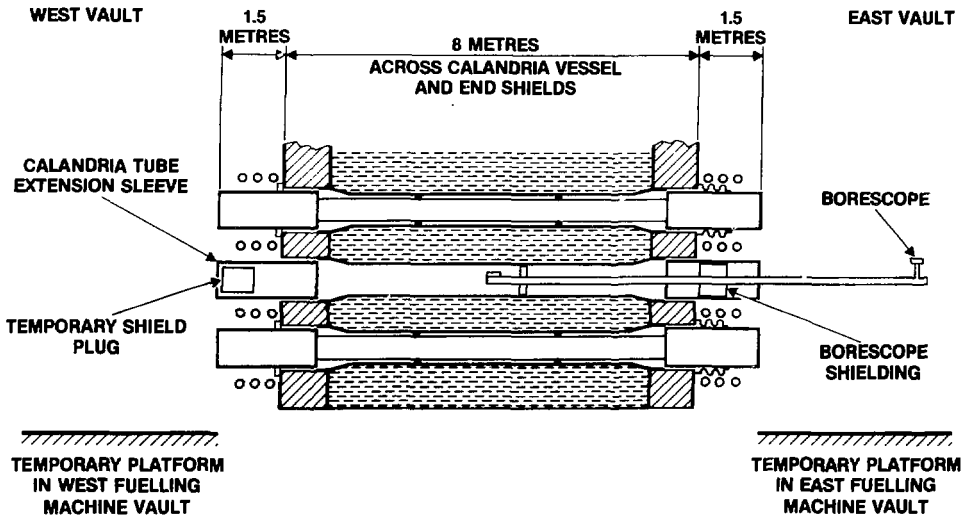
FIGURE 20 BORESCOPE INSIDE THE CALANDRIA TUBE

The calandria tube was then cleaned by pulling swabs through it, the bore visually examined using a borescope and its condition was found to be excellent, Figure 20. The calandria tube extension sleeves were then removed from both ends of the reactor.
