The Axial Location of Cladding Failure During a Slow Transient Overpower TREAT Test

R. J. Page, W. F. Murphy and J. W. Holland

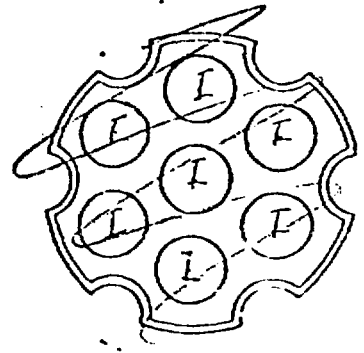
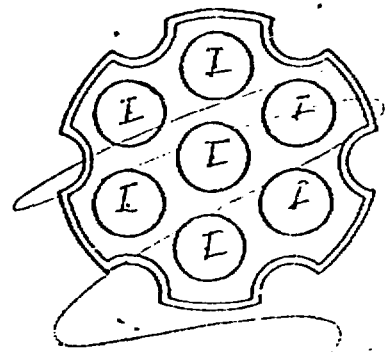
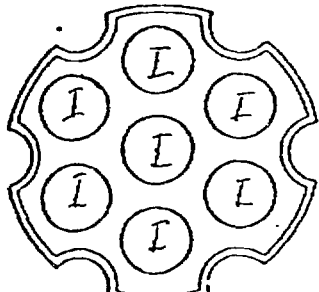
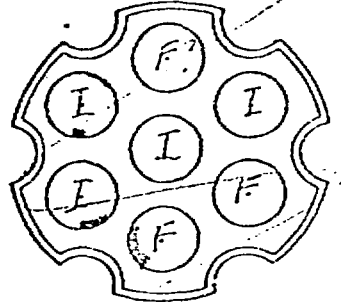
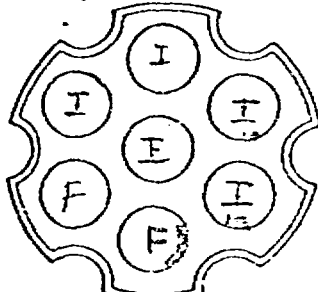
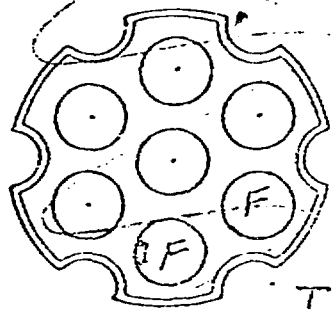
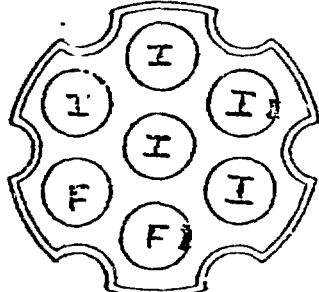
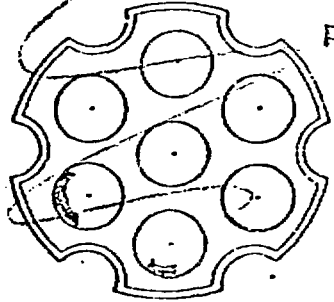
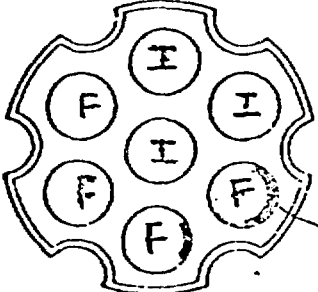
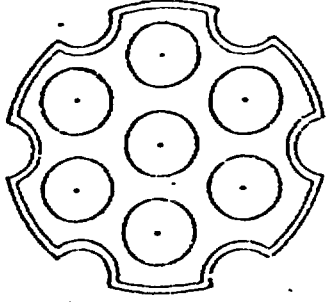
Fig 1

The fuel pins at 2, 4 and 6 o'clock failed. The failures started at the tops of the fuel columns and extended upward along the insulator pellets for a total length of about 20 mm. Cladding failures tended to be toward the outside of the cluster with a bias toward an adjacent pin. The fuel expelled from one pin may have contributed toward failure of an adjacent element. The fuel expelled from the three failed elements was not enough to make a significant blockage to coolant flow.

The axial and circumferential locations of cladding failure are showed schematically in Fig. 1. Also shown are the locations of fuel pellets and insulator pellets, indicating the extent of fuel expansion. Fig. 2 is a cross-section of the fuel pin bundle about 10 mm above the top of the original active fuel column.

Cladding failure locations for the J1 test.

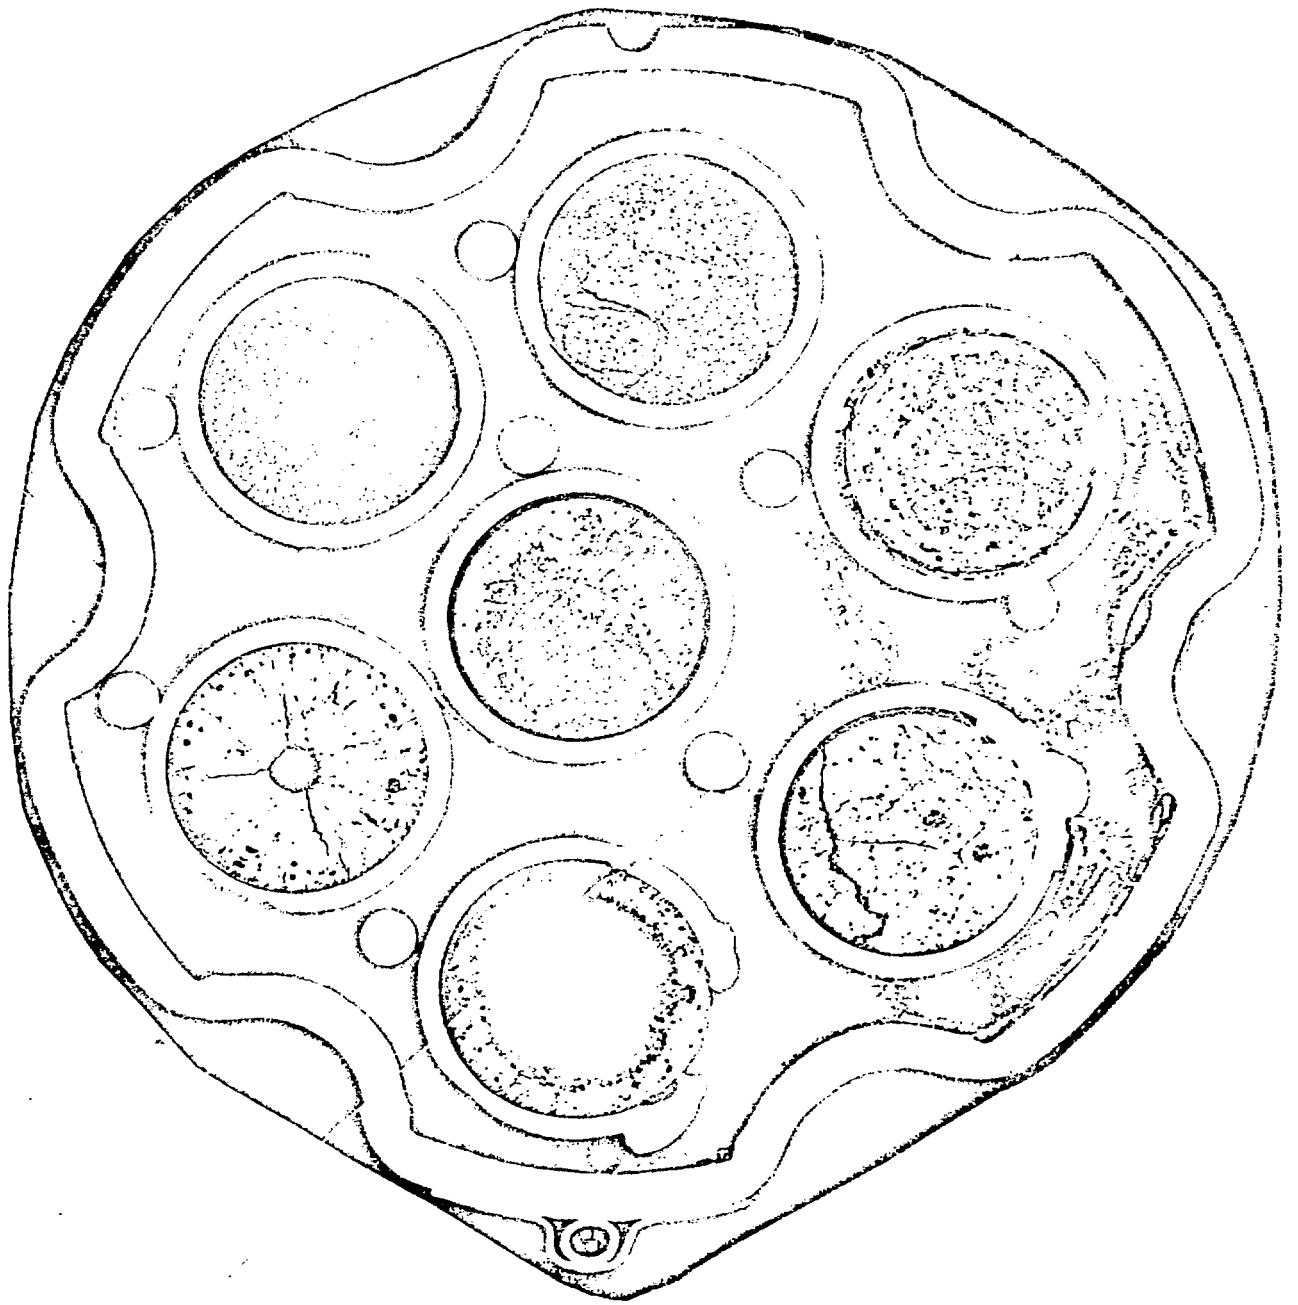
Fig 2. Cross-section of J1 fuel pin bundle at $x/L = 1.03$.
