**FLAW DENSITY EXAMINATIONS OF A CLAD BOILING WATER
REACTOR PRESSURE VESSEL SEGMENT***

K. V. Cook and R. W. McClung

Metals and Ceramics Division
OAK RIDGE NATIONAL LABORATORY
Oak Ridge, Tennessee 37831

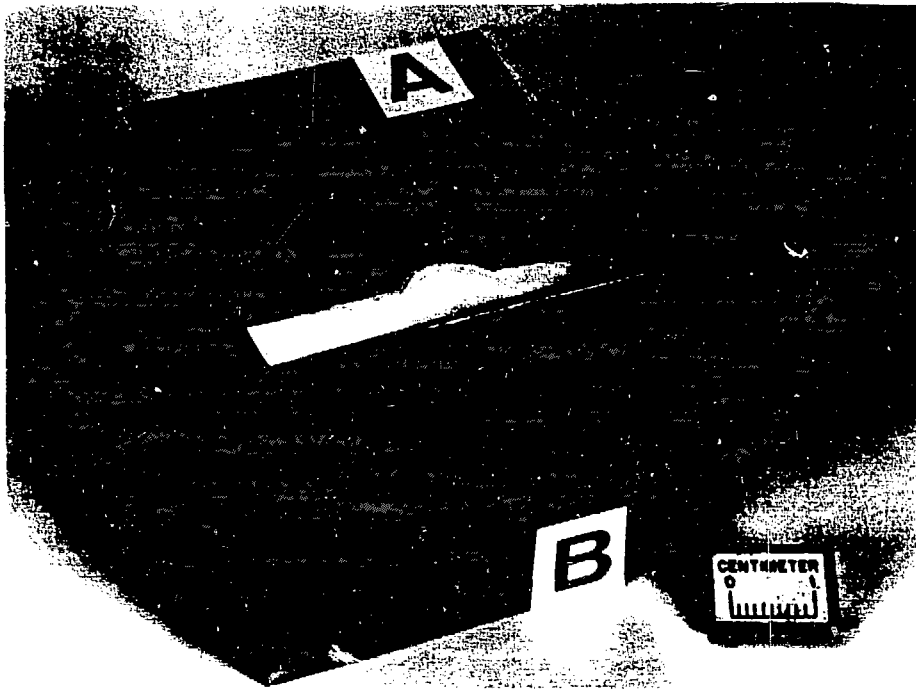
One indication located approximately 25 mm (1 in.) from the end of sample 2 in the longitudinal seam weld was detected by multiple ultrasonic examination techniques as described in the previous sections. Prior to removing the cladding, we removed a slice containing this indication (from sample 2) and, after further machining, currently have it in an approximate 51-mm-square (2-in.) specimen as shown in Fig. 7. Radiographs (Fig. 8) of the 51-mm-square specimen indicate the three-dimensional shape of the reflector as projected on the surfaces identified arbitrarily as A, B, and C (Fig. 7). Subsequent ultrasonic evaluation of the specimen confirmed a similar shape for the reflector and reconfirmed the two discrete (i.e., time-separated) indications from the clad side as reported earlier in the section on supplemental normal-beam evaluations (i.e., measurements made prior to machining the specimen from the vessel segment).

Fig. 7. Cubic sample (51 mm) containing discontinuity.

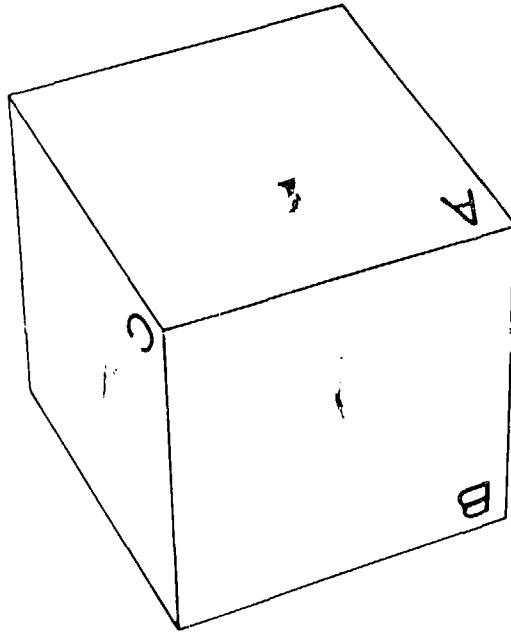
The reflector is basically a linear indication along the weld direction with a planar extension of about 6 mm (view A of Fig. 9) in one small zone [~ 3 mm wide in the shape of the vertical tail section of an airplane (view C of Fig. 9)]. The linear dimension approximates 20-mm. Figure 10 is a three-dimensional drawing showing the assumed flaw shape. Plans are to further analyze the size and source with metallographic techniques.

Fig. 9. Approximate shape of discontinuity in Hope Creek Unit 2 specimen (projections from radiography).

The one indication that remains is apparently a real discontinuity located in the longitudinal weld. It appears to be a "pipelike" indication, about 20 mm (0.8 in.) long extending along the length of the longitudinal weld in which it is located, and is about 20 mm below the clad surface. As observed from three-view radiography, the flaw appears to be three-dimensional and has a through-wall dimension (or length) of about 6 mm (~0.24 in.) for an approximate 3-mm (0.1-in.) distance along the 20-mm major length. The maximum through-wall dimension (i.e., the 6-mm length) determined by radiography begins about 14 mm (0.6 in.) below the clad surface and extends to the approximate 20-mm depth of the major (pipelike) flaw that it intersects.

Further investigations of the actual dimensions and sources will be done with metallographic sectioning. This indication is being destructively analyzed, even though it is not of Code size because it was recorded by a 20% DAC recording criteria and was detected by multiple ultrasonic tests.

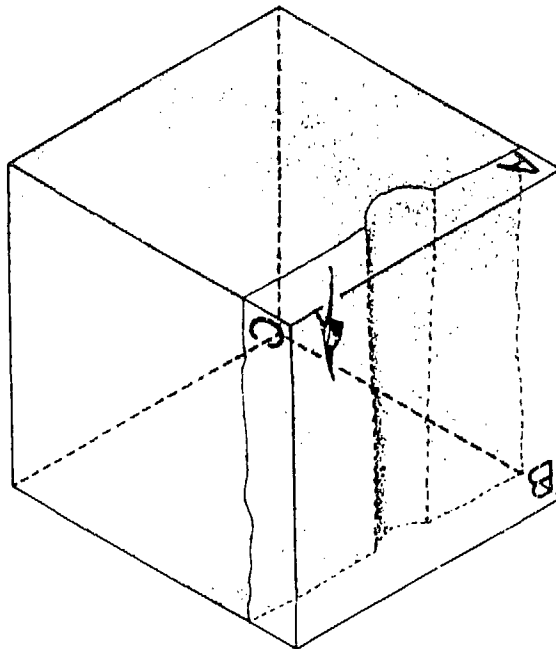
Fig. 10. Isometric drawing showing approximate shape of discontinuity detected in Hope Creek Unit 2 sample by ultrasonics.
