**FAILURE INVESTIGATION OF STEM OF VALVE DISC IN
REACTOR RECIRCULATION SYSTEM OF TAPS UNIT-1**

**E. Ramadasan, J.K. Bahl and K.S. Sivaramakrishnan
Radiometallurgy Division**

**BHABHA ATOMIC RESEARCH CENTRE
BOMBAY, INDIA**

1986

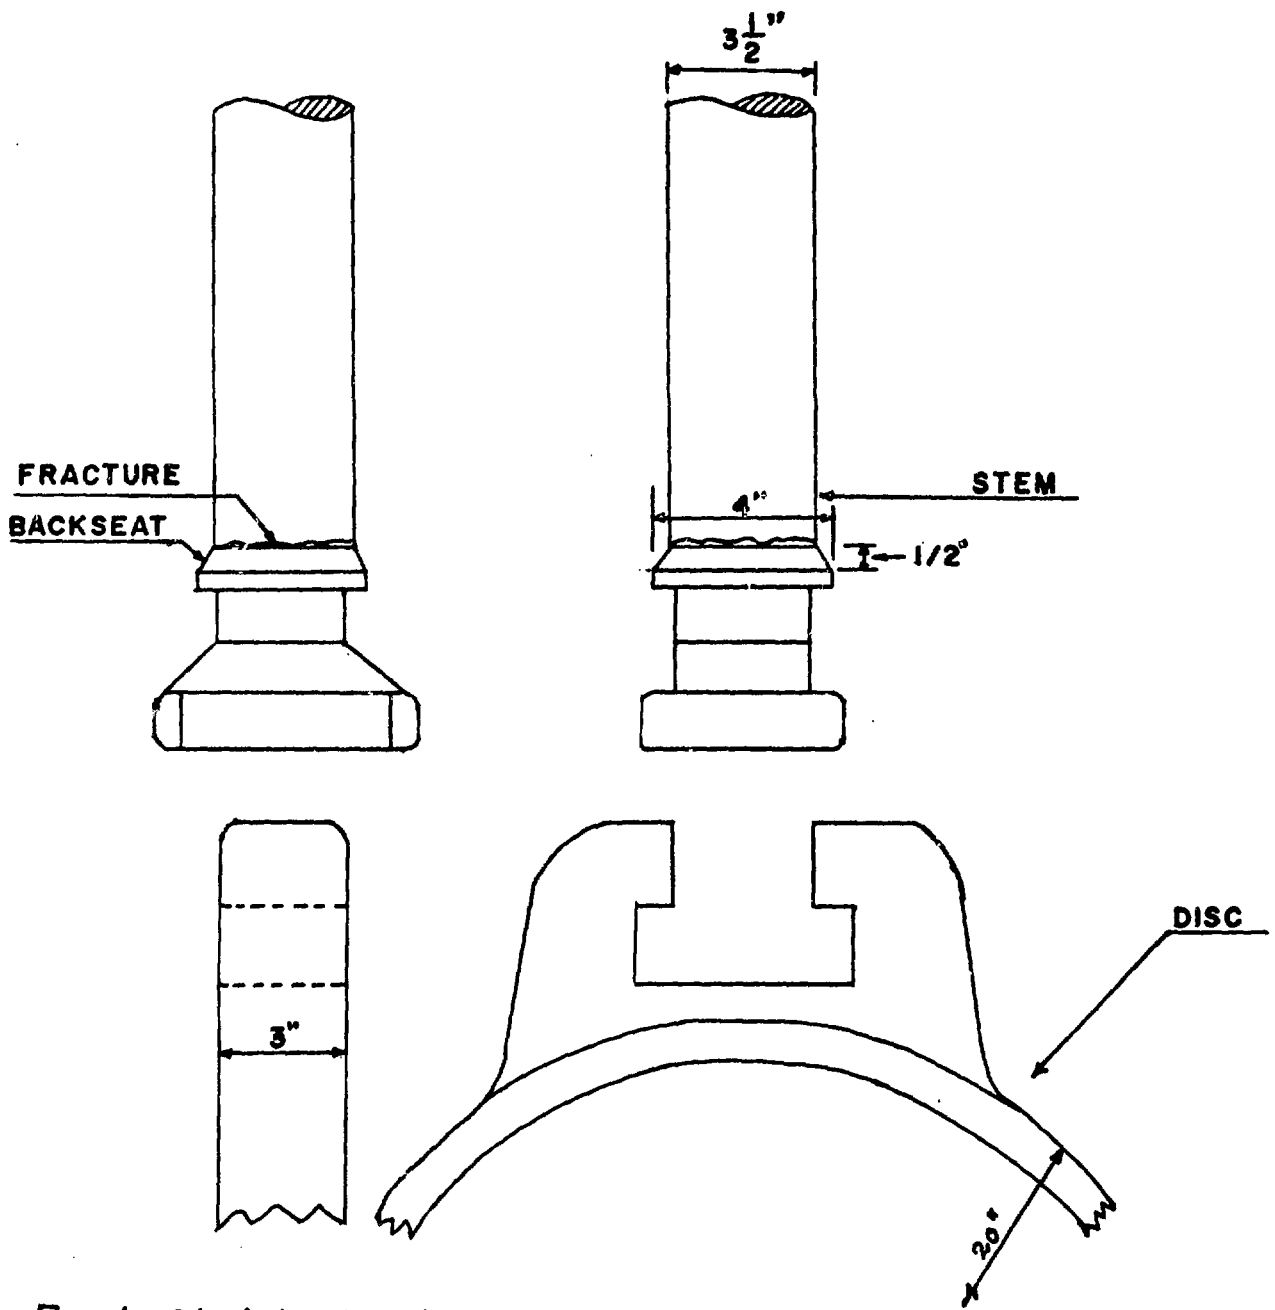
A failed portion of the stem of motor operated valve MOV-1404 was received at Radiometallurgy Division, BARC for failure analysis. This stem, during service, had been operated for moving a valve disc while opening and closing the motor operated recirculation valve MOV-1404 in loop B of TAPS Unit 1. The location of failure is given in fig. 1. The stem was made of SS 17-4 PH in H 1100 condition.

Fig: 1. Sketch of stem/disc showing the fracture

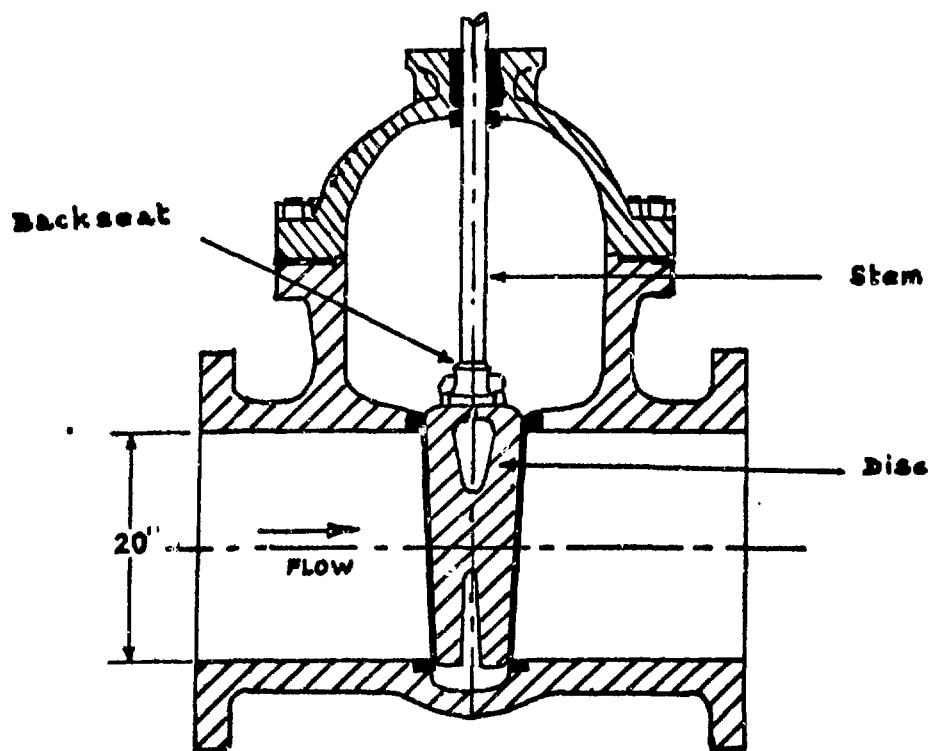
The failure of stem of MOV-1404 occurred during functional test on the loop . The valve had been closed during the test and while opening the valve , it was observed that the stem had separated from the valve disc. The stem had severed at the root edge to back seat region. The wedge disc was found binding on the valve body between the seats. Inspection of the valve body seating area did not reveal any abnormal scratch marks or damage and seats were seen to be perfectly matching. The disc seemed to have over travelled by about 9 mm, as seen from the markings.

Fig. 2. Valve section with disc in closed position.

c) Effort should be made to prevent over travel and consequent seizure of the valve disc between the body seat openings during cooling down of the valve.

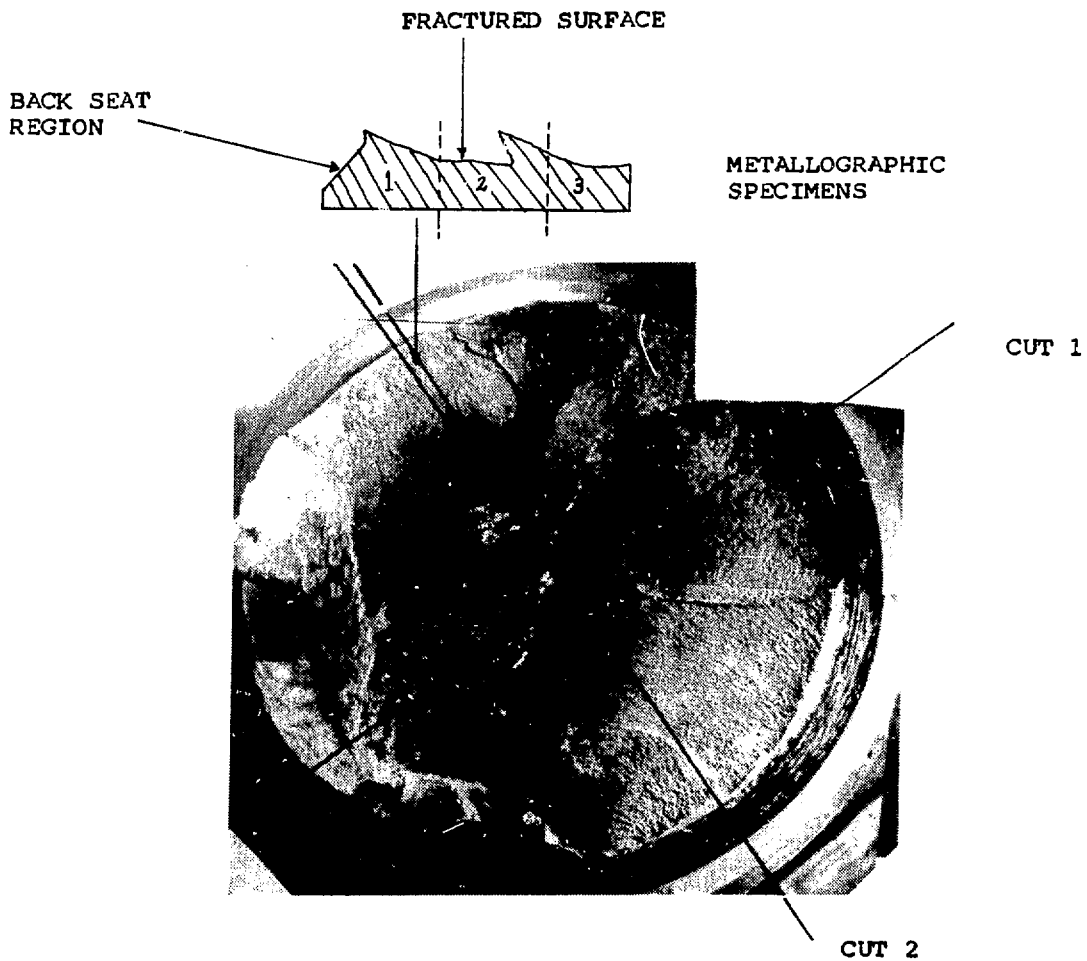
A composite picture of the failure surface (disc side) is given in fig.3, as obtained under a periscope. Visual examination, using a periscope and a stereo microscope, revealed that the failure had taken place in two stages. The peripheral part of the failed surface had the tell tale striation markings of failure due to fatigue with multiple initiation sites at or near the periphery. The final failure had occurred at the inner region of the failed surface under tensile/torsional stress. The lip seen at the inner region of the failed surface (fig.3) corresponding to the second stages of failure, indicated that the stem material had limited ductility. There was no necking or dimensional change in any part of the stem and the failure was essentially of brittle nature. At higher magnification under the stereomicroscope, it was observed that there was evidence of significant corrosion on the failure surface. It was felt that microscopic details on the failure surface had been corroded off. Thus a metallographic examination was essential to get microscopic details of the failure.

Fig. 3. Periscope Photograph of the Failed Surface.

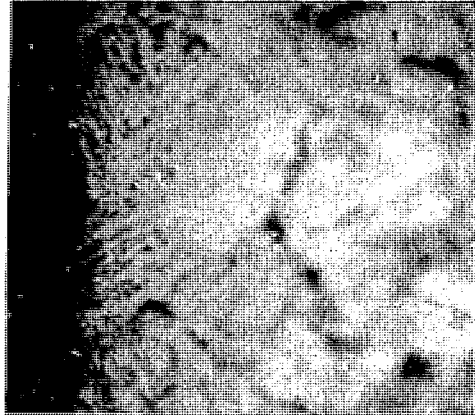
Metallographic examination of the back seat surface in specimen 1 (fig.3) showed that there was no stellite portion or any such abrasion resistant layer on the back seat portion. The back seat surface had an oxide layer almost uniform in thickness. The average thickness of the oxide layer was about 4 microns (fig.4), though at certain regions the thickness was

Fig. 4. Tenacious Oxide Layer on the Backseat Surface of the Stem.

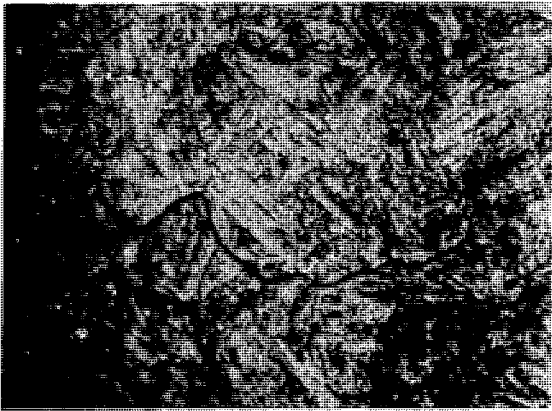
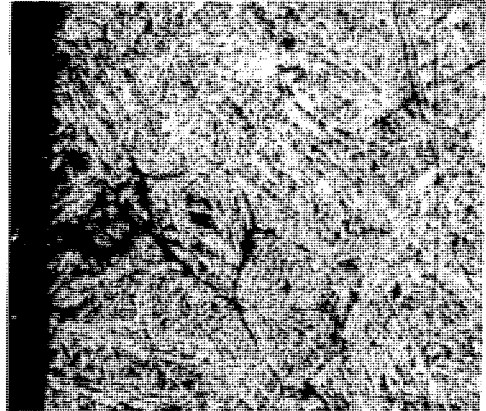
as much as as 20 microns and there were isolated locations having dents at the edge. At two locations on the outer edge of the back seat surface, there were intergranular micro cracks filled with oxide layer (fig.5). The micro cracks penetrated into the material to the extent of 3 to 4 grains of the prior austenite region.

Fig. 5. Intergranular Micro Cracks with Oxide Deposit in them at Outer Edge of the Back Seat Surface. The micro cracks are wider at the outer surface and extend inwards along austenite grain boundaries.

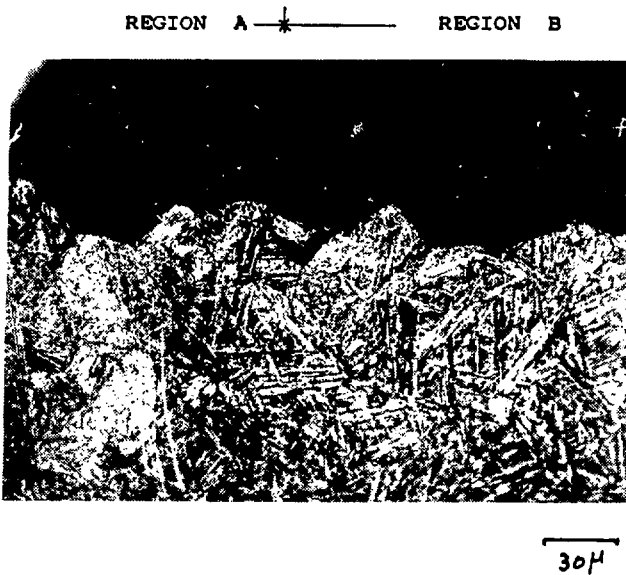
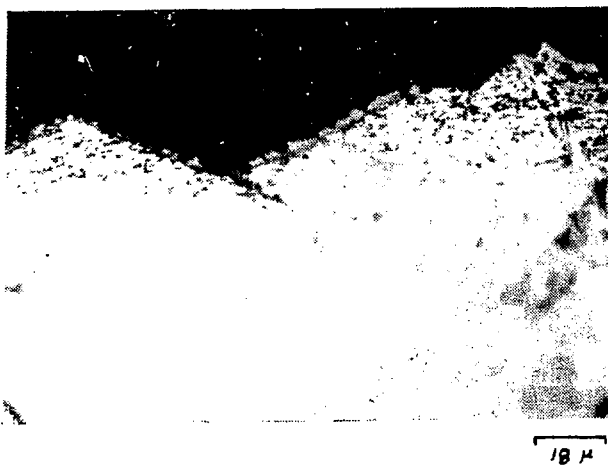
The observations made during metallographic examination support and confirm the observations made during visual examination of the failure surface. The region A of the failure surface (fig.6) having tenacious oxide layer is suggestive of the fact that this portion of the failure occurred at an early stage in a relatively slow mode. The region B having no adherent oxide layer (fig.6) is indicative of the fact that this portion of failure occurred fast after which the stem was not exposed to the in-service oxidising environment for a considerable time which could produce a tenacious oxide layer. The tenacious oxide layer on Region A is almost as thick as that on the outer surface, suggesting that an equilibrium oxide layer had been produced on outer surface as well as on the Region A. The crack propagation in the stem is transgranular and non-branching, which rules out the possibility of the stem failure being due to SCC. The secondary cracking observed in Region B is indicative of fast crack propagation in a brittle material. These evidences all point towards a fatigue failure in the peripheral Region A

followed by fast fracture in the inner Region B due to over loading by the high tensile and torsional stresses generated by the driving motor on the stem, as the valve disc lay thermally bound between the body seat openings due to over travel and cooling down of the valve.

A. Failure Edge Showing the Boundary of the Region A and Region B.

B. Region A - Details of Oxide Layer on Failed Surface.

Fig. 6. Details of Region A (Oxidised) and Region B (not Oxidised) on the Failed Surface.

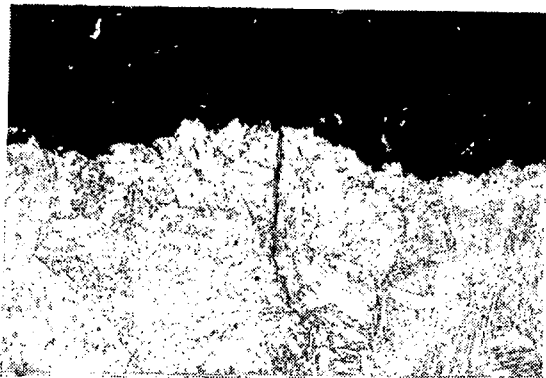
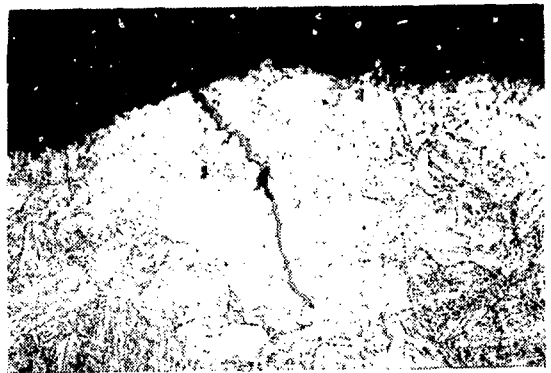
The propagation of the failure at the fractured edge was transgranular and non-branching. The fractured edge showed the presence of a tenacious oxide right from the outer edge near the back seat surface. The thickness of the oxide layer varied considerably from the outer surface towards the axis of the stem. At certain regions it was as thick as 10 microns and up to a distance of 10mm from the outer surface of the stem, this oxide layer had an average thickness of about 3 microns. After a distance of 13.5 mm from the outer edge the oxide layer became non-existent (fig.6). The region with no oxide layer on the failed surface extended upto the centre of the stem cross section. Let us designate the region with oxide layer on failure surface as Region A and that without oxide layer as Region B. Region A accounted for about 30% of the radius in the metallographic specimen examined. Region A did not show any secondary cracking whereas region B showed about 4 number of secondary cracks transgranular in appearance and spreading in a direction perpendicular to the main crack propagation (fig.7). The secondary cracks had tenacious oxide filling them.

Fig. 7. Secondary Cracking in Region B (not oxidised) of Failure Surface.

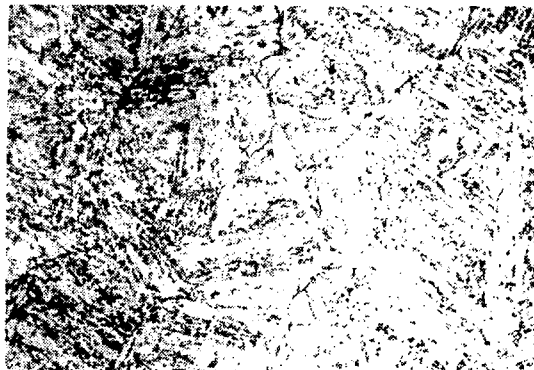
The microstructure of the material is shown in fig.8. It mainly showed transformed martensite with prominently seen prior austenite boundaries ^{which} had extensive precipitation indicating effects of overaging typical of H 1100 material of 17-4 PH steel. There were ferrite stringers in the material, the size and distribution of which varied from periphery to centre of the stem, which is also typical of 17-4 H steel bars of larger diameters. Microhardness measurements were carried out

The hardness of the stem material examined was found to be 462 VHN, which ^{is} much higher than that of the H 1100 material. In fact the equivalent strength of a steel of hardness 462 VHN would be in the higher range of that of 17-4 PH in H 900 condition (UTS: 1310 MPa, Y.S: 1170 MPa). This shows that the original H 1100 material had deteriorated in mechanical properties due to prolonged ageing during long residence time at the reactor water temperature and as such can no more be considered to be in H 1100 condition. This observation indicates that 17-4 PH steel is not suitable for prolonged use at the reactor water temperature (540°F), if the original properties of the stem are to be retained. It is possible that the same phenomenon would occur in other precipitation hardening steels which may restrict their use as stem material for such valves.

Fig. 8. General Microstructural of the Stem Material Showing Tempered Martensites and Ferrite.

a) As the station has already replaced the failed stem by a SS 316 stem in valve MOV-1404 and accepted the load bearing capacity of SS 316 stem, it is recommended that the stem of the remaining such MO valves be replaced by the available SS 316 spare stems.
