Submitted for the Proceedings of the Fifth National Conference on Synchrotron Radiation Instrumentation, June 21-25, 1987, University of Wisconsin-Madison.

ANALYSIS OF SURFACE CONTAMINANTS ON BERYLLIUM AND ALUMINUM WINDOWS

Nicholas F. Gmur
National Synchrotron Light Source
Brookhaven National Laboratory
Upton, New York 11973, USA

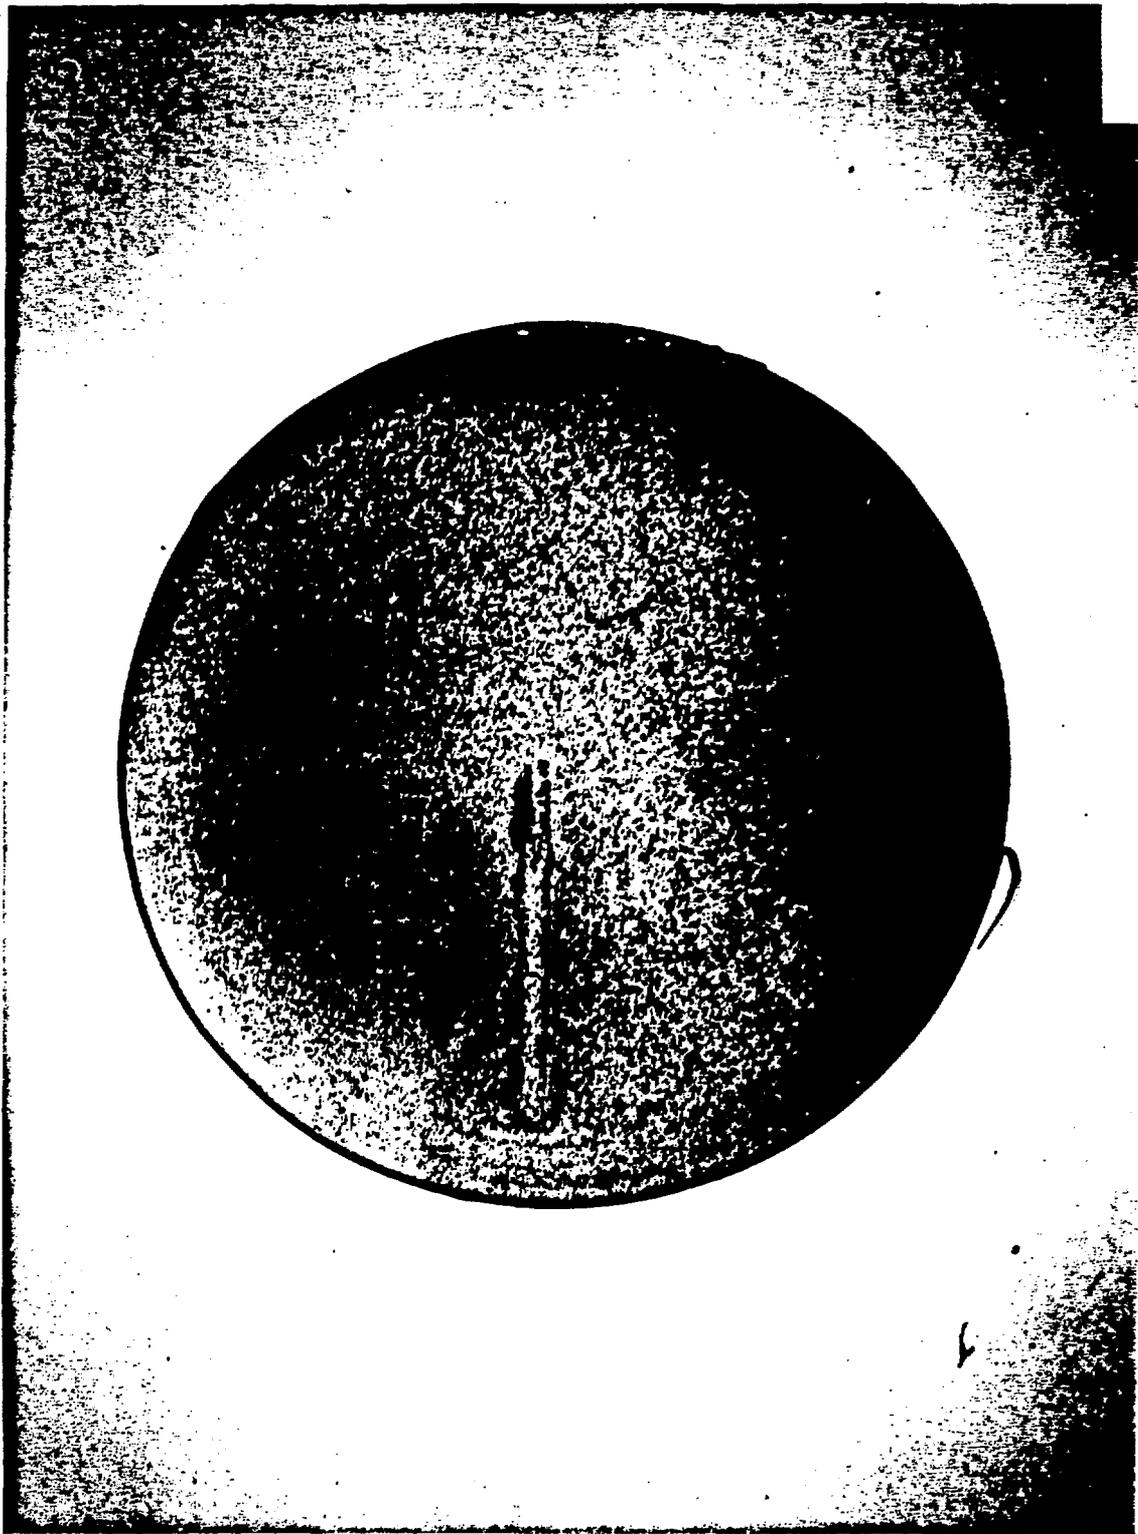
Fig. 1

During the NSLS x-ray ring commissioning period, each beam line front end section (consisting at that time of a water-cooled mask and a gate valve) was sealed at its downstream end by a beryllium window exposed to UHV on its upstream face and air on its downstream face. A white SR beam of $x = 16$ mm and $y = 4.5$ mm dimensions as measured by the carbon deposit on the upstream window face generated a downstream face deposit of $x = 16$ mm and $y = 2$ mm dimensions (Fig. 1). This deposit typically consisted of a narrow white crystalline mid-

portion surrounded by a very thin shiny lacquer-type layer which was hard, clear and slightly yellow in color (see Fig. 2). Another variation was a window with only the thin shiny lacquer deposit. Conditions during this commissioning period [4] were approximately as follows: ring energy 1.7 GeV, ring current < 5 mA, length of beryllium window exposure to photon beam < 5 hours.

- Fig. 1. Type A beryllium window - full view (diam. = 1.5"); powder and lacquer deposits.
- Fig. 2. Type A beryllium window - 25x bright field image of surface deposit seen in Fig. 1.
- Fig. 3. Type B beryllium window - full view (diam. = 1.5"); white powder surface deposit.
- Fig. 4. Type B beryllium window - 25x bright field image of powder deposit ends seen in Fig. 3. A,B and C indicate positions of three separate horizontal aperture openings.
- Fig. 5. Type C beryllium window - full view (size = 4.0" x 0.75"); various types of deposits.
- Fig. 6. Type C beryllium window - 80x bright field image of blue/green gel deposit (white gel deposit has a similar appearance).
- Fig. 7. Type C beryllium window - 80x bright field image of surface pitting and orange colored crystals.
- Fig. 8. Electron diffraction pattern of white powder - BeO.

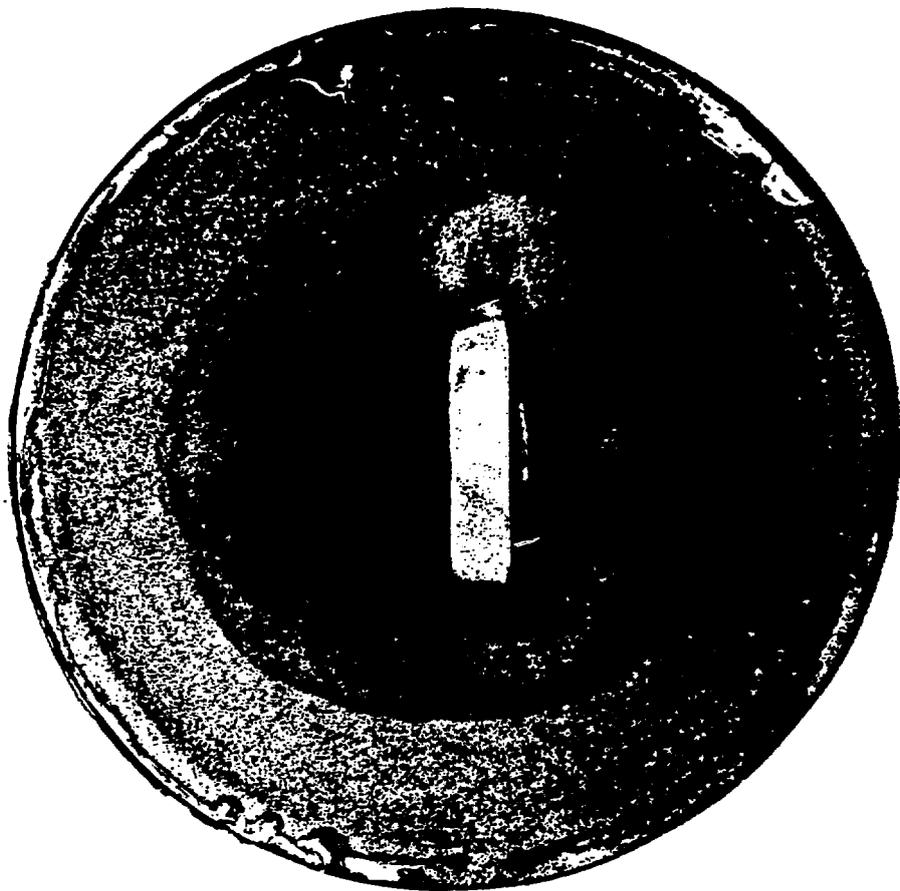
Fig 3

In May 1986, a condition arose on a white x-ray beam line which created this type of window surface deposit. A circular (1.5" diameter) window was mounted in the beam line at 13,182 mm from the dipole magnet source. Another pipe section was mounted downstream of the window. This pipe was, as per regulations, filled with He gas at atmospheric pressure and was capped by a Kapton window. Typically, the Kapton window was replaced once a week, but in this situation it was not and the SR beam burned a hole through it. The He gas leaked out of the pipe section (it was not replaced by the associated He supply system) and air entered the pipe. This condition continued for 48-72 hours with SR beam at which point the damage was discovered. The resulting deposit which formed on the downstream face of the beryllium window (Fig. 3) was a thin white powdered area (x = 13.3 mm, y = 2.5 mm) similar to the dimensions of the incoming beam. Figure 4 is a 25x image of the end of the deposit (side is away from the ring) and also shows the result of accumulated deposits due to three different horizontal aperture settings (A = narrowest --> C = widest).

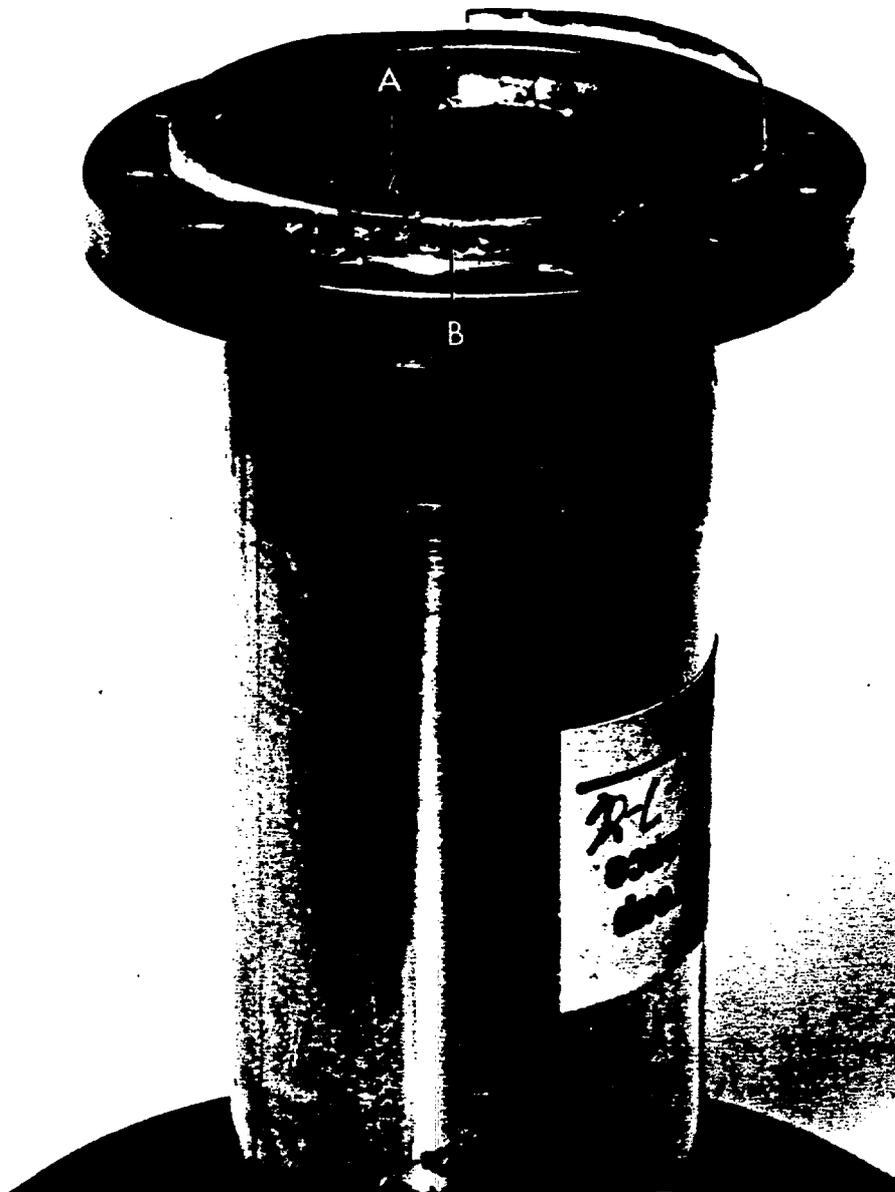
Fig. 14

The configuration, as shown, remained in place exposed to white SR beam for a further three months. The tail piece assembly was then removed from the beam line and disassembled. A moist brown deposit was found on both the tail piece flange inner rim and upon the downstream surface of the beryllium window (Fig. 14 and 15). As can be seen in Fig. 14, portions of the downstream aluminum gasket were eaten away. Ion chromatography analysis of the brown deposit showed nitrate to be the very dominant anionic species. Emission spectroscopy showed beryllium and aluminum to be the major cationic species. The picture this presents is that of nitric acid forming within the tail piece volume, settling in the area of the KF flange and beryllium window, and slowly dissolving portions of both the aluminum gasket as well as the beryllium window. Such a condition might, in the long run, cause a vacuum leak.

Fig. 14. Brown deposit (A) on inner rim of tail piece flange. Note aluminum gasket (B) which is partially eaten away in this region.

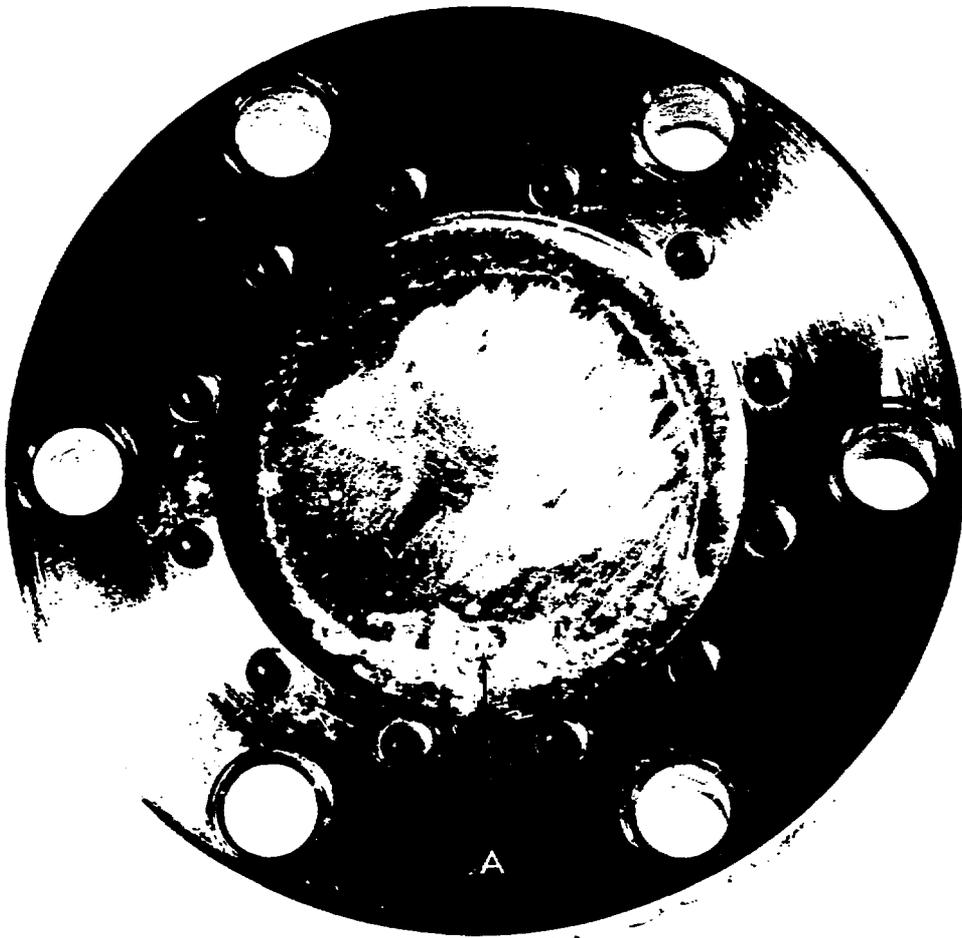
Fig. 15

Fig. 15. Brown deposit (A) on downstream surface of beryllium window.

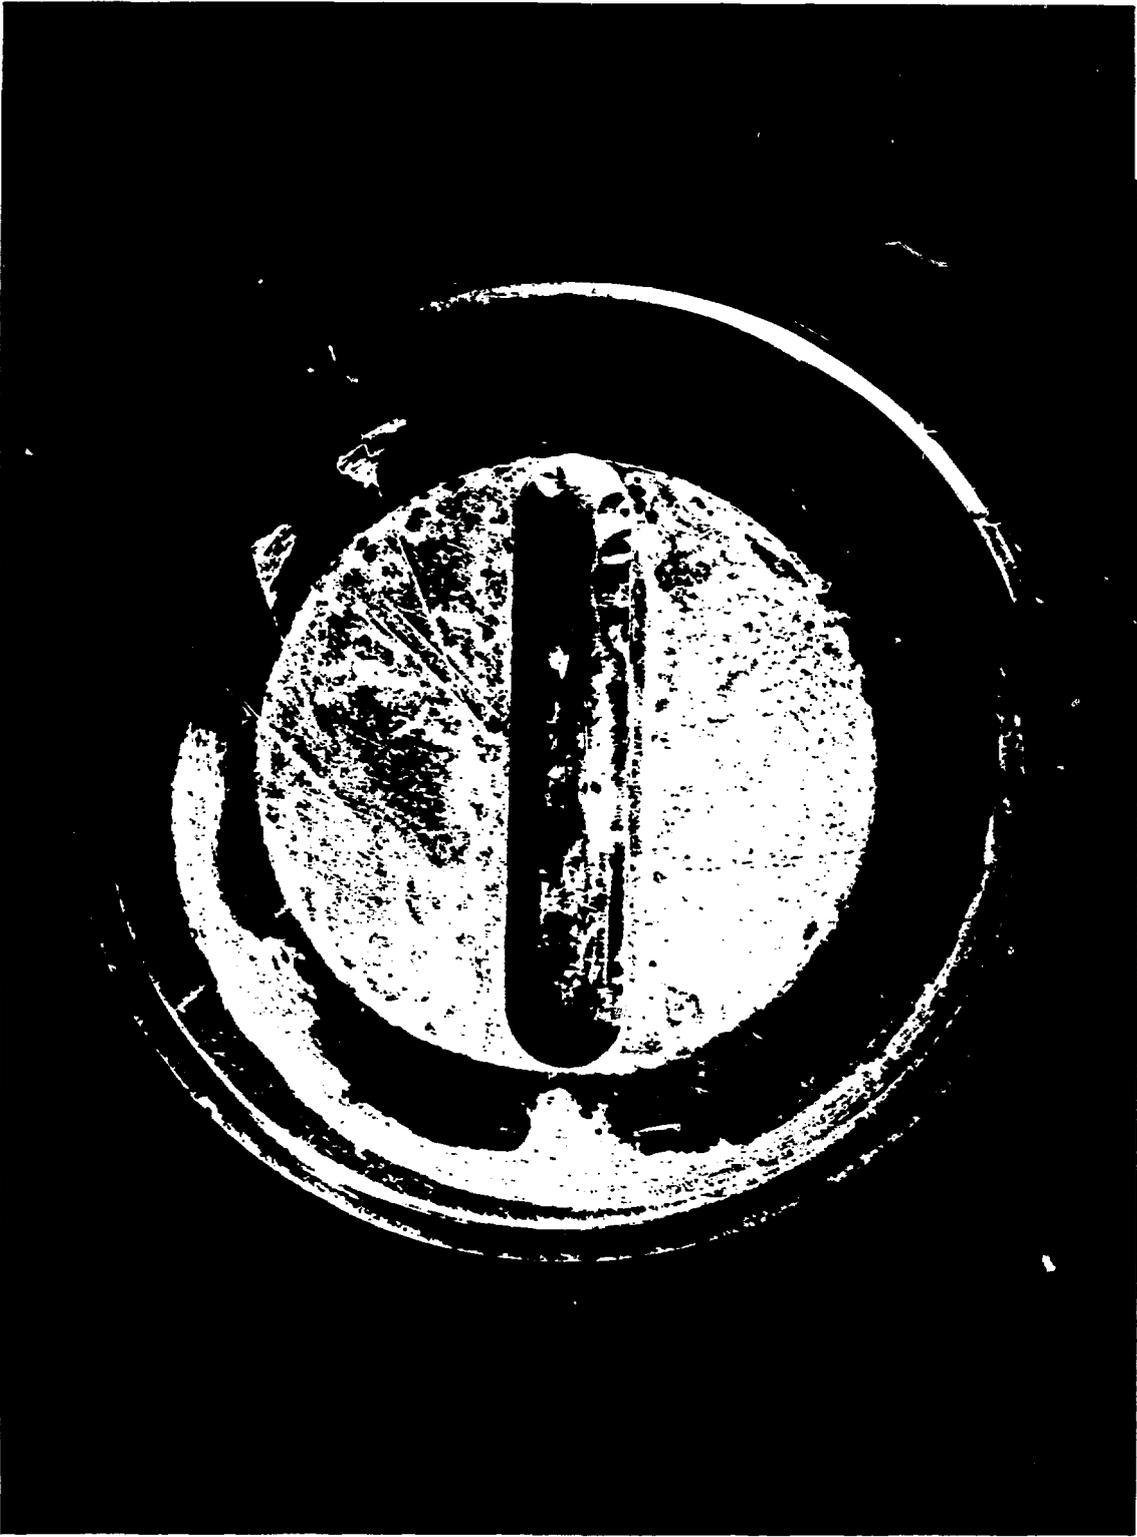
Fig. 16

When exposed to white SR beam, the downstream face of the aluminum window reacts with the air and locally formed ozone producing white crystals on the window surfaces. Such crystals were collected from an aluminum window on the X19A beam line by gently brushing the surface of the window with a camels hair brush. The majority of the crystals were from the surface of the 1100-0 apertured disk.

While only slight surface degradation was observed by the naked eye on the aluminum foil of this particular window assembly, aluminum windows on the other beam lines have been known to develop vacuum leaks. Some of these leaks were traced to mechanical damage of the foil and/or the weld of the assembly itself. However, with the presence of severe surface oxidation of the foil due to an intense white SR beam, it is possible that surface degradation may cause a vacuum leak.

Fig. 16. Aluminum window - full view (diam. = 3.25"); powder deposits.
