FRACTOGRAPHY EVALUATION OF IMPACT AND TENSILE SPECIMENS FROM THE HFBR

C. J. Czajkowski

October 1989

Nuclear Waste and Materials Technology Division
Department of Nuclear Energy, Brookhaven National Laboratory
Upton, New York 11973

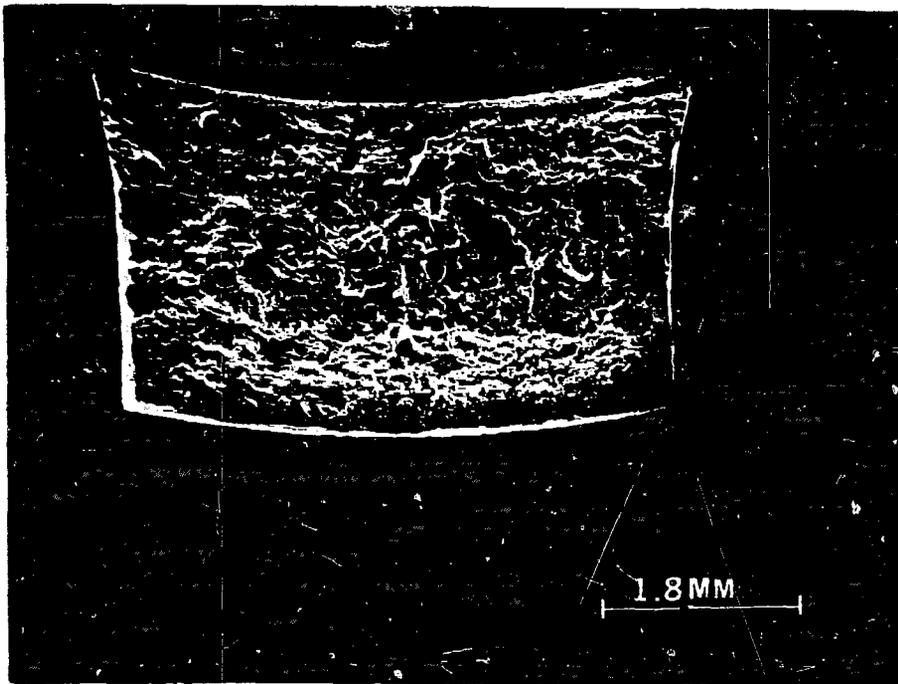
Figures 1 - 2a are SEM fractographs of 6061 T-6 (unirradiated) tensile specimen (Figures 1 and 1a) and an aluminum alloy 4032 tensile fracture (Figures 2 and 2a). The overlay was applied to both of the higher magnification photographs (approximately 400X) which resulted in measured 95.4% and essentially 100% areas of ductility present on the fractures.

Figure 1 Fractograph of unirradiated 6061 T-6 tensile specimen.

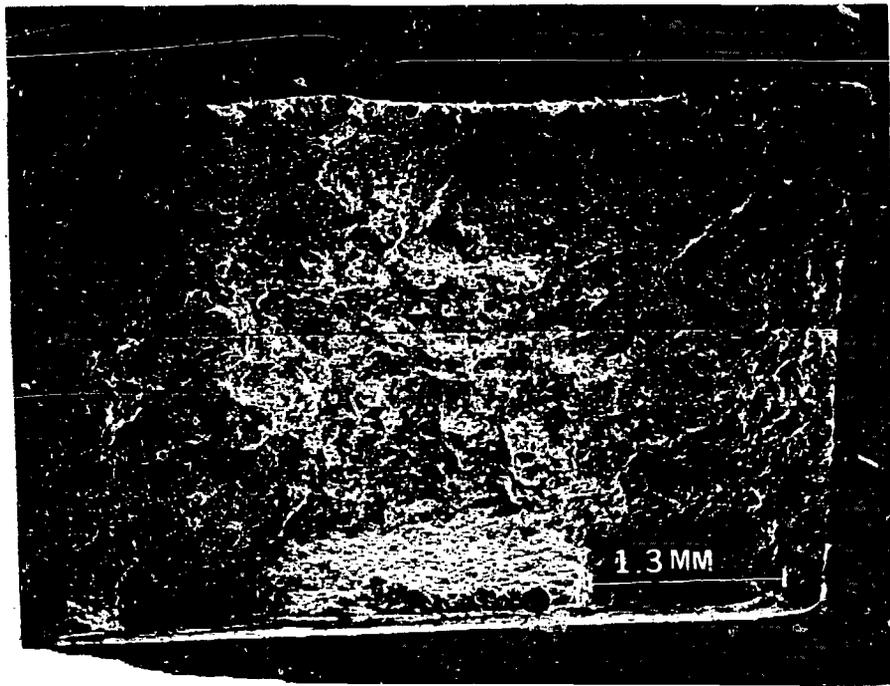
Figure 2 Low magnification fractograph of an unirradiated tensile specimen (4032 alloy).

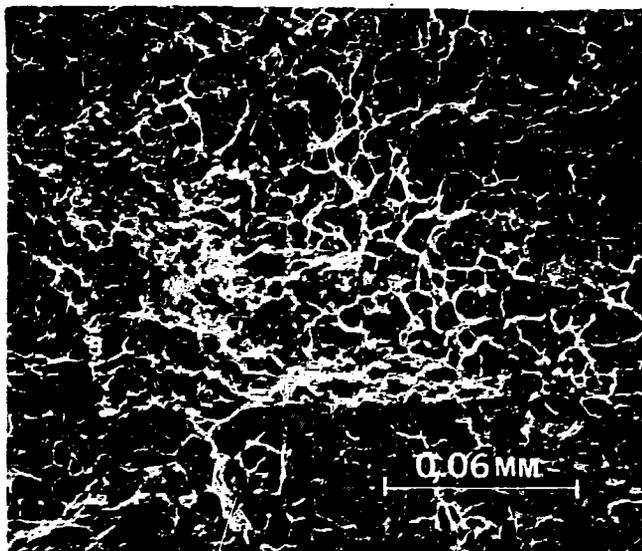
Figure 2a Higher magnification photo showing essentially 100% ductility on fracture surface.

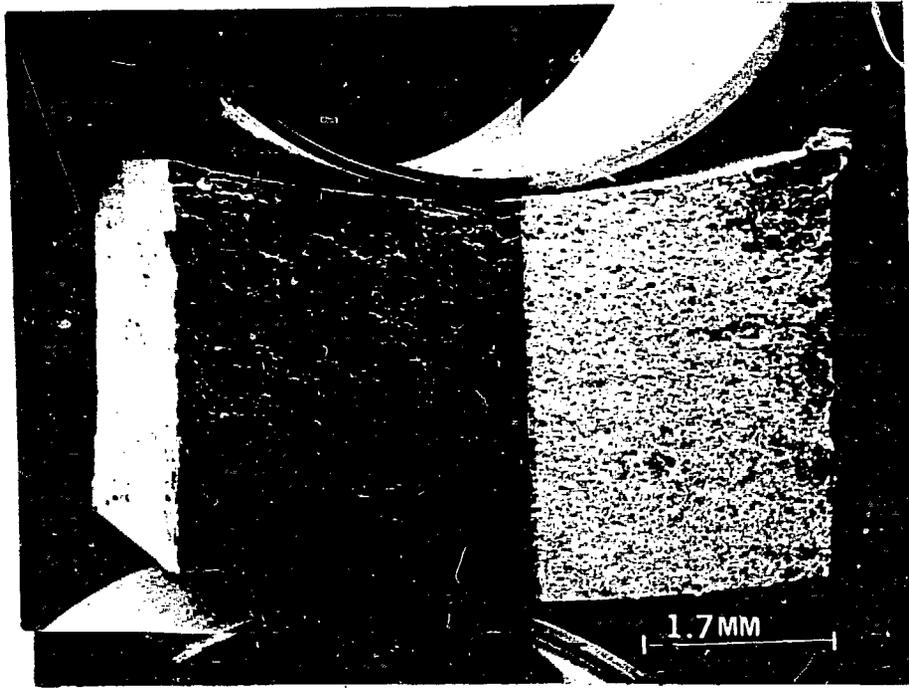
Figures 3 and 3a are SEM photographs of HFBR irradiated tensile specimen T-3. This fracture had a measured ductility area of 7.4%.

Figure 3 Low magnification fractograph of an irradiated tensile specimen from the HFBR.

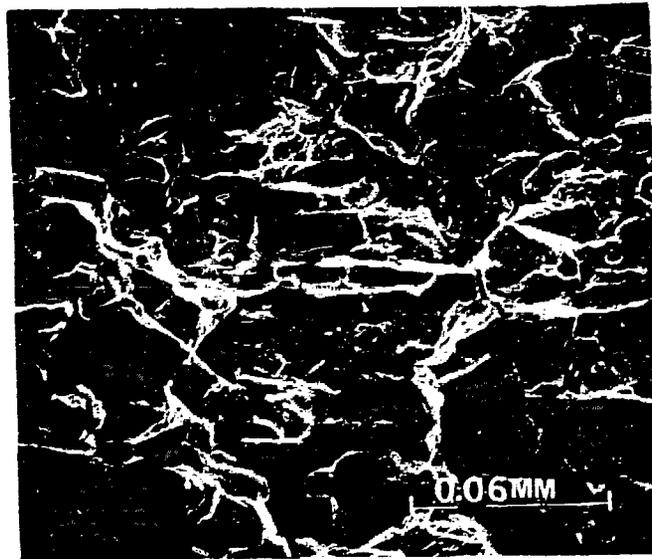
Figure 3a Higher magnification photograph (typical) depicting approximately 7.4% ductility (as measured).

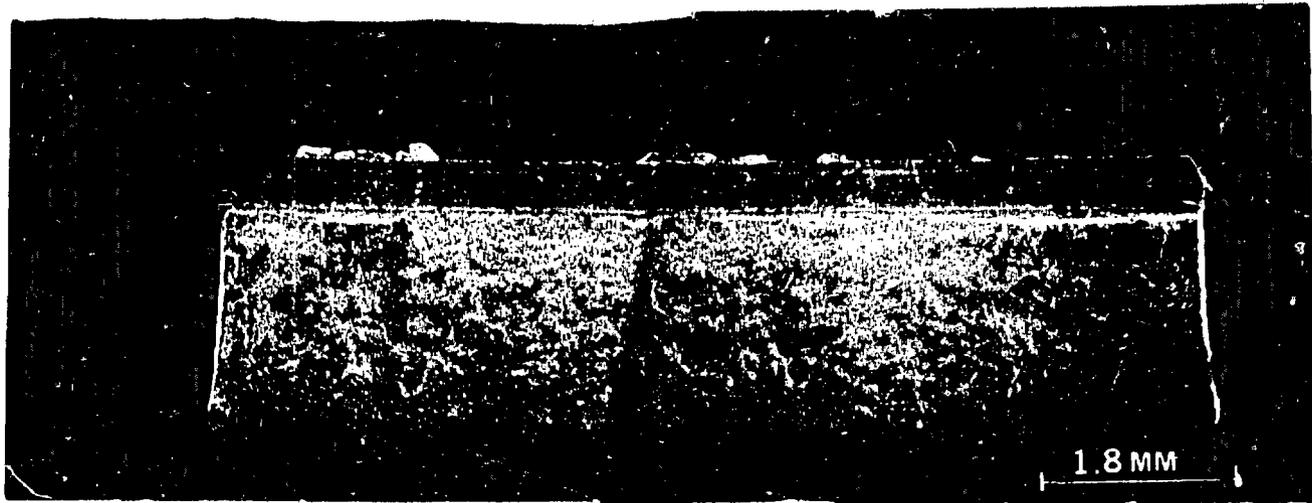
Unirradiated fracture faces were also examined on 6061 T-6 and 4032 aluminum alloy Charpy "V" notch specimens. These specimens were tested either at room temperature (Figures 4, 4a, 4b and 7) or at 210°F (Figures 5, 5a, 5b and 6). In all cases the fractures showed essentially totally ductile fractures.

Figure 4 Fractograph of Charpy "V" notch specimen from a 4032 alloy tested at room temperature (9.75 inch-lbf).

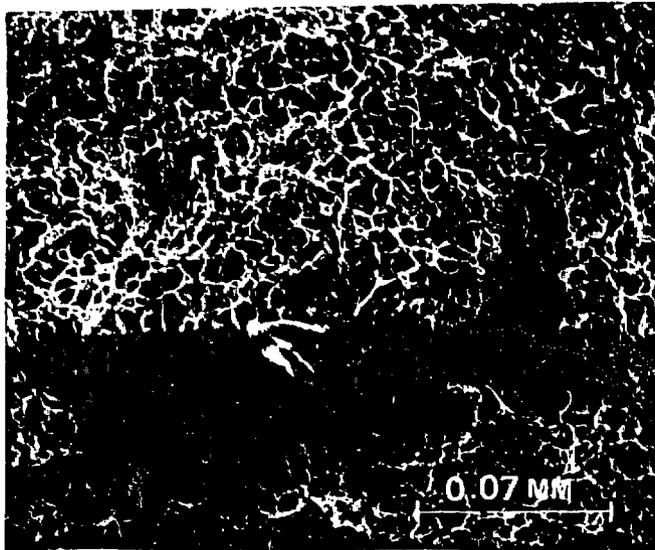
Figure 4a Fractograph of area near the notch. Totally ductile fracture (typical).

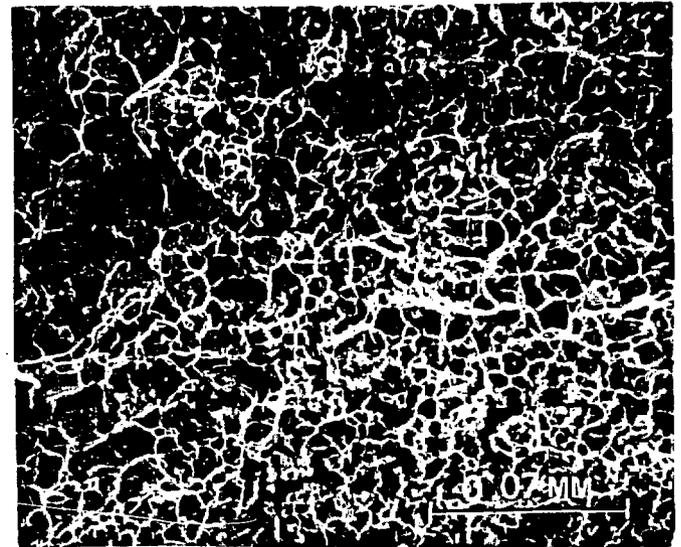
Figure 4b The side opposite the notch of the specimen was also purely ductile (typical).

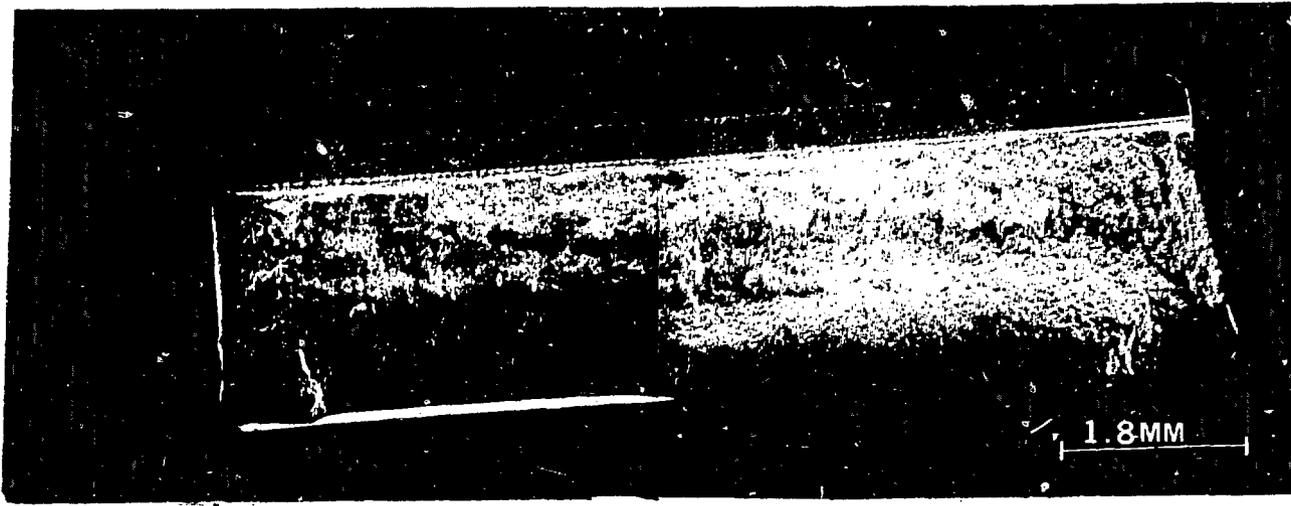
Figure 5 Fractograph of Charpy "V" notch specimen from a 4032 alloy tested at 210°F (12 inch-lbf).

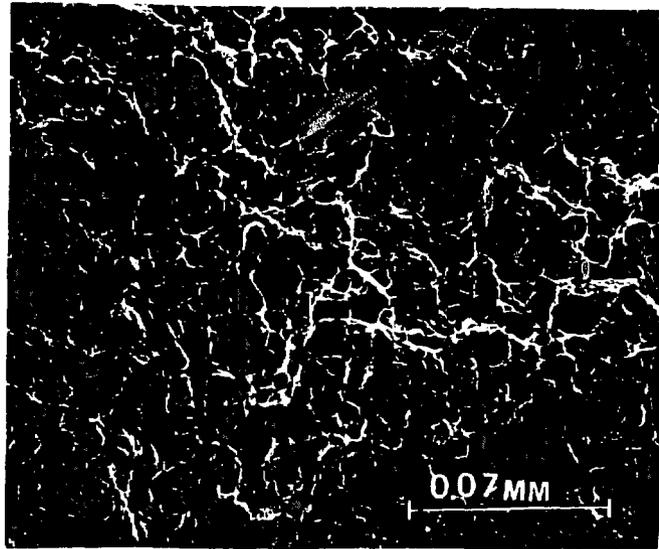
Figure 5a Essentially pure ductile failure was seen at higher magnification near the notch (typical).

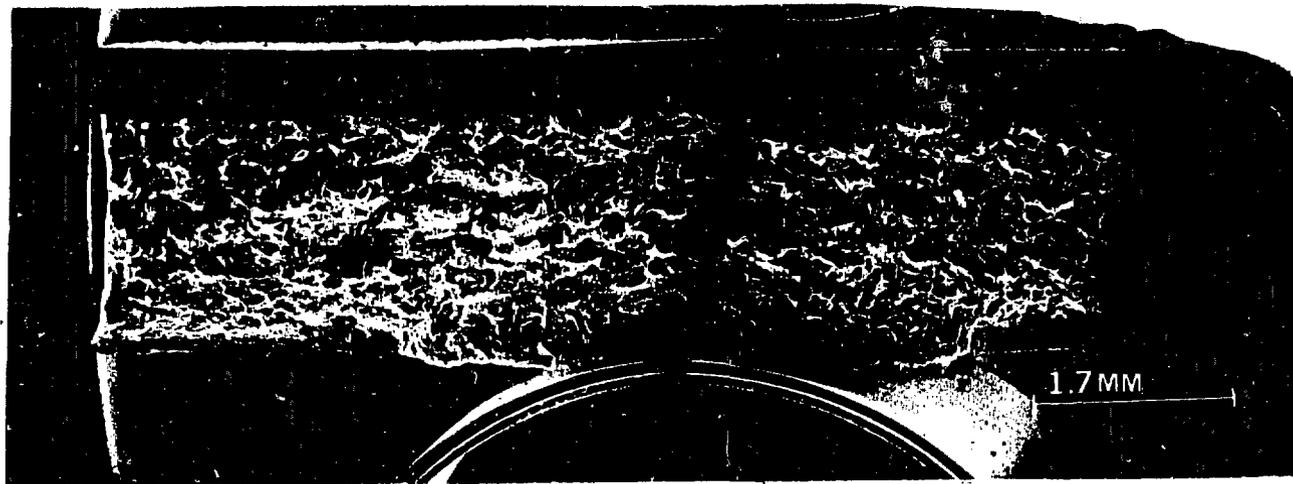
Figure 6 Low magnification SEM photograph of the fracture from a 6061 T-6 alloy impact tested at 210°F (18.75 inch-lbf).

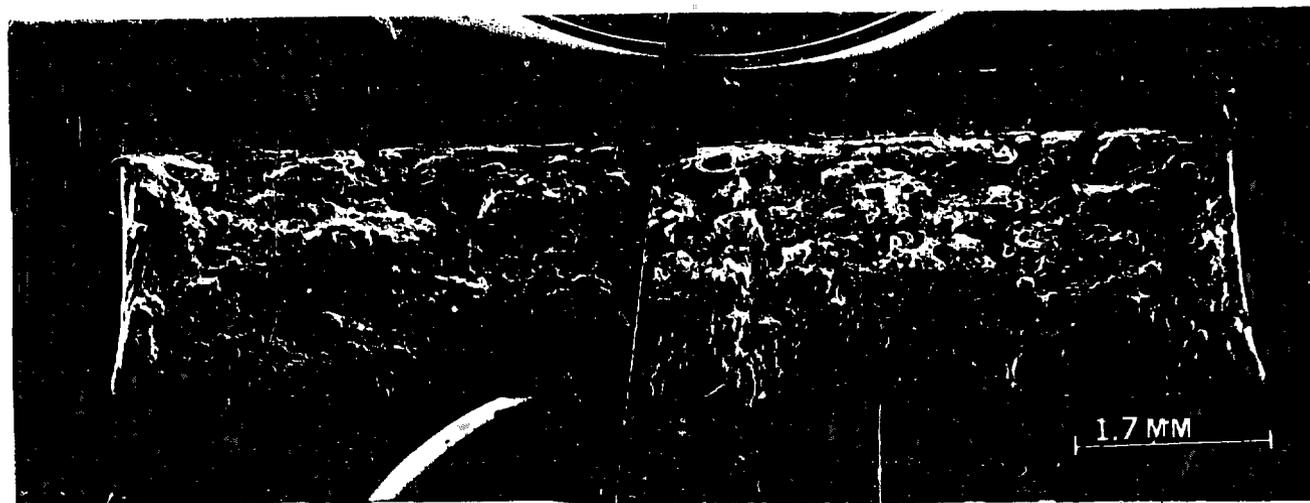
Figure 7 Fractograph of impact specimen tested at room temperature 6061 T-6 (21.75 inch-lbf).

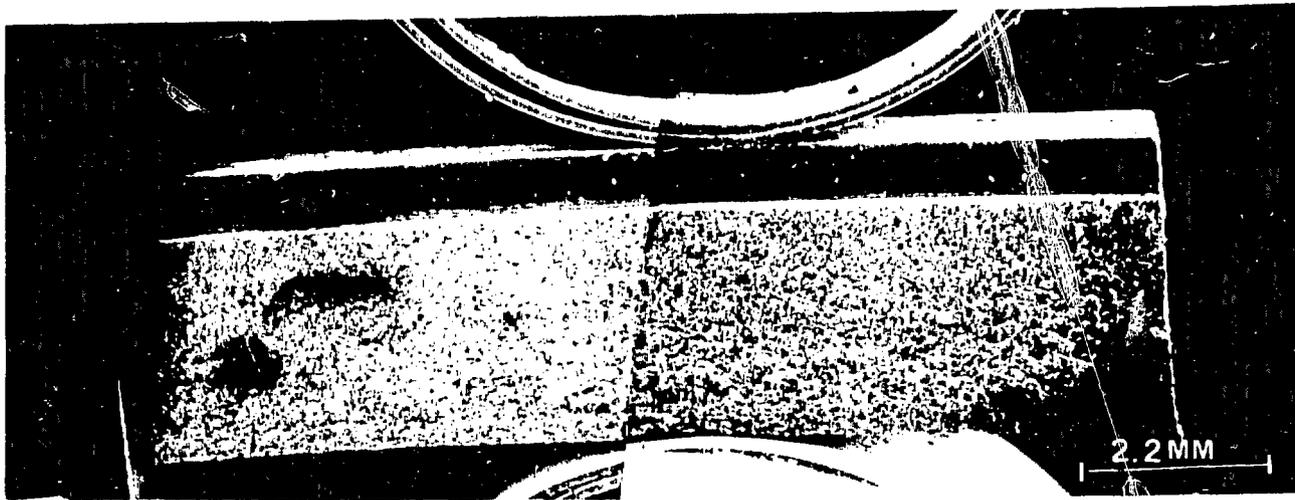
The first irradiated specimen examined (Figure 8) came from an area outside the area of highest fluence. The fractures of all of the irradiated impact samples had a predominantly cleavage appearance with some ductility present. This sample had values of 8.7% (Figure 8a) and 8.1% (Figure 8b) obtained with the overlay.

Figure 8 Low magnification SEM photograph of irradiated HFBR impact specimen (outside high flux area). Testing was accomplished at room temperature.

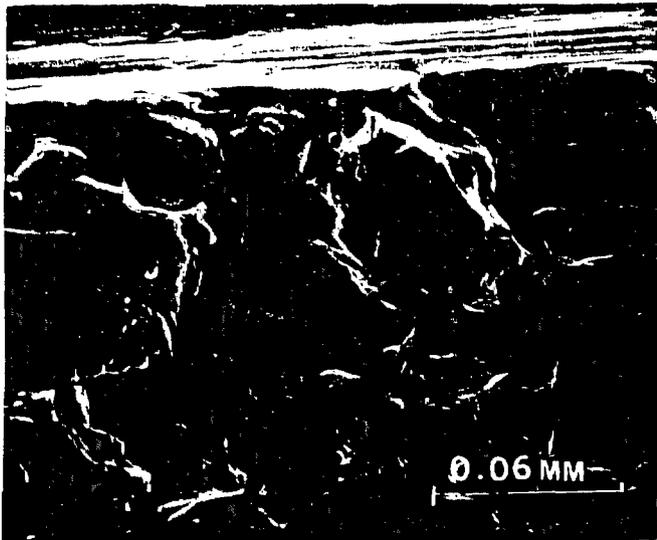
Figure 8a The measured ductility area of the specimen near the notch was 8.7% (typical).

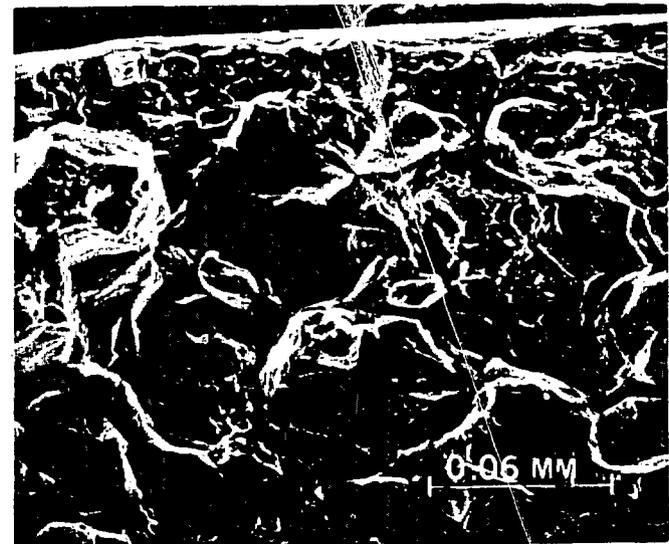
Figure 8b The ductility measured on the opposite side of the specimen was 8.1% (typical).

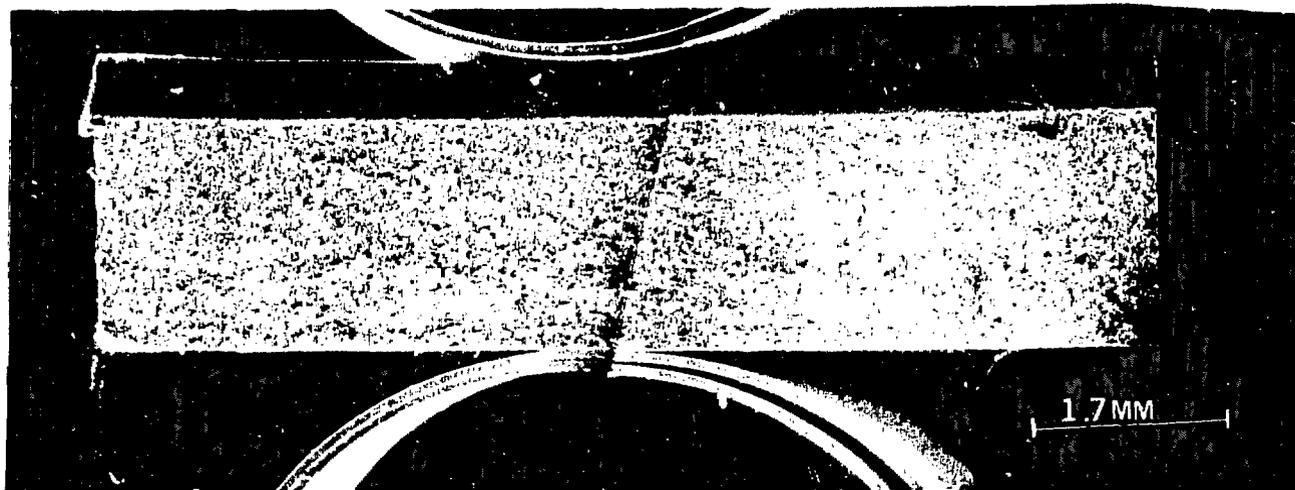
Figures 9 - 10b correspond to SEM photographs of fracture surfaces from two irradiated HFBR impact specimens (C-1 and C-8). The measured ductility areas (typical) for C-1 were 5.3% (Figure 9a) and 4.6% (Figure 9b).

Figure 9 Fractograph of irradiated impact specimen C-1 (HFBR). The specimen was tested at room temperature (3.0 inch-lbf).

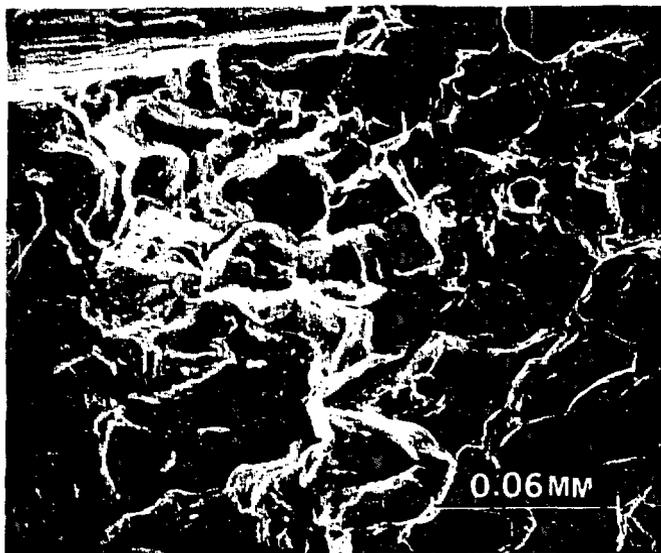
Figure 9a The ductility area measured 5.3%(typical) near the notch.

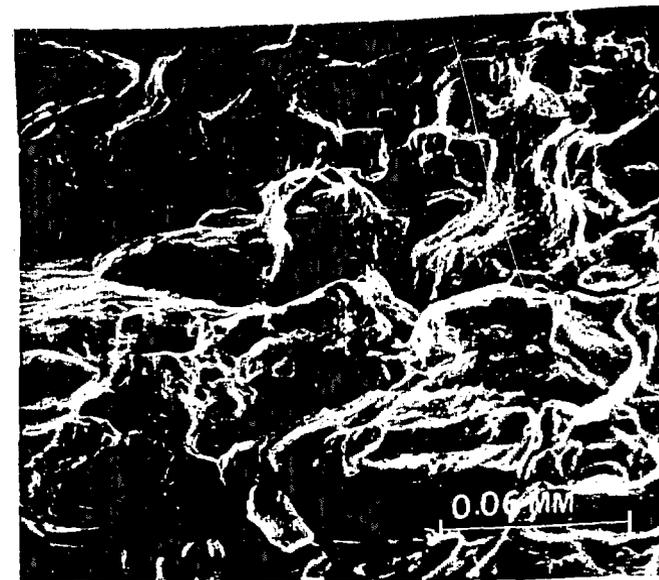
Figure 9b The opposite side of the specimen had a measured area ductility of 4.6%.

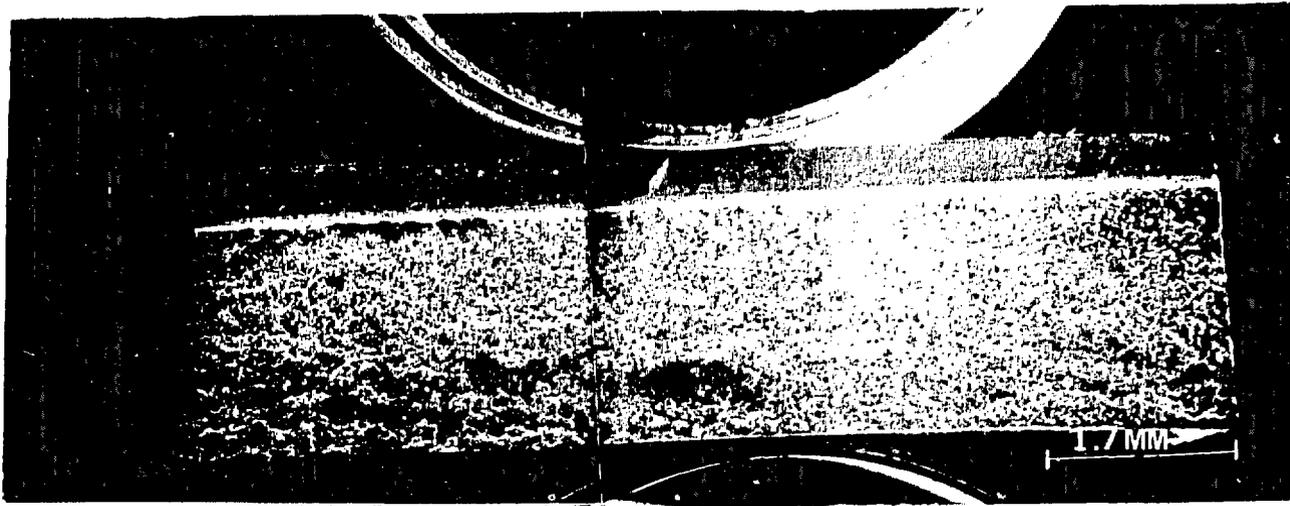
The measured ductility areas for specimen C-8 were 5.3% (Figure 10a) and 5.4% (Figure 10b).

Figure 10 HFBR follower specimen (impact) C-8 tested at room temperature (2.75 inch-lbf).

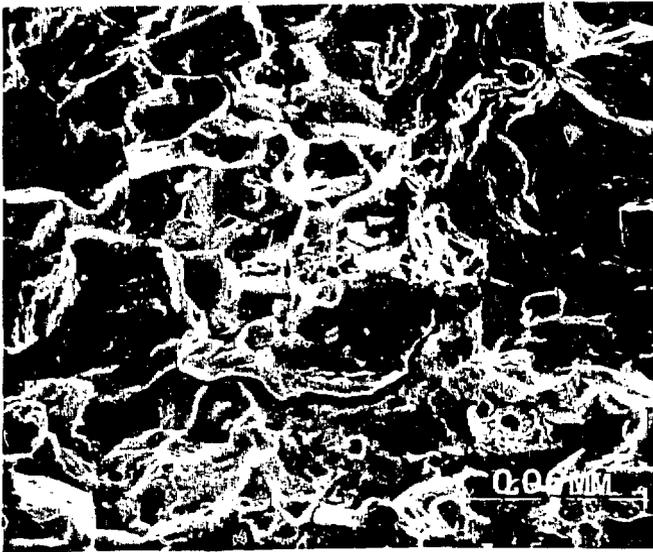
Figure 10a The area near the notch (typical) exhibited a measured ductility area of 5.3%.

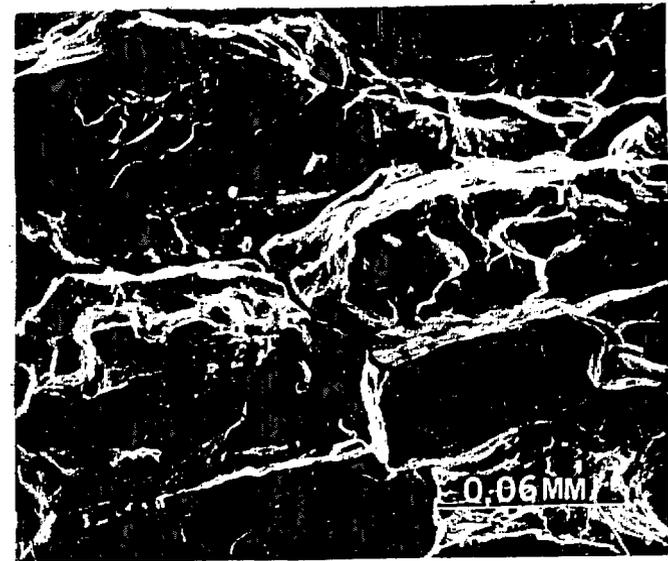
Figure 10b The opposite side of the fracture face had an area of 5.4% ductility.

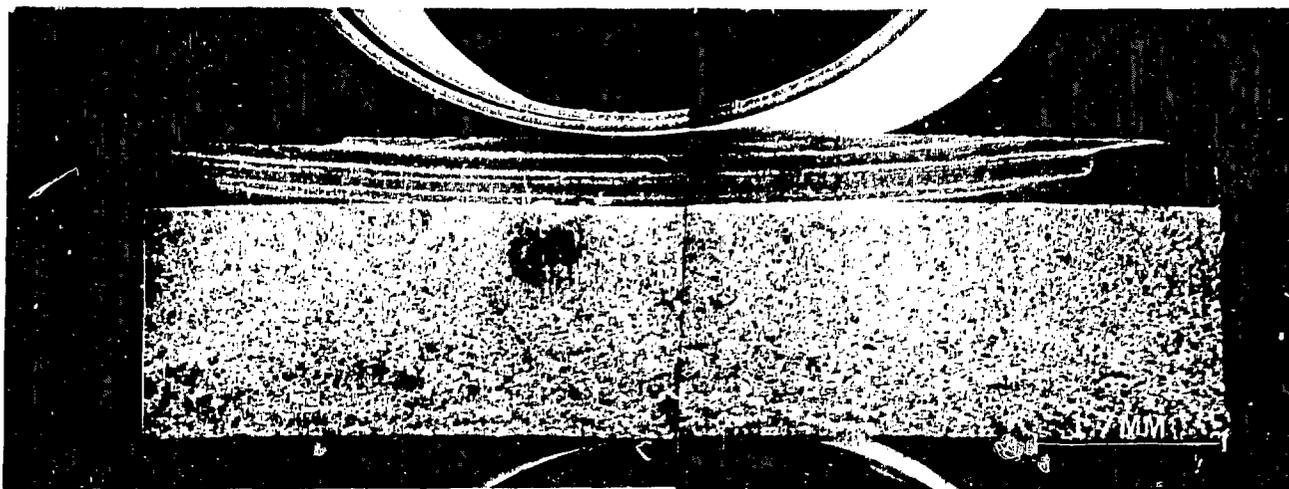
The last two specimens examined were irradiated impact specimens (Figures 11 - 12b) tested at 210°F. Specimen C-4 had ductility measurements of 9.5% (Figure 11a) and 8.4% (Figure 11b) which were the highest values obtained. It is interesting to note that this specimen exhibited the lowest impact value (energy absorbed), 2 inch-lbf.

Figure 11 HFBR follower specimen (impact tested at 210°F) C-4 had an absorbed impact energy of 2.0 inch-lbf.

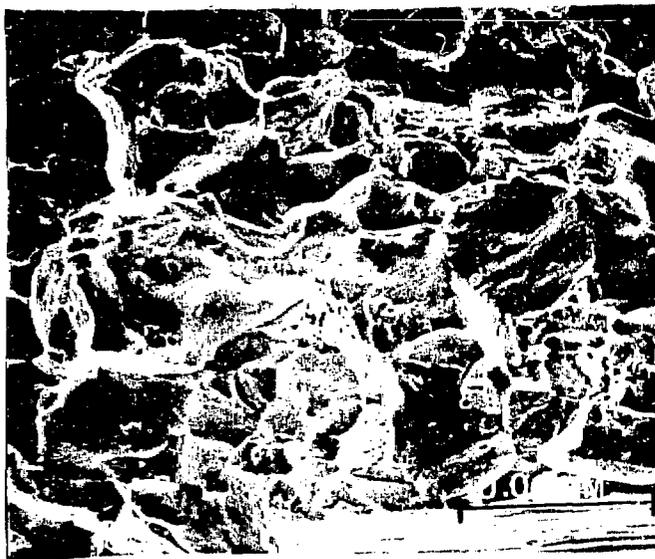
Figure 11a The fracture face of C-4 near the notch showed a ductility area of 9.5%.

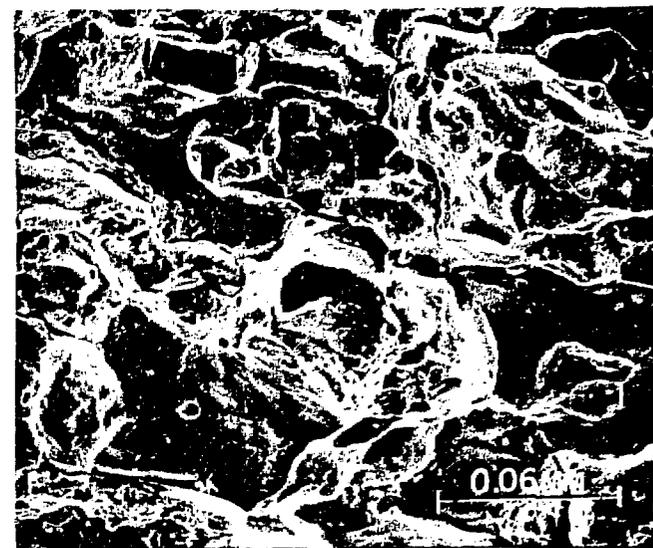
Figure 11b The ductility area on the opposite side of the fracture face measured 8.4%.

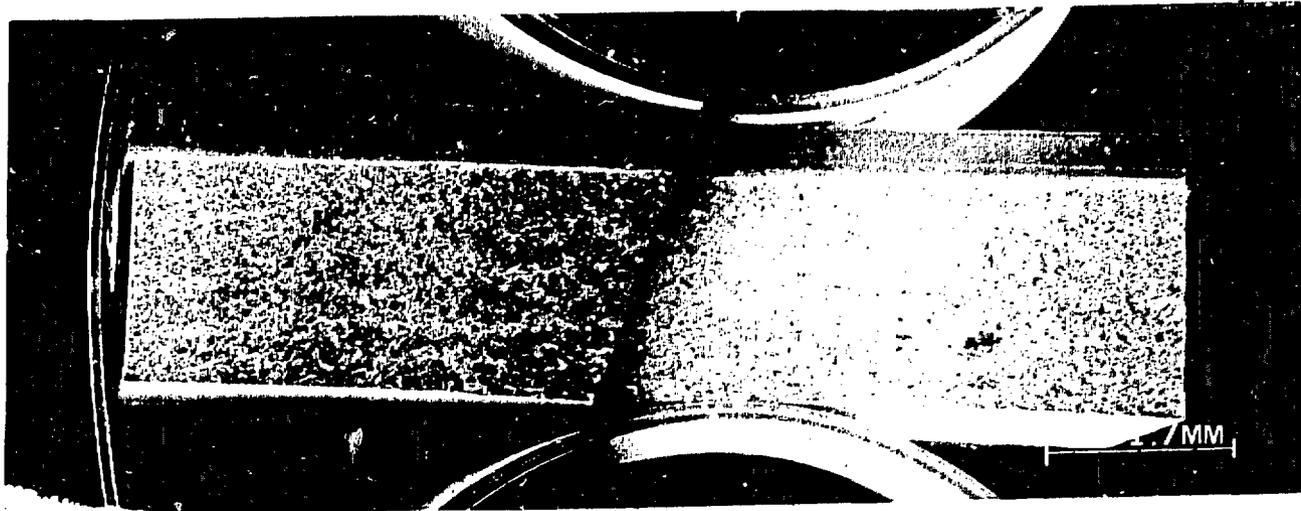
Figures 12 - 12b are fractographs of impact sample C-5. Ductility areas equalling 6.3% (Figure 12a) and 6.8% (Figure 12b) were seen on these specimens.

Figure 12 Another HFBR specimen (C-5) impact tested at 210°F had an absorbed impact energy of 3.25 inch-lbf.

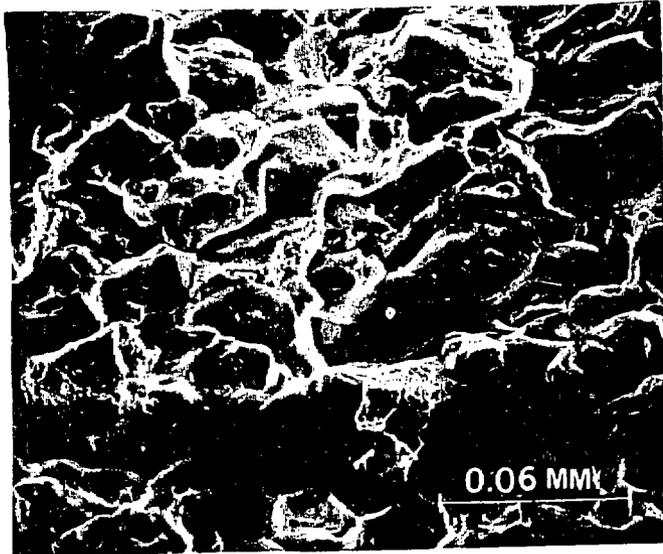
Figure 12a A ductility measurement of 6.3% was obtained near the notch.

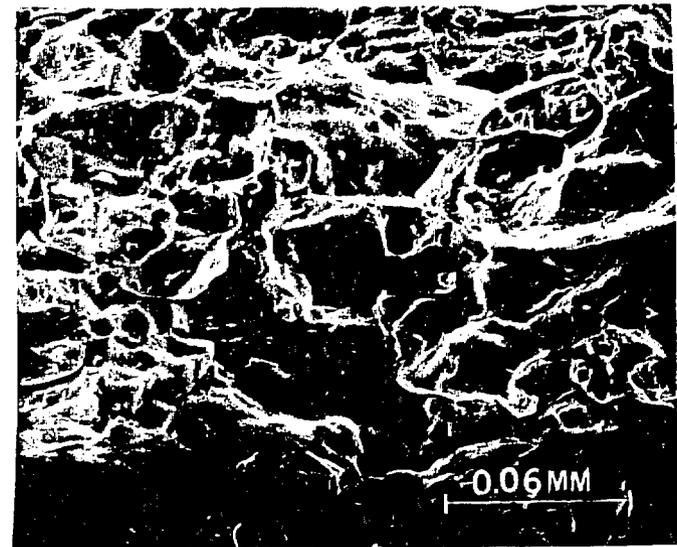
Figure 12b A ductility area of 6.8% (typical) was seen near the opposite side of the fracture.
