**AECL-9710**

**EXAMINATION OF CORE COMPONENTS  
REMOVED FROM CANDU REACTORS**

**B.A. CHEADLE, C.E. COLEMAN, D.K. RODGERS, P.H. DAVIES,  
C.K. CHOW and M. GRIFFITHS**

**Chalk River Nuclear Laboratories**

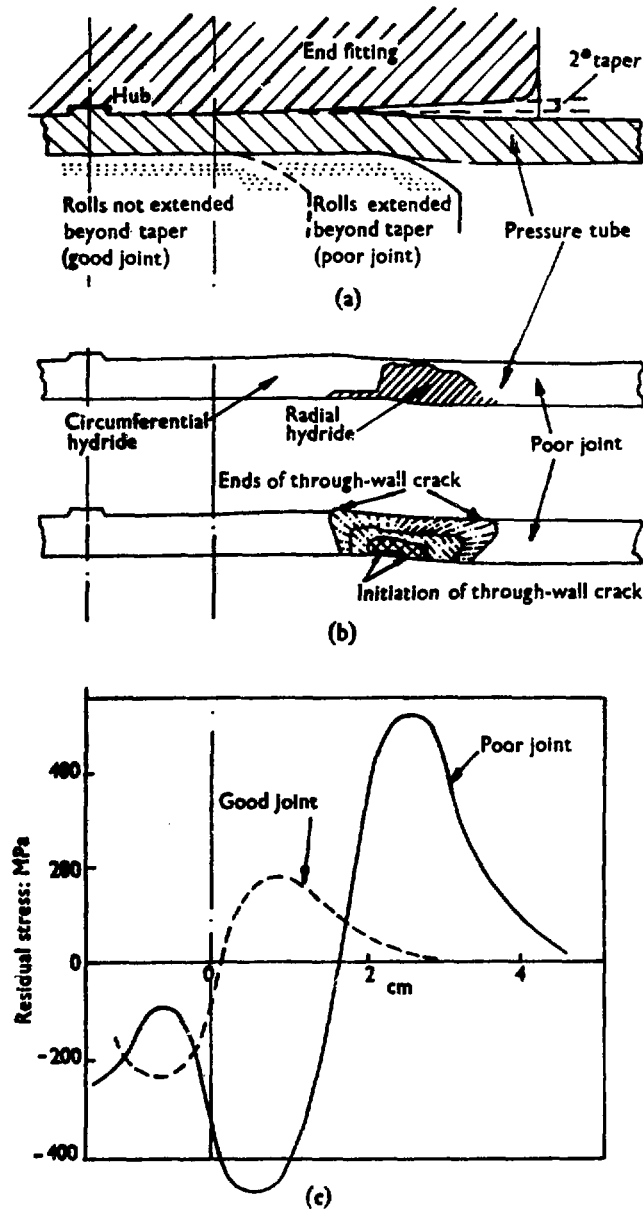
The pressure vessels in CANDU reactors are seamless tubes made from cold-worked zirconium alloys. They are mechanically joined to 403 stainless-steel end fittings by a rolled joint. In 1974-5 in Pickering Units 3 and 4 leaking cracks developed in a few Zr-2.5 Nb pressure tubes just inboard of the rolled joints. The cracks started on the inside surface and grew by a mechanism called delayed hydride cracking (DHC). An important feature of these failures was the presence, over a length of about 20 mm, of large residual tensile stresses in the hoop direction, up to 600 MPa, caused by an improper rolling procedure, Figure 1. The measurements of stress were made using a strain gauge and slitting technique in protective cells. The pressure tubes are designed to withstand a hoop stress from the pressure of the coolant of about 120 MPa, so the residual stresses were clearly unacceptable.

When the cracks and large residual stresses were discovered, Bruce Units 1, 2 and 3 were already built and their rolled joints had the same fault. To save retubing the reactor, the regions of high residual stress in each tube were heated to about 500°C for 0.5 h to relieve the stresses. This treatment was too late for two tubes that cracked in Unit 2 in 1982. However, measurements of residual stress showed that the heat treatment had been successful - the residual stresses had been reduced to between 50 and 100 MPa - so the prognosis for the remaining tubes is good. In subsequent reactors the rolled joints have been made with much smaller residual stresses, and in some reactors the stresses are minimised by keeping the clearance between the pressure tube and its end fittings as small as possible. In a "zero clearance" rolled joint the residual stresses are very low or compressive.

Figure 1: Rolled joints from Pickering 3 and 4: (a) relative position of rolling tool during installation; (b) position of radial hydrides and cracks in a poor joint; (c) residual hoop stress distribution on the inner wall of a good and poor joint.

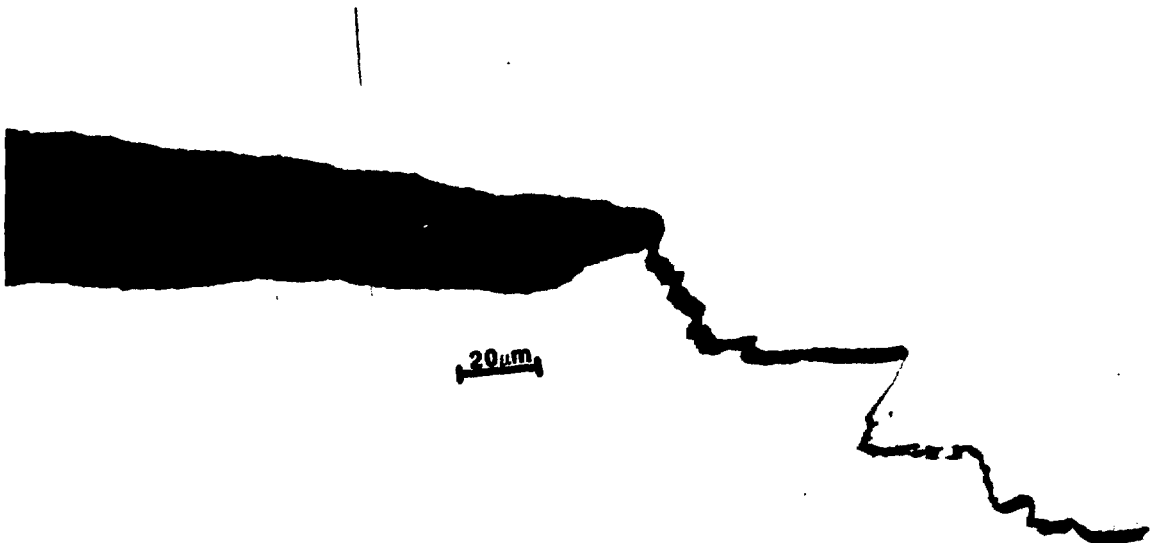
FIGURE 4: Delayed hydride cracking caused by oxide wedging in Zr-2.5 Nb pressure tube. Contrast enhanced by IBAS image analyzing computer.

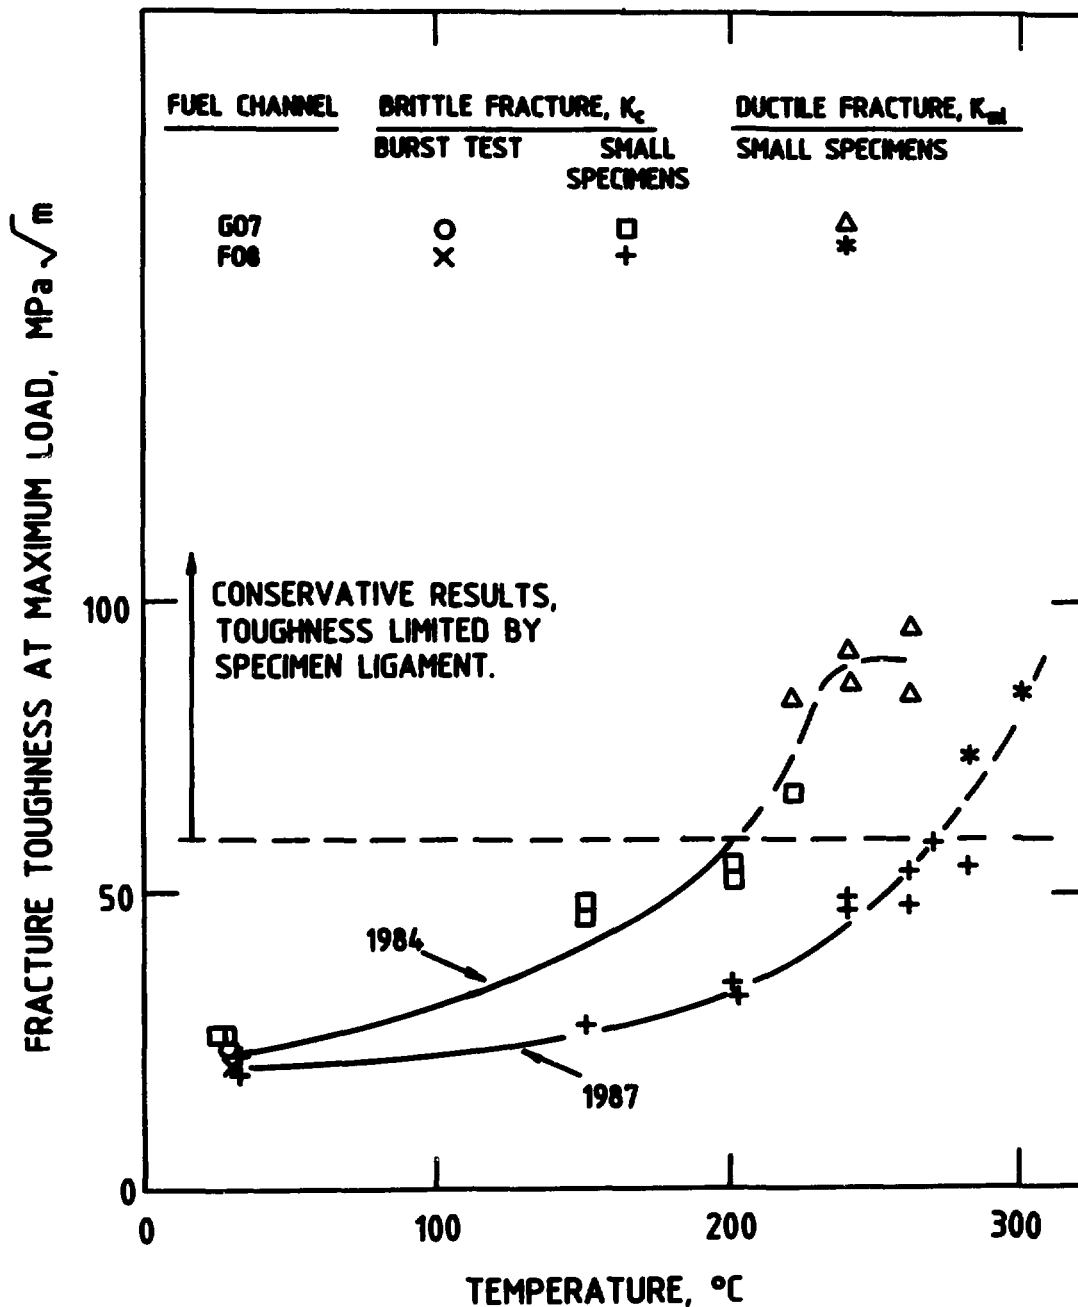
In February 1984, the Zircaloy-2 pressure tube was removed from fuel channel G07 in NPD after operating for 134 000 EFPH. Fracture toughness tests on small specimens machined from the region of the tube that had a high fluence and deuterium concentration (about 0.8 at% deuterium) exhibited a brittle-ductile transition temperature of about 220°C, Figure 5. In May 1987, the pressure tube was removed from fuel channel F08 after operating for 156 900 EFPH. Both the fluence and the deuterium concentration (about 2.2 at% deuterium) were higher than the previous tube and the brittle-ductile transition temperature was 280°C, Figure 5. This temperature is above the operating temperature range of 252 to 277°C for NPD pressure tubes. Since leak-before-break could not be assured for pressure tubes exhibiting brittle fracture behaviour in the operating temperature regime (unacceptably short critical crack lengths), a recommendation was made to discontinue operation of the pressure tubes. A shift in transition temperature of about 60°C during the last 3 years of operation indicated that the rate of deterioration had been rapid, mainly due to an accelerating deuterium pick-up rate.

FIGURE 5: Comparison of fracture toughness of Zircaloy-2 pressure tube NPD F08 (1987) with previous results for NPD G07 (1984). Note that small specimens provide conservative results once the failure mode is ductile.
