CORROSION PROBLEM IN THE C.R.E.N.K.
TRIGA MARK II RESEARCH REACTOR.

Professor MALU WA KALENGA *

* Centre Régional D'Etudes Nucléaires de Kinshasa
(C.R.E.N.K.); B.P. 184; Kinshasa XI; Zaïre.

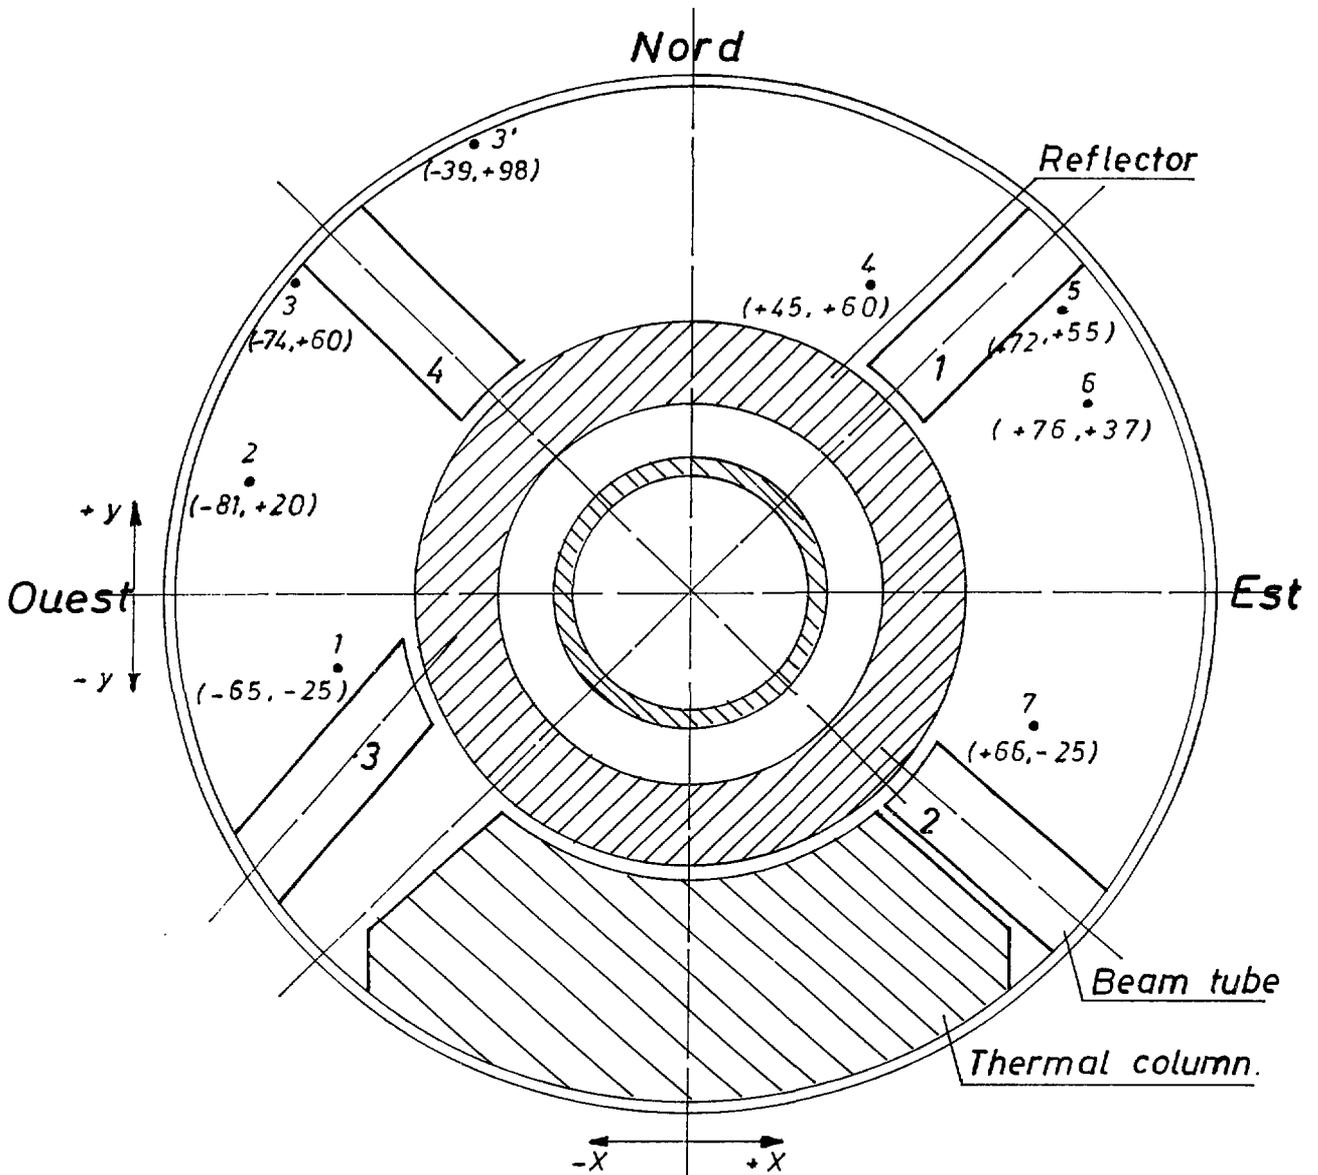
The inspection of the aluminum tank carried out after the removal of the core structure showed a less serious corrosion problem than was anticipated. Only 8 pits were identified as resulting from the corrosion of the aluminum plate. The most advanced corroded spot has a depth of 2,5 mm. The range of the depths of the 8 pits was between 1 mm and 2,5 mm. The pit shape vary somewhat but the mouth of a pit tended to be circular, while the cross section was roughly hemispherical. Figure 2 gives the location of the 8 pits that were identified, relative to the ground position of some elements of the core structure.

Taking into account the fact that all the pits are located outside the area covered by the core, that is outside the reflector, (see 'fig.' 3), it is likely that the corrosion process was initiated by galvanic couples, with impurities dropped into the aluminum tank during the operation of the reactor playing the cathodic role. If the pit created survives the initiation phase, it propagates by galvanic reaction with the aluminum being anodic and the impurities being cathodic.

Fig.2 Approximate location of pits in the tank bottom. Figures in bracket give the coordinates of pits relative to the centre. (in cm.)

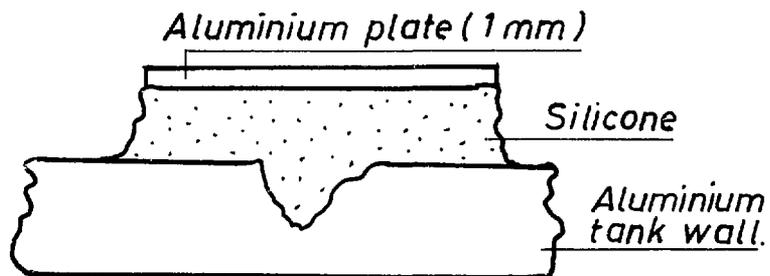
Fig.3 Filling of pits

The filling by welding procedure was deemed unfit because one has to heat the aluminum tank to such a high temperature as to cause local defects. The filling of the pits with epoxy resins was discarded because it was felt that under hard and intensive radiations epoxy will not remain stable in the long run. Before using the third solution, that is filling the cavities with silicone, a sample made of aluminum pieces binned together with silicone was irradiated at the BR2 Material Testing Nuclear Reactor in Mol (Belgium) to an integrated flux equivalent to a 1 Mw(th) reactor working full time for 20 years. No damage of the sample was recorded. The repair was thus carried out using silicone covered by small pieces of 1 mm aluminum to act as a protective barrier, ('Fig.' 3).
