Operation of Finnish nuclear power plants

Quarterly report
2nd quarter, 1990

Kirsti Tossavainen (Ed.)
DECEMBER 1990

STUK - B - YTO - - 76.

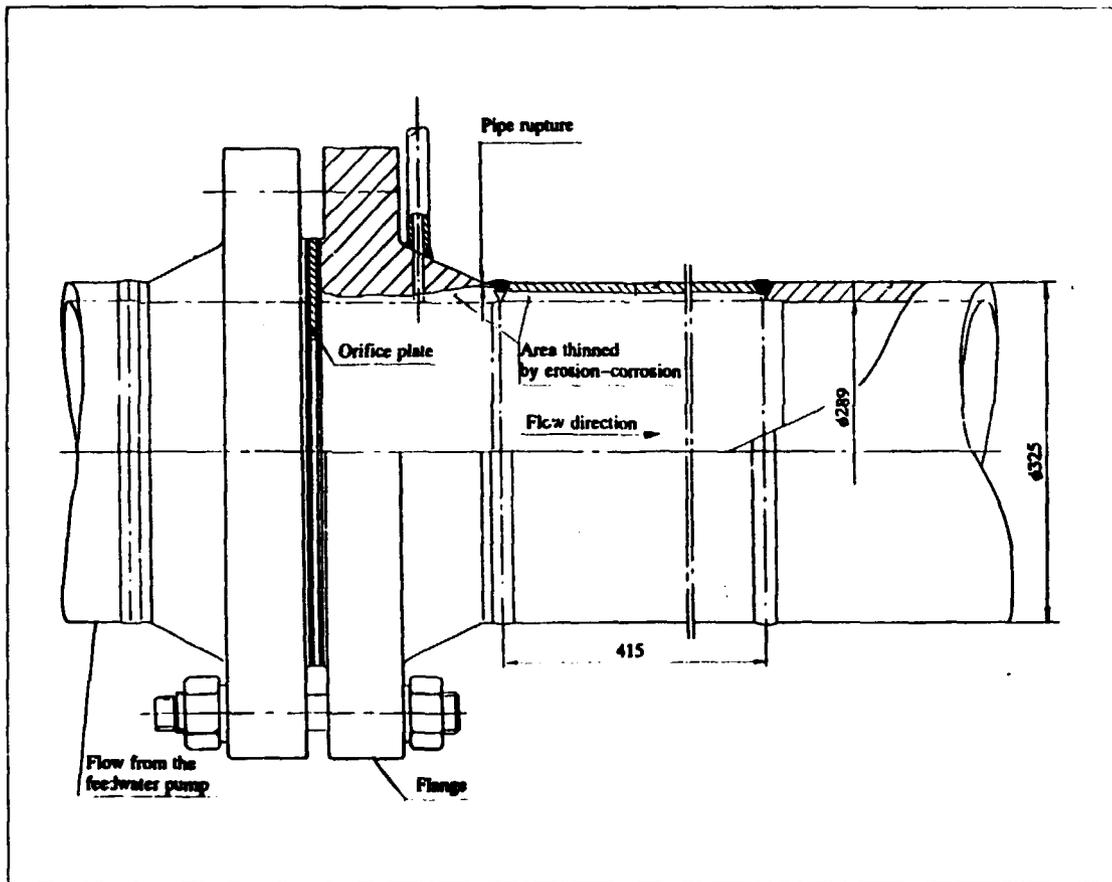
Fig.5. A diagram of the feedwater pipe rupture at Loviisa 1.

The feedwater pipe rupture was downstream of a feedwater pump in the flange of an orifice plate used for flow measurement close to a welded seam. The rupture was attributed to heavy erosion corrosion which had reduced pipe wall thickness to 1 - 2 mm circumferentially in the rupture point. A schematic presentation of the rupture is given in Fig 5.

The pipe rupture and the water discharged through the rupture damaged cable trays and cables near the pipe. Cables and adjacent measurement devices were inspected and damages repaired. Water damaged also fire suppression systems located in the same room. The damage was repaired temporarily without delay. Repairs on a more permanent basis will be carried out during the annual maintenance outage.

After the event four other corresponding locations in feedwater lines were inspected. The rupture and the other four locations in the other lines were repaired temporarily. In feedwater lines also the flanges of orifice plates of each steam generator used for power measurement were inspected. One of them was repaired temporarily. Permanent repairs will be conducted in the annual maintenance outage.
