# Operation of Finnish nuclear power plants

Quarterly report  
3rd Quarter, 1990

STUK-B-YTO 78  
FEBRUARY 1991

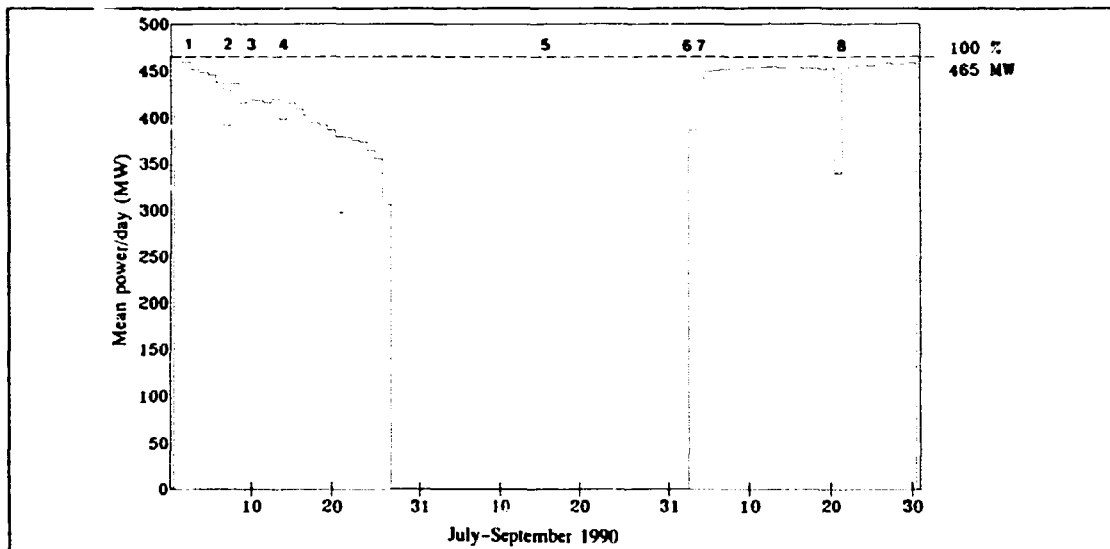
Fig 1. Average daily gross power of Loviisa 1 in July-September 1990

| <ol style="list-style-type: none"> <li>1 Nuclear fuel had burnt to such an extent that reactor power started to decrease gradually (so called stretch-out)</li> <li>2 Testing of safety valves of the fresh steam lines, reactor operating at 65 % power</li> <li>3 Stand-by feedwater pump trip, reactor to 89 % power</li> <li>4 Turbine tripped by high level of collecting tank for water separated from the superheater, reactor to 40 % power</li> </ol> | <ol style="list-style-type: none"> <li>5 Annual maintenance (see Chapter 2.2)</li> <li>6 Generator was disconnected from the grid to repair an endoscope nozzle</li> <li>7 Turbine tripped by high level of collecting tank for water separated from the superheater</li> <li>8 Generator was disconnected from the grid to repair superheater leaks</li> </ol> |

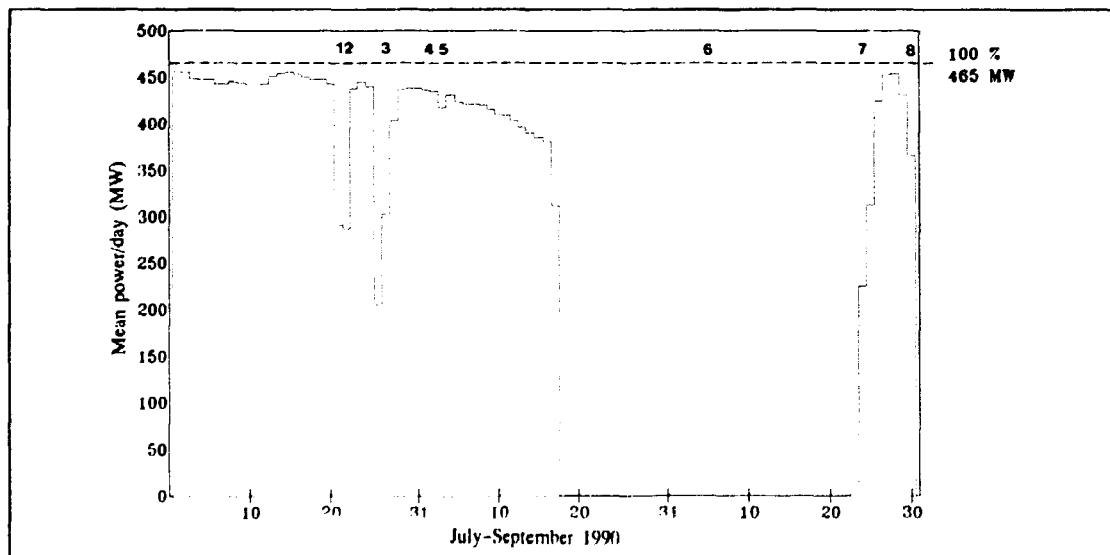
Fig 2. Average daily gross power of Loviisa 2 in July-September 1990.

| <ol style="list-style-type: none"> <li>1 Testing of safety valves of fresh steam lines, reactor operating at 67 %</li> <li>2 Repair of a superheater leak, reactor operating at 77 % power</li> <li>3 Hot shutdown for repairing a check valve of the emergency core cooling system (see Chapter 3.4)</li> <li>4 Nuclear fuel had burnt to such an extent that reactor power started to decrease gradually (so called stretch-out)</li> </ol> | <ol style="list-style-type: none"> <li>5 Generator disconnected from the grid owing to a magnetizing disturbance, reactor to 71 % power</li> <li>6 Annual maintenance (see Chapter 2.3)</li> <li>7 Generator was disconnected from the grid for repairing leaking flanges of superheater</li> <li>8 One HP turbine was repaired, the other turbine's bearings were tested for vibrations and a leaking superheater flange was repaired, reactor operating at 50 % power</li> </ol> |

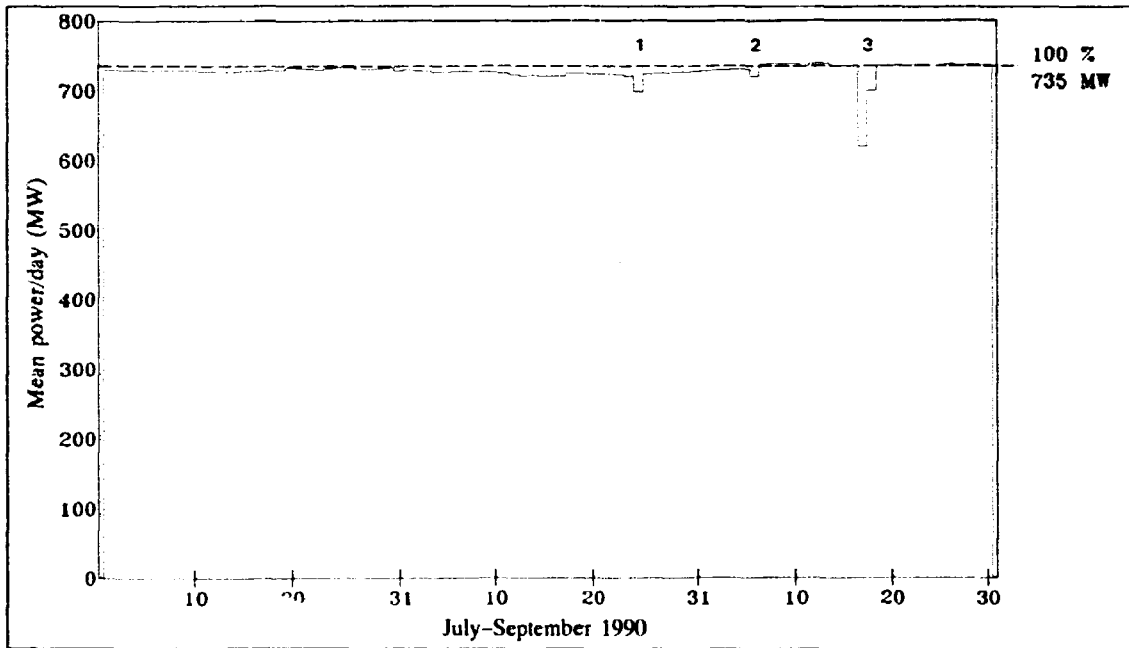
Fig 3. Average daily gross power of TVO I in July-September 1990.

| <p>1 Periodic tests, reactor operating at 70 % power</p> <p>2 Test of reactor protection system and flattening of drainage pipe of the seal and leakage steam system, reactor operating at 60 %</p> | <p>3 Repair of a sealing weld of a HP pre-heater access hatch in the feedwater system of the turbine plant, reactor operating at 60 %</p> |

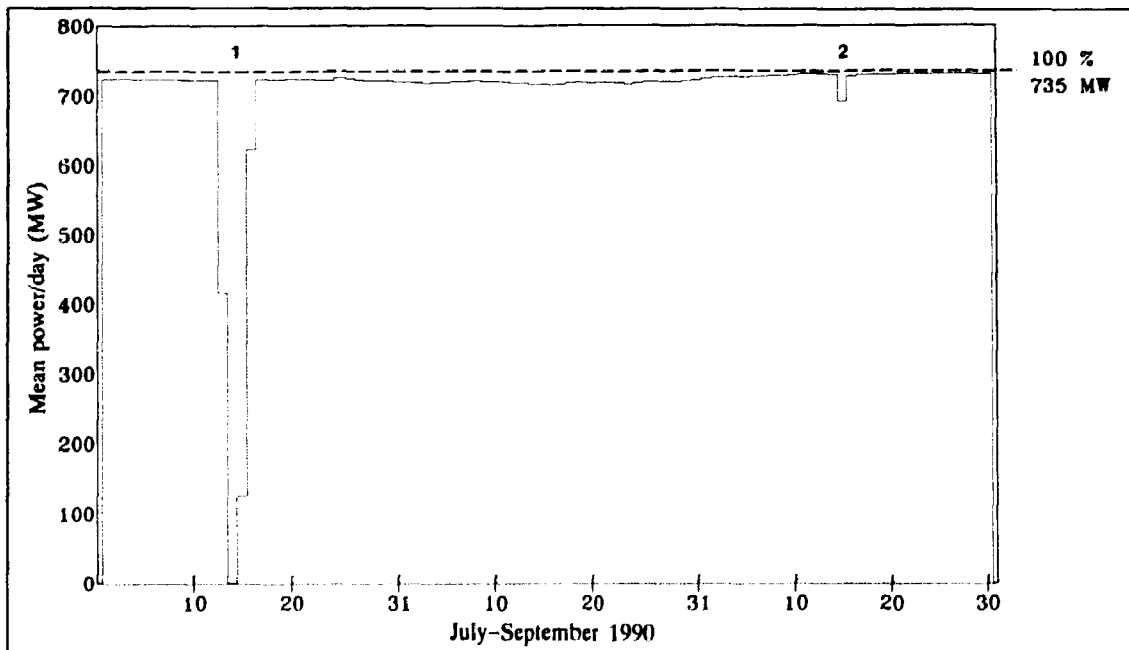
Fig 4. Average daily gross power of TVO II in July-September 1990.

| <p>1 Cold shutdown for repairing an inner isolation valve of the auxiliary feedwater system (see Chapter 2.4)</p> | <p>2 Periodic tests, reactor operating at 60 % power</p> |

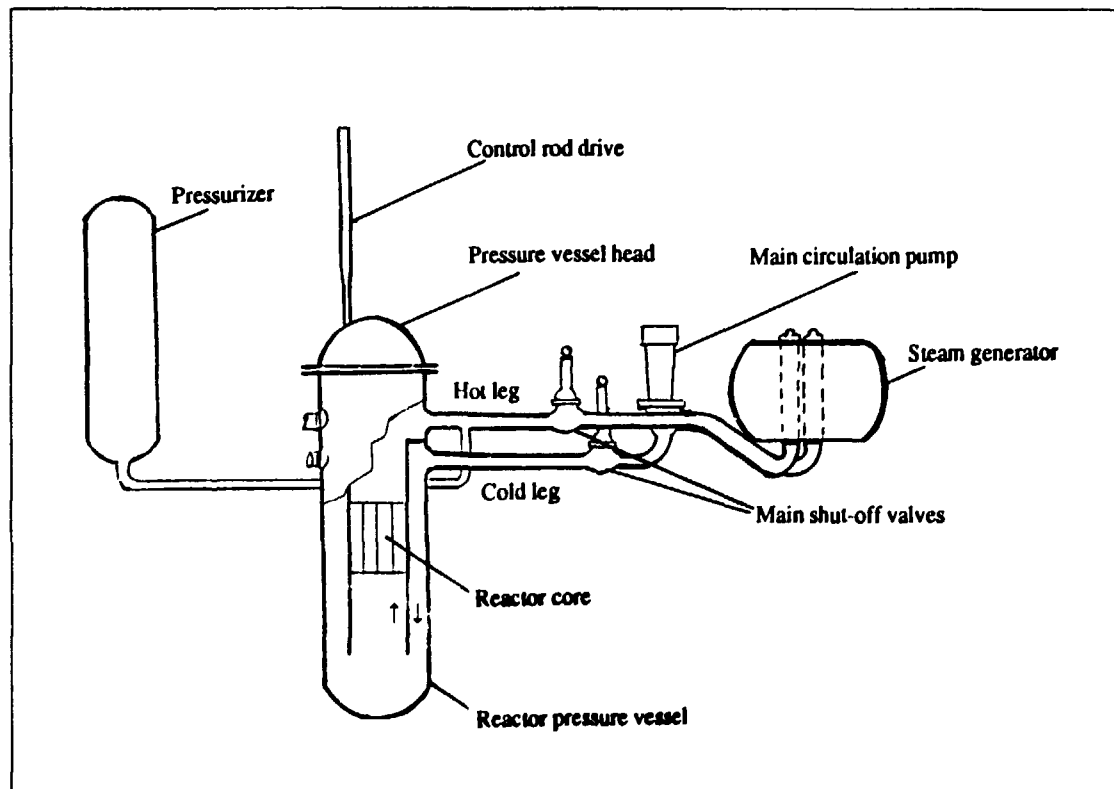
Fig 5. Loviisa 1 primary circuit (schematic).

During the annual maintenance of Loviisa 1 on 24.8. the reactor water level was lowered for repairing a mechanical position indicator of a control rod drive. For this purpose the reactor water level had to be lowered from level +20.5 m to level +16.5 m which is about three meters above the upper edge of the hot leg main circulation pipes. Primary circuit mean temperature was 79°C. The RPV head was on its place but the primary circuit was devoid of pressure. Residual heat removal took place by the introduction of natural circulation in two loops. Increased reactor

water temperature was an indication of disturbed natural circulation. The reactor water level was re-raised for restoring natural circulation. Each coolant loop at a time was isolated from the reactor by isolation valves and gas was removed by venting from the water circulating in the loops. Natural circulation was thus restored.

A considerable volume of gases escapes from reactor water during the depressurization of the reactor. These gases are removed by the recirculation of primary water and by venting the primary circuit. In this case, removal of gas was incomplete. The minute decrease in pressure resulting from the lowering of reactor water level had resulted in the ca 1.3-fold expansion of released gases in the upper bends of the coolant loop. The formation of gas bubbles prevented natural circulation.

In future, the primary circuit will be vented more efficiently in connection with the lowering of the reactor water level to avoid recurrence of the event.
