## SEISMIC ISOLATION RETROFITTING OF THE SALT LAKE CITY AND COUNTY BUILDING

J. Bailey and E. Allen (E. W. Allen and Associates - USA)

*The City and County Building, a massive unreinforced masonry structure completed in 1894, has been seismically retrofitted using base isolation. The isolation system consists of 443 lead-rubber isolators installed underneath the building on top of existing spread footings. The building is isolated from the surrounding ground by a perimeter moat wall, permitting lateral movement to take place during an earthquake.*

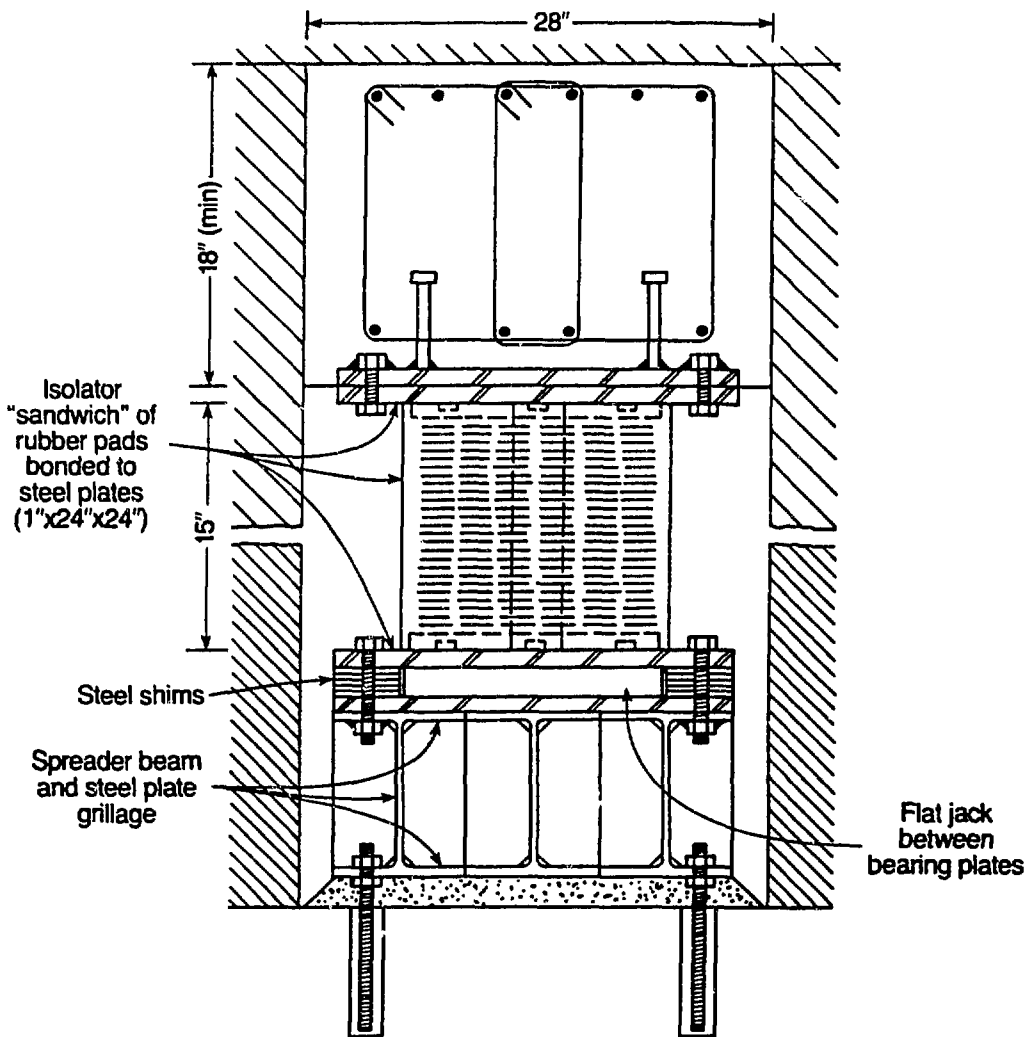
Fig. 2. Typical Installed Base Isolator

A typical bearing used on this project is 43 cm square by 38 cm tall (Fig. 2). It consists of a sandwich of alternating steel and rubber layers with a lead core. The purpose of the lead core is twofold: it acts as a fuse, preventing building motion due to wind loads, but yielding and providing inelastic viscous damping to absorb energy during a seismic event. This damping also helps to control horizontal deflections. The steel plates, which are bonded to the rubber, prevent the rubber from spreading outward under vertical loading, thus making the bearings very stiff in the vertical direction.

3. Below the isolators, several small steel beams are welded together to form a grillage to distribute vertical loads from the isolator onto the existing footing (Fig. 2).

Preloading was accomplished using Freyssinet flat jacks in a shim space provided for this purpose below each isolator. The particular flat jack used is 41-cm diam x 3.18 cm thick, with a rated load of 172,000 kg. Two workmen could easily preload three isolators in an hour. The procedure used is as follows:
