STUK-B-YTO 90

Operation of Finnish nuclear power plants

Quarterly report
2nd quarter, 1991

Kirsti Tossavainen (Ed.)
DECEMBER 1991

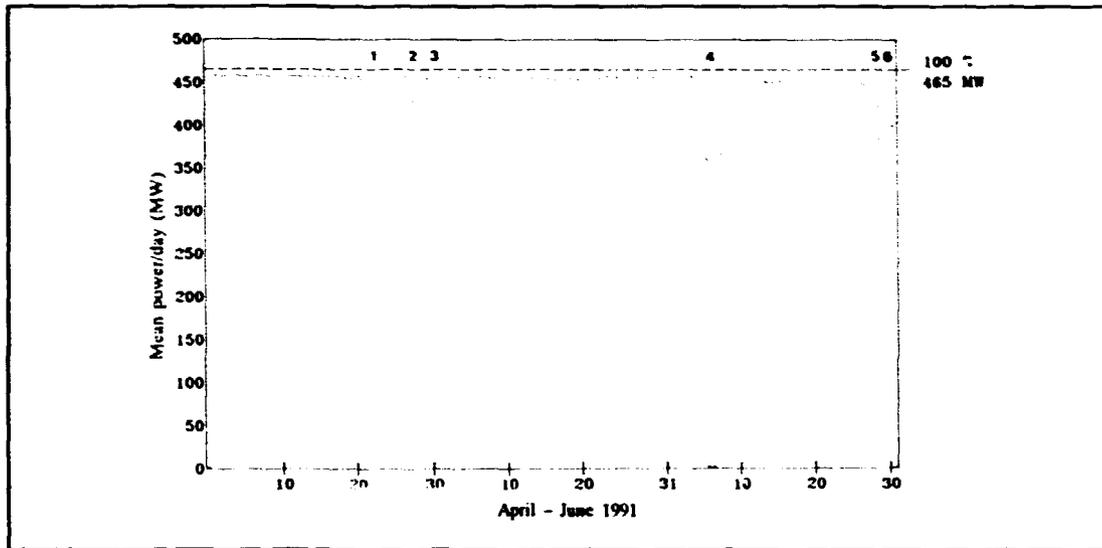
Fig 1. Average daily gross power of Loviisa 1 in April - June 1991.

| <ul style="list-style-type: none"> 1 Repairs of leaks in HP bleeding points 2 Repair of a HP turbine drain pipe, reactor operating at 52 % power 3 Superheater leaks repaired, reactor operating at 52 % power | <ul style="list-style-type: none"> 4 Hot shutdown to repair drainage pumps in the special sewerage system (see Chapter 2.2) 5 Superheater leak repaired, reactor operating at 52 % power 6 Less demand for electricity during weekend and repair of a control valve of the HP pre-heater |

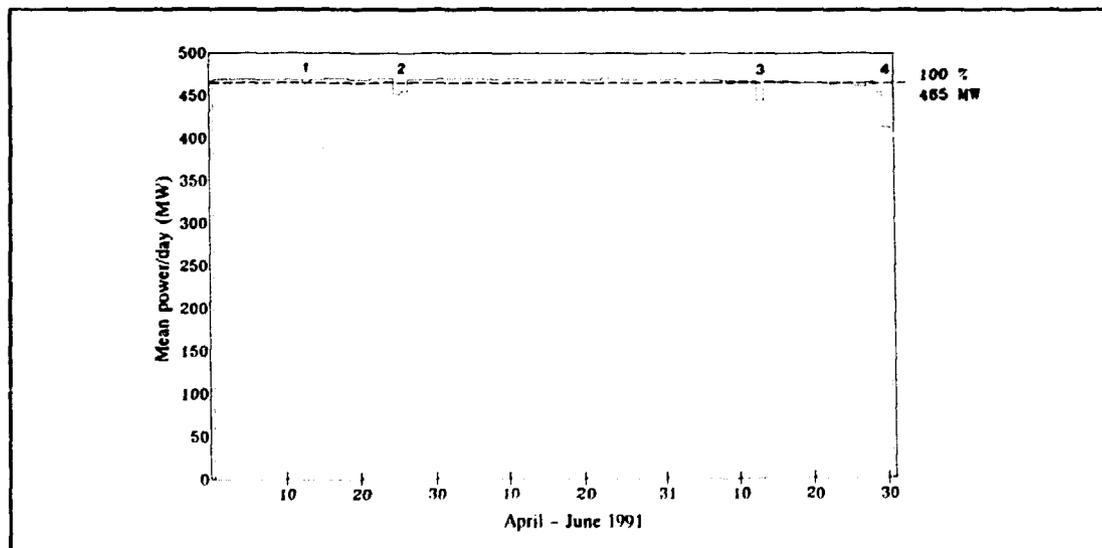
Fig 2. Average daily gross power of Loviisa 2 in April - June 1991.

| <ul style="list-style-type: none"> 1 Sea water pump tripped in connection with relay replacement, reactor power level to 85 % 2 One main circulation pump tripped due to a relay fault, reactor power level to 76 % | <ul style="list-style-type: none"> 3 One main circulation pump tripped due to an erroneous temperature measurement, reactor power level to 77 % 4 Less demand for electricity during weekend |

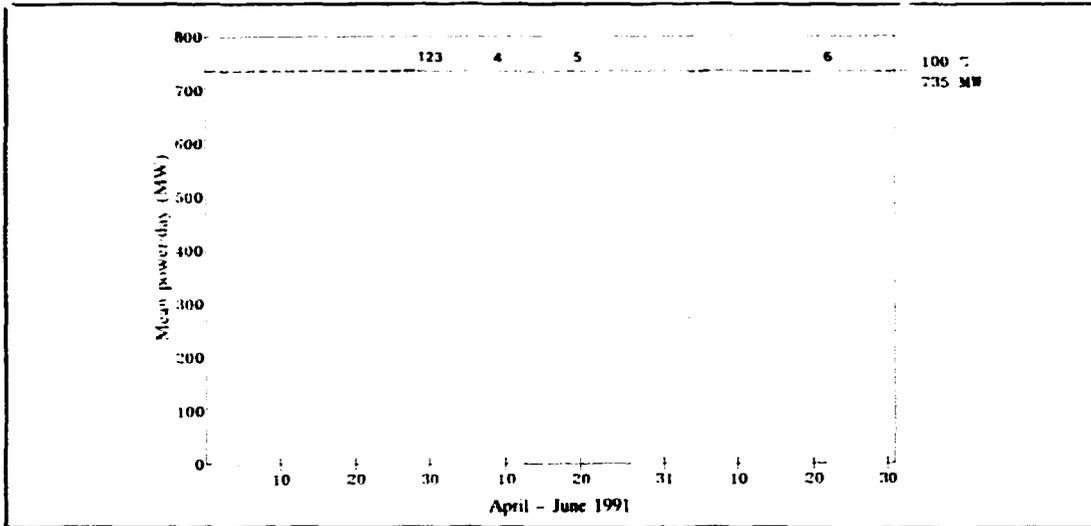
Fig 3. Average daily gross power of TVO I in April - June 1991.

| <ul style="list-style-type: none"> 1 Reactor trip caused by a phase short-circuit of the 400 kV line (see Chapter 2.3) 2 Localization of a small fuel leak observed on 11.4.1991, reactor operating at 50 % power (power reduction was also necessary due to less demand for electricity) 3 Periodic tests, reactor operating at 70 % power (power reduction was also necessary due to less demand for electricity) | <ul style="list-style-type: none"> 4 Nuclear fuel had burnt to such an extent that the power has started to decrease gradually (coast-down) 5 Annual maintenance outage (see Chapter 2.4) 6 Cold shutdown to repair an inner isolation valve and power reduction (reactor operating at 55 % power) due to less demand for electricity (see Chapter 2.5) |

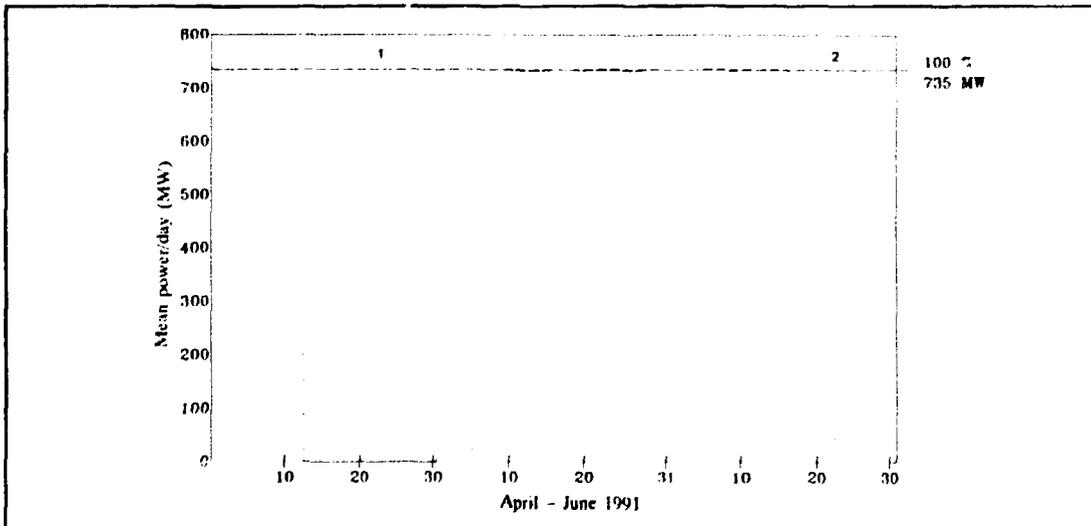
Fig 4. Average daily gross power of TVO II in April - June 1991.

| <ul style="list-style-type: none"> 1 Outage caused by a switchgear fire and the annual maintenance outage (see Chapters 2.6 and 3.4) | <ul style="list-style-type: none"> 2 Power reduction (reactor operating at 60 % power) and hot shutdown due to less demand for electricity (see Chapter 2.7) |

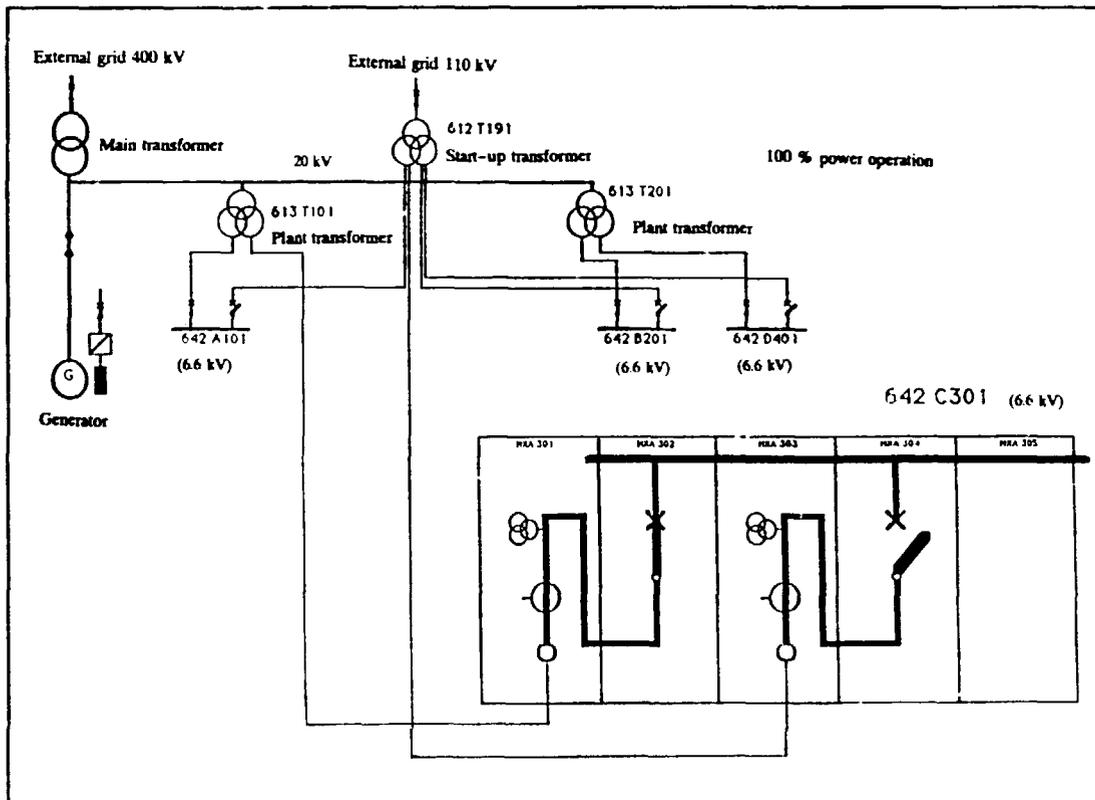
Fig 5. Diagram of the general 6.6 kV system of TVO II.

It had been found out at TVO II on 8.4. that the power measurement of one busbar (642 C301) of the general 6.6 kV system indicated a value considerably too low. Investigations into the fault were initiated in the late morning of 12.4. Damaged terminal blocks were found in the secondary circuit of the current transformer which measures the power of the incoming cable from the plant transformer to the busbar. The terminal blocks are located in the unit's cubicle HXA 301. To make the terminal blocks currentless, the busbar's power supply was switched from the 110 kV external grid via the startup transformer to the unit's second cubicle (HXA 303). The damaged terminal blocks sparked when touched and the cubicle started to emit smoke. The fire brigade was alerted at 13.38.

In consequence of the fire, a short circuit by arching occurred in the busbar owing to which relay protection opened both the 400 kV and the generator breakers. Loss of the 400 kV grid connection resulted in a turbine trip, partial scram and the tripping of the recirculation pumps. Somewhat later, when the fire had reached the cubicle (HXA 303) containing the incoming cable from the start-up transformer, another short circuit by arching occurred. Due to the short

circuit, the relay protection of the 110 kV grid breaker of the startup transformer opened the breaker. A total loss of external power supply thus resulted. Due to the loss of power supply, the turbine's condenser system was not available anymore and a scram resulted.

The event was probably caused by a break in the test plug of the current transformer's secondary circuit. The break obviously occurred in relay testing during the 1990 annual maintenance. During plant unit startup after the annual maintenance outage, such high voltage was established in the defective secondary circuit that the insulation of the terminal blocks of the circuit and of the adjoining voltage transformers overheated. When inspecting and touching the

The busbar (642 A101) in which soot and molten metal were scattered around during the fire was cleaned, tested and connected to the grid on 16.4. Four cubicles (HXA 301-304) of the busbar (642 C301), which sustained damage in the fire, were replaced and the sooty, damaged cubicles were cleaned and repaired. Incoming cables from the plant transformer and the start-up transformer to the busbar were replaced. The whole unit was tested and energized on 21.4.

During the annual maintenance, the physical separation of the current and voltage transformers was enhanced by means of terminal block rows. A measure was included in the instructions for relay tests to post-test check the integrity of the secondary circuits of the current transformers. Tightness of the terminal blocks was checked and old terminal blocks were replaced with new ones. Thermography of the terminal blocks and test plugs of the general 6.6 kV system was carried out. Monitoring of the internal consumption measurements carried out by the control room was made more efficient.
