MANAGING THE AGING OF BWR CONTROL ROD DRIVE SYSTEMS*

Rebecca H. Greene
Oak Ridge National Laboratory
Oak Ridge, TN 37831-8038
and
William S. Farmer, USNRC-RES
5650 Nicholson Lane, NLS-217B
Rockville, MD 20852

ABSTRACT

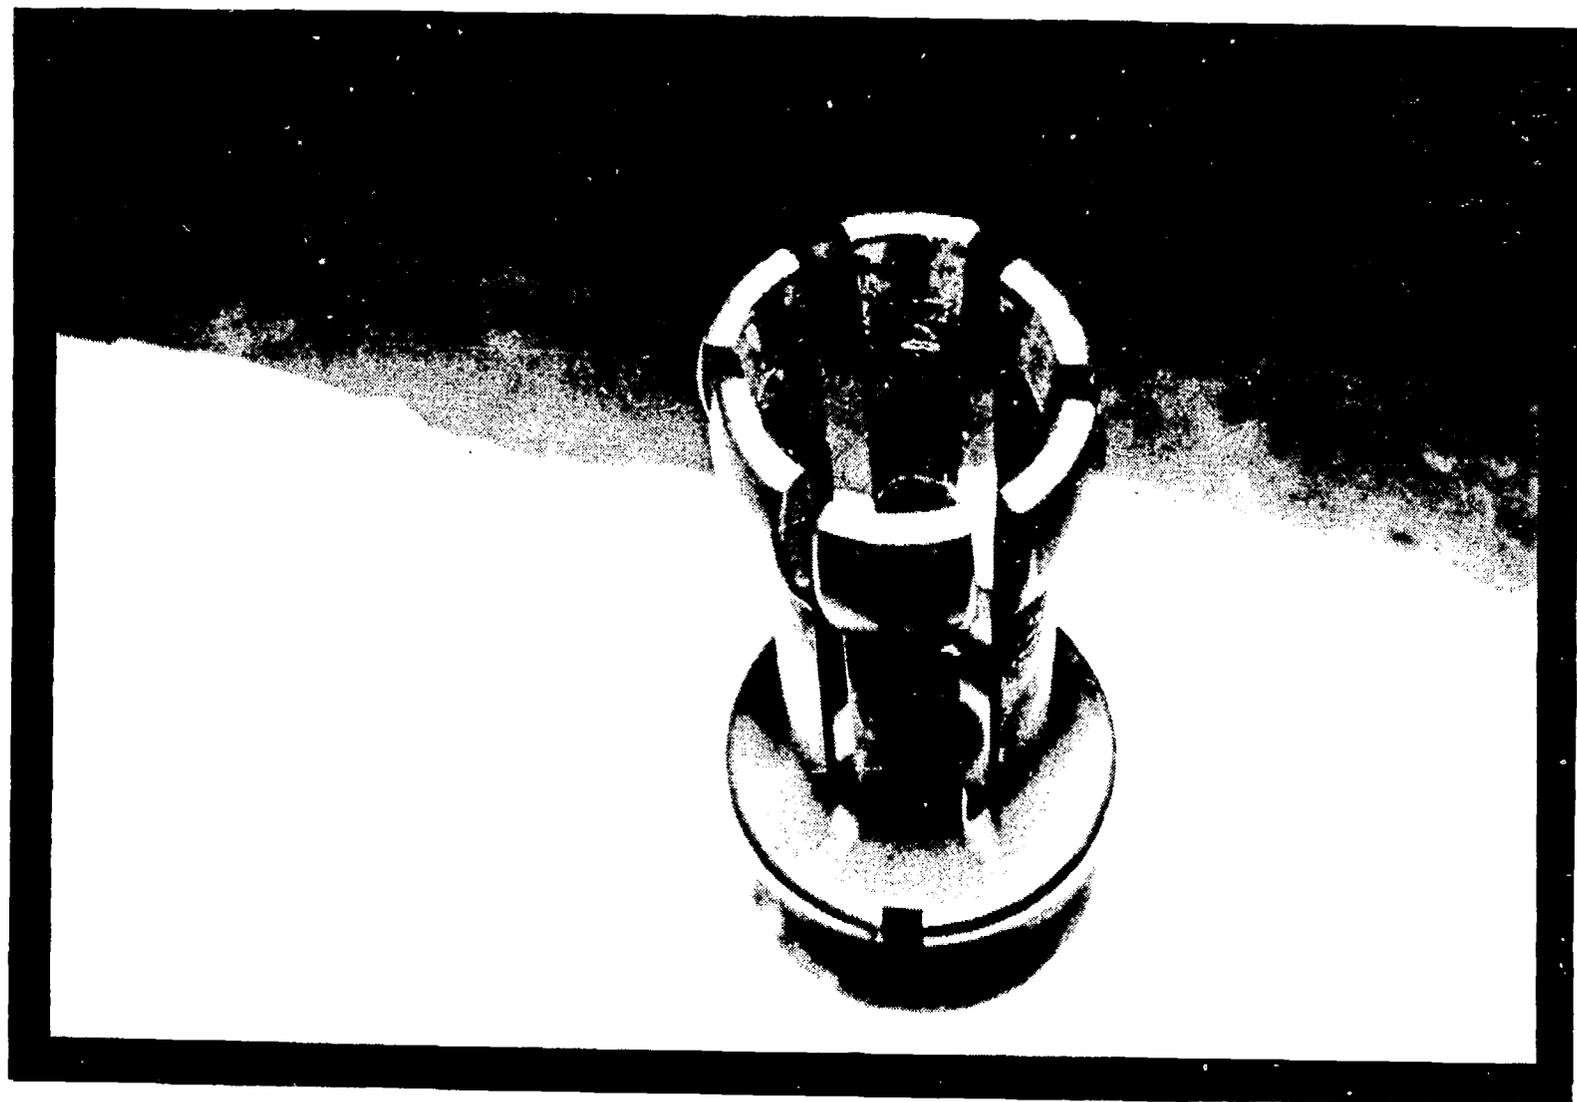
Fatigue and/or mishandling is suspected to be the cause of certain effects observed in the spud, the CRDM component that engages the control rod assembly blade via the uncoupling rod. There have been reports of the "fingers" of this Inconel X-750 component being easily bent after a prolonged service history (> 15 years) in the reactor vessel. CRDM rebuilding technicians have described the effect as the fingers "losing their memory," and have used screwdrivers to pry and bend the fingers back into a proper concentricity (a practice which is not recommended). Although no professional metallurgical examinations have been conducted on a malformed spud, the cause of the bent fingers is speculated to be (1) fatigue caused by mechanical loads imposed by repeated scrams, (2) deformation resulting from mishandling during CRDM installation, or (3) deformation from CRA installation while the CRDM is partially

inserted. This type of spud damage (as shown in Figure 3) can present a myriad of coupling and uncoupling difficulties with the CRA. The spud, like all CRDM components, should be exchanged with a new spare part during rebuilding activities if it is damaged.

Figure 3. Bent CRDM spud fingers (notice lack of concentricity).

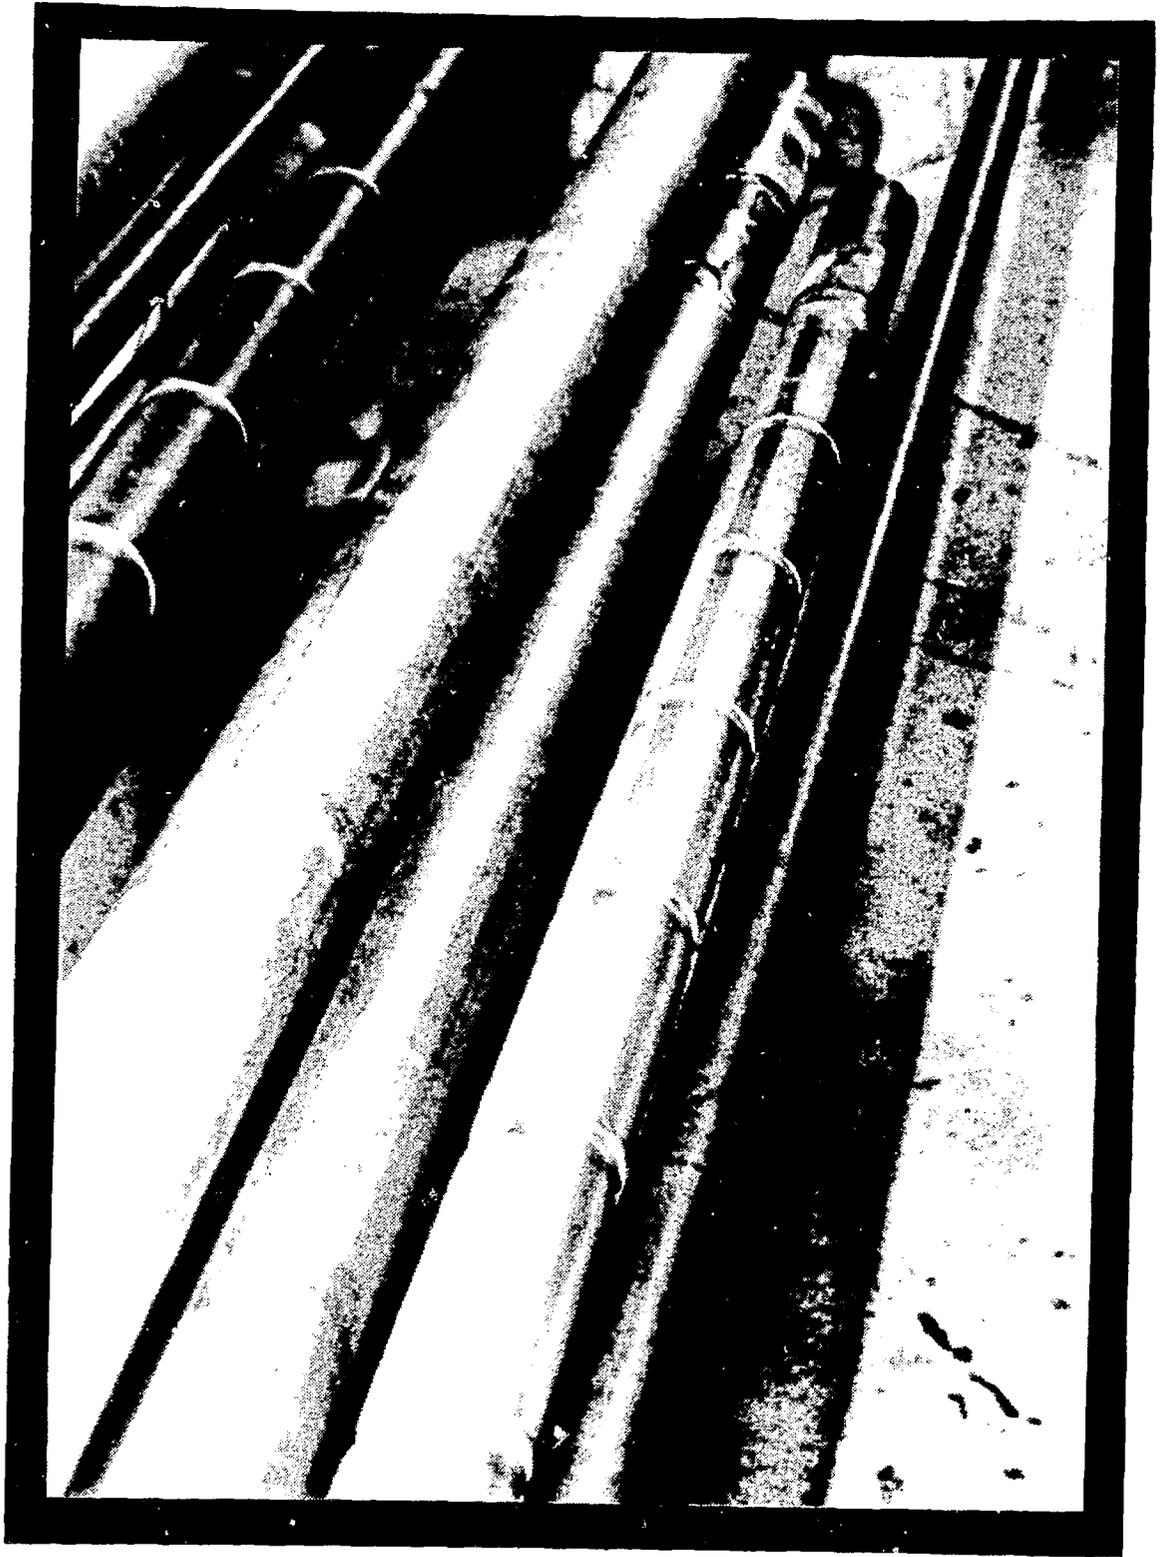
In some CRDMs having a continuous service history greater than 15 years, degradation of the nitriding has been observed to the extent that, in one particular example, the unusually rough surface of an index tube could be easily scored with a piece of wood.² Although no formal metallurgical investigations have been conducted to determine the nature of this effect, it could be the result of a combination of causes: prolonged radiation exposure, poor water chemistry, high operational temperatures, and variations in the case hardening from the nitriding process. It should be noted that no operational problems were reported for one CRDM with a longitudinally "striped" index tube (as shown in Figure 4), but the component was not reused in the rebuilt device because its continued serviceability was considered questionable.

Figure 4. CRDM index tube surface degradation (notice striping left by collet fingers).

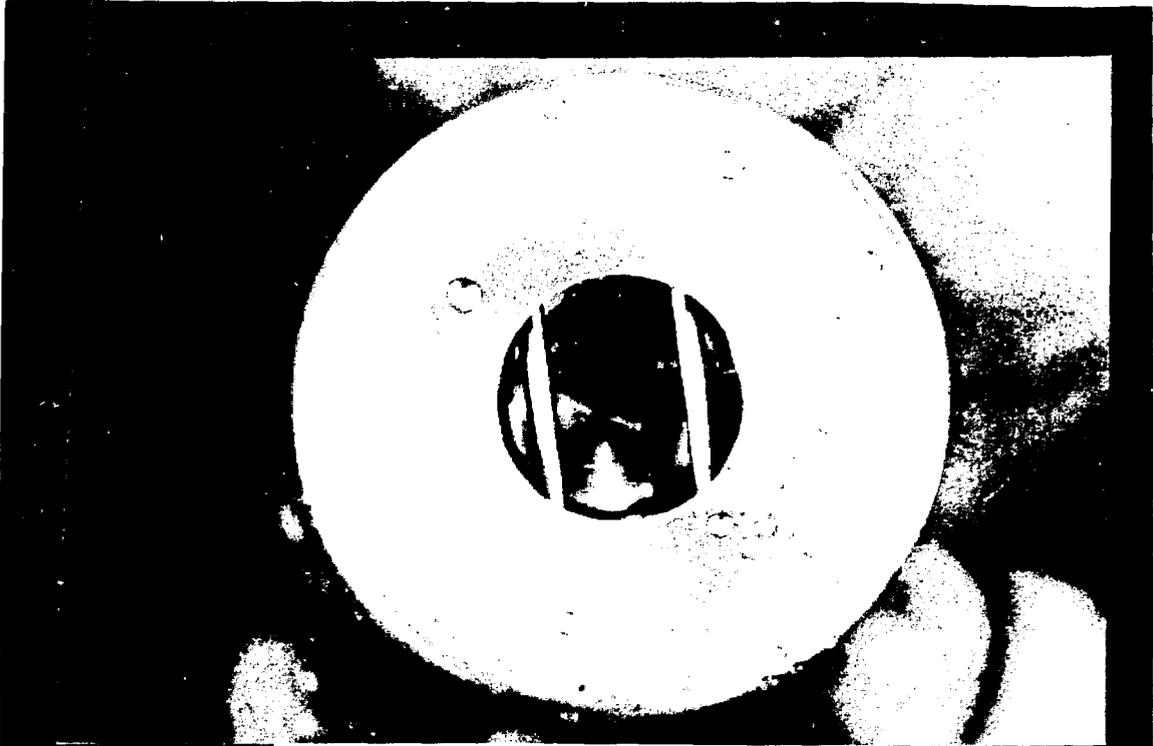
Each CRDM has an inner and outer filter which serves to collect debris from reactor water that might otherwise damage the CRDM. The inner filter has been attributed with 90 failure reports in the NPRDS. Installation and maintenance errors were cited in 35 cases. Inner filters that are incorrectly installed during CRDM rebuilding can become loose during drive operation and cause the CRA to uncouple itself from the CRDM's spud. Uncoupling is a symptom observed in 27 of these reports. The inner filter is mechanically attached to the stop piston by means of a spring clip (Fig. 5). When

Figure 5. CRDM inner filter spring clip.

assembled, the inner filter engages the piston connector knob and is retained by locking flats that capture its spring clip after the filter is pushed onto the piston knob and rotated about 90° (Fig. 6). To test the proper installation of the inner filter, General Electric recommends using a filter assembly tool to pull the inner filter away from the stop piston with a force of about 89 to 133 N (20 to 30 pounds). After engagement has been verified, the tool is removed from the CRDM, sometimes with an unintentional jiggling or twisting motion. When this is done, the filter becomes improperly oriented and can easily be disengaged. Even if the filter is not fully rotated 90°, the filter may be inadvertently rotated more during CRDM rebuilding and handling activities.

The Toshiba Corporation has instituted a modification in its inner filter's base configuration in order to provide an improved design that would prevent uncoupling trouble due to misassembly. To date, there have been no design enhancements made in the attachment configuration of inner filters used in CRDMs operating in US BWRs that would circumvent this type of disengagement.

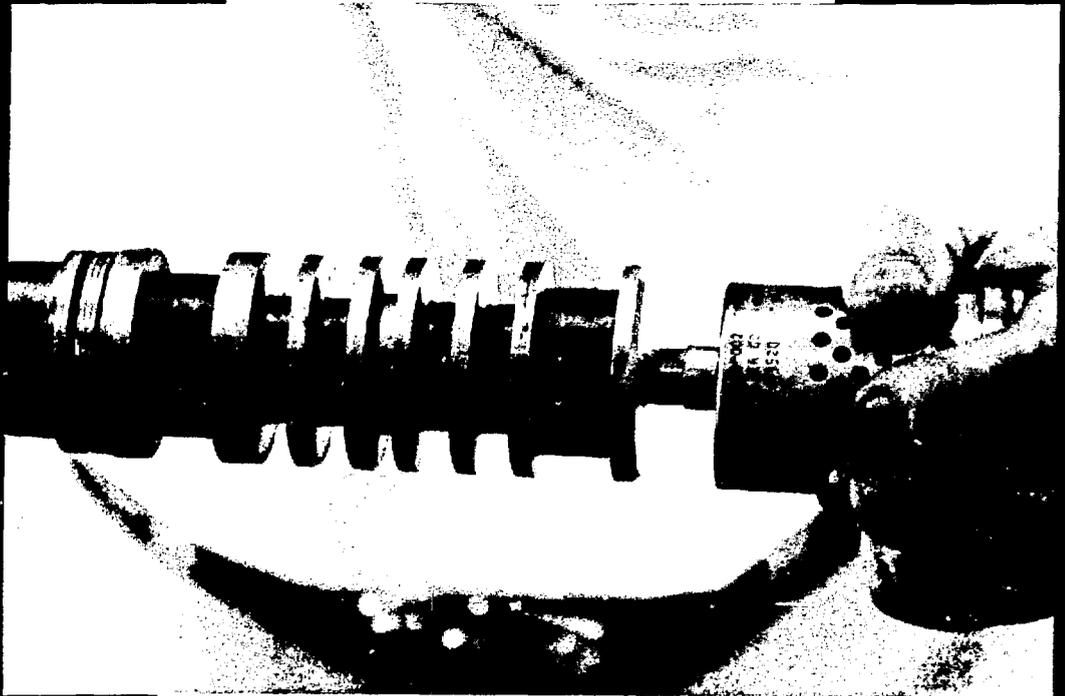
Figure 6. Attachment of inner filter to stop piston.

During the initial withdrawal venting of entrapped air for a reinstalled CRDM, the CRDM is inserted to a notch position less than 06 and then fully withdrawn back to position 48. If the inner filter was not truly engaged during the rebuilding process, it could bind against the inner surface of the CRDM index tube during CRDM withdrawal. In this scenario, the inner filter can become disconnected, cocked, and suspended. During the applied withdraw signal, the uncoupling rod could jam against the side or top of the inner filter. When the CRDM is fully withdrawn at position 48, the misconfiguration of the internal components can result in the CRDM uncoupling with the CRA.

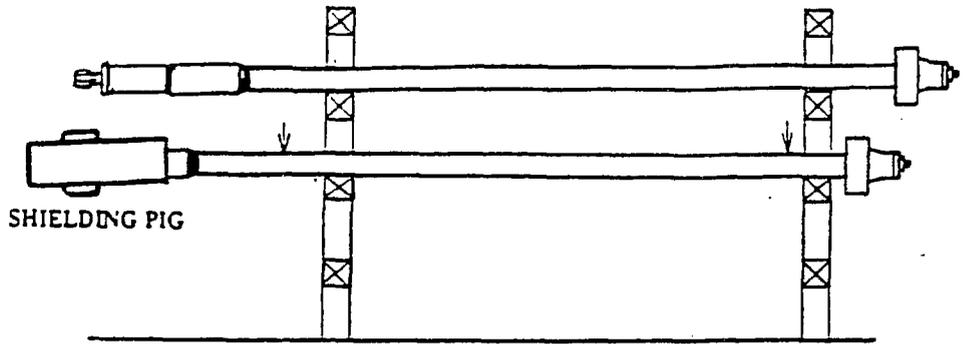
The 4.7m, 204 kg (15.5 ft, 450 lb) CRDM can be a challenge to store. Inadequate storage support has been blamed for a few observed cases of CRDM "sagging", which were confirmed by performing runout measurements along the length of the drive. Utilities store CRDMs in shielded vaults, on specially built racks, and sometimes in their original shipping crates. CRDM components can be damaged by laying drives on the floor with only the collet housing and the flange end supporting the weight as shown in Figure 7. CRDMs should not be stacked on top of each other, separated by wooden blocks, which, in

IMPROPERLY SUPPORTED CRDMs
WITH ADDITIONAL WEIGHT FACTOR

essence, transmits the weight of the stack to the lowest drive. Heavy, lead shielding "pigs" are sometimes left hanging on the spud end of "hot" drives for long periods of time, which places a moment on the collet housing. As shown in Figure 8, CRDMs should be stored in racks or vaults with a minimum of 2 points of support located 61 cm (24 in) from the flange end and 137 cm (54 in) from the spud end.

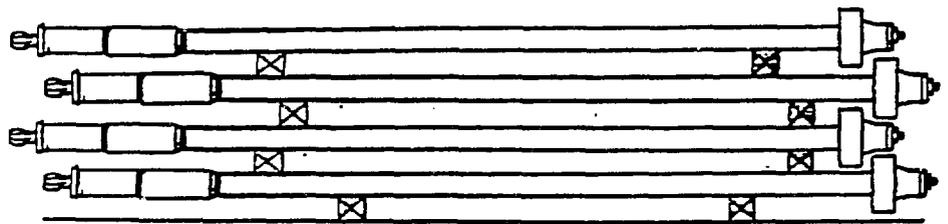
IMPROPERLY SUPPORTED CRDMs
WITH STACKING BLOCKS
