CORROSION OF BREACHED UF₆ STORAGE CYLINDERS

E. J. Barber and M. S. Taylor
Enrichment Technical Operations
P. O. Box 2009
and
J. H. DeVan
Oak Ridge National Laboratory
Martin Marietta Energy Systems
P. O. Box 2008
Oak Ridge, Tennessee USA 37831

ABSTRACT

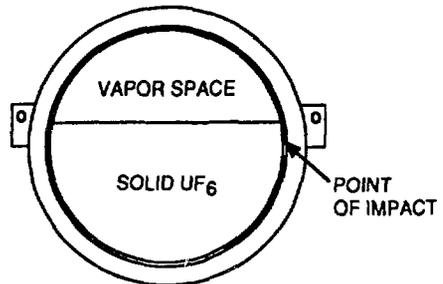
The duration of this phase is of the order of milliseconds. The sharp corner of a lifting lug of one cylinder strikes or is struck by another cylinder near a stiffening ring below the surface of the solid UF_6 . On rare occasions, the result is an undetected fracture that extends completely through the wall of the cylinder. Immediate detection may or may not be possible as discussed under phase 2.

Figure 4 - Initiating mechanism is impact fracture at the position shown.

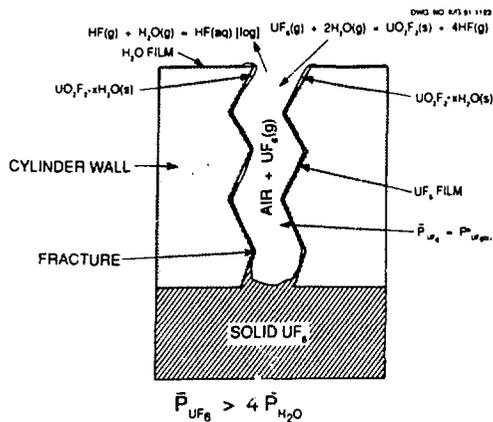
The next phase is development of a plug in the fracture produced in phase 1. The time frame for this phase is hours, and the plug will be developed fully in about 24 h. Figure 5 shows a very early stage in the plug development. Chemical attack begins in the fracture at or near the external surface of the cylinder wall. It must be here because the sublimation pressure of UF_6 is approximately four times the vapor pressure of water, and two moles of water are required for

Figure 5 - Schematic cross section of a fracture shortly after impact, showing results of chemical reaction initiation

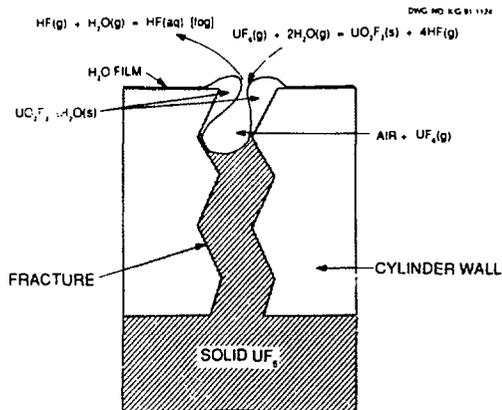
The conditions illustrated in Figure 6 exist in the fracture just before final closure of the fracture by hydrolysis products makes another change in the time frame for reaction. The reactions at this point in the process are the same as in Figure 4, except for being slower.

Figure 6 - Schematic cross section of a fracture showing development of initial plug nearing completion

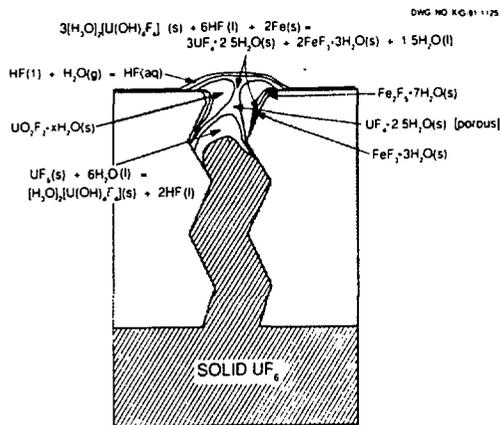
The initiation of chemical attack on the wall is illustrated in Figure 7. The reaction of $UF_6(s)$ with H_2O within the fracture is given by:

Figure 7 - Schematic cross section of a fracture showing initiation of reduction and interior hydrolysis reactions in phase 3

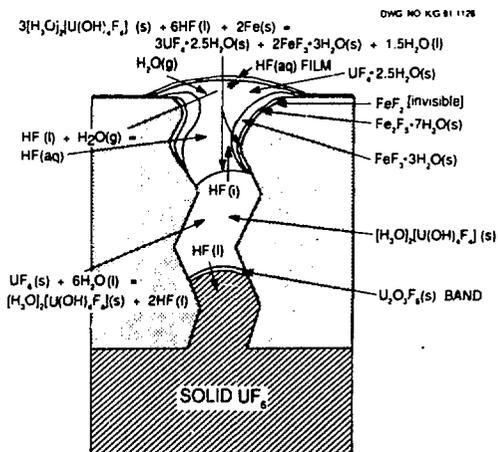
Figure 8 represents the condition existing in the fracture a few months later. The original plug of UO_2F_2 hydrate is entirely converted to UF_4 hydrate, and both the hydrolysis of the UF_6 and the conversion of the hydrolysis product to a UF_4 hydrate have proceeded deeper into the cylinder wall. The overall layering pattern of the products is established and perhaps includes, as shown, the development of the orange-colored layer. The rate of reaction is expected to be increasing as the fraction of the fracture surface attacked increases.

Figure 8 - Wall attack at fracture continues. Outer layer of UO_2F_2 hydrate is replaced by UF_4 hydrate. Internal hydrolysis reaction continues down the fracture.

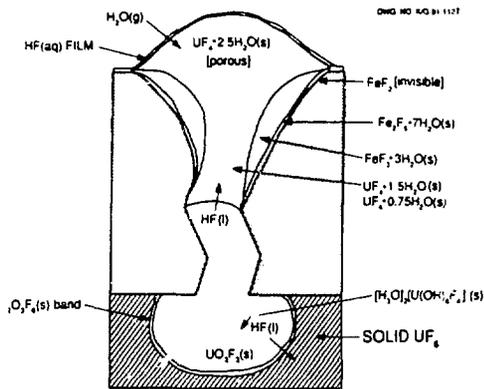
Figure 9, which represents the conditions in the fracture several months later, shows the hydrolytic attack of the $\text{UF}_6(\text{s})$ has proceeded into the UF_6 inside the cylinder itself. The same redox reactions continue to deepen the UF_4 hydrate layer, and the area of the fracture surface attacked continues to enlarge. The degree of hydration of UF_4 is less in the locations where the concentration of H_2O is expected to be less, namely, toward the UF_4 -uranium oxyfluoride complex interface. The overall rate of attack of the steel surface is increasing. Note that the ordered layering of the reaction products continues.

Figure 9 - Wall attack at fracture continues. Hydrolysis reaction enters the cylinder UF_6 . Fracture is enlarging from the outside in.

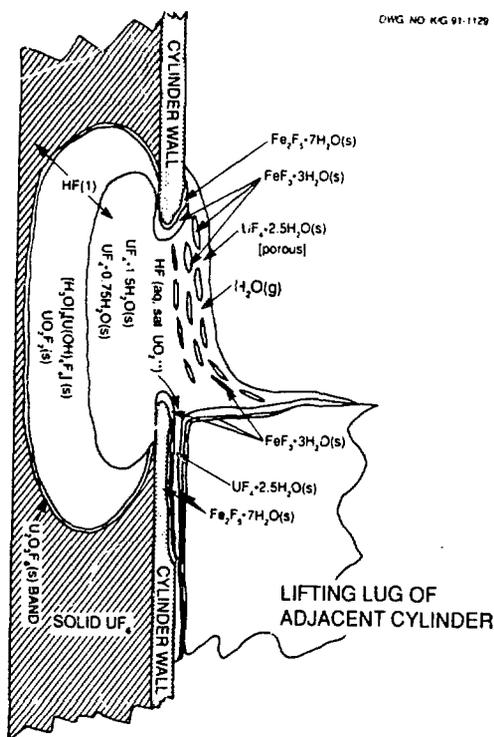
Figure 11 is a schematic, cross-sectional drawing that illustrates distribution of reaction products in the small hole and on the lifting lug of the adjacent cylinder after a 4-year exposure. The layered isolation of products is seen, except that, directly over the hole where no iron remains, the different layers are mixed on a macroscopic basis with retention of identity. The pattern of attack on the cylinder wall below the hole, and on the top and sides of the lifting lug toward the cylinder and the stiffening ring, provides evidence of the acidic, hexavalent uranium-bearing solution that has oozed from the hydrolysis products being produced in the hole. At this stage of hole development, it appears that the hexavalent uranium being transported from the cylinder is reduced to the insoluble UF_4 hydrate by iron and retained at the reduction site.

Figure 11 - Main reactions continue to be hydrolysis of UF_6 inside and reduction to UF_4 inside and outside the cylinder. The fracture has become a small hole after 4 years.

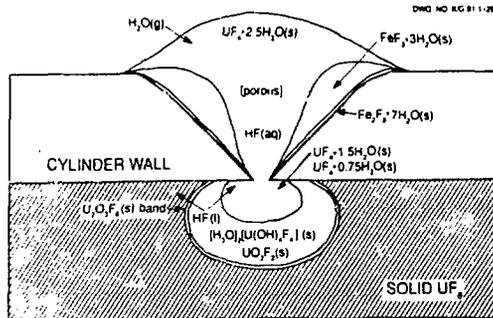
Phase 3 ends when attack on the iron is occurring over the full depth of the fracture, as illustrated in Figure 10. The attack on steel is proceeding from the outside in and is producing a hole with the bevel facing the outside. Once the bevel reaches through the wall thickness, the rate of attack will increase as the circumference of the crack increases, but the rate of attack per unit length of the circumference will remain practically constant. When this occurs, 10 to 14 months will have elapsed since the impact. As shown, $\text{UF}_4 \cdot 1.5\text{H}_2\text{O}$ and $\text{UF}_4 \cdot 0.75\text{H}_2\text{O}$ will have begun to be produced inside the cylinder, with a major yellow layer between it and the $\text{UF}_6(\text{s})$.

Figure 10 - Phase 3 is completed as fracture is enlarged along full depth. The UF_4 hydrate is now forming inside the cylinder. Hydrolysis of UF_6 reactions surrounds the UF_4 inside the cylinder.

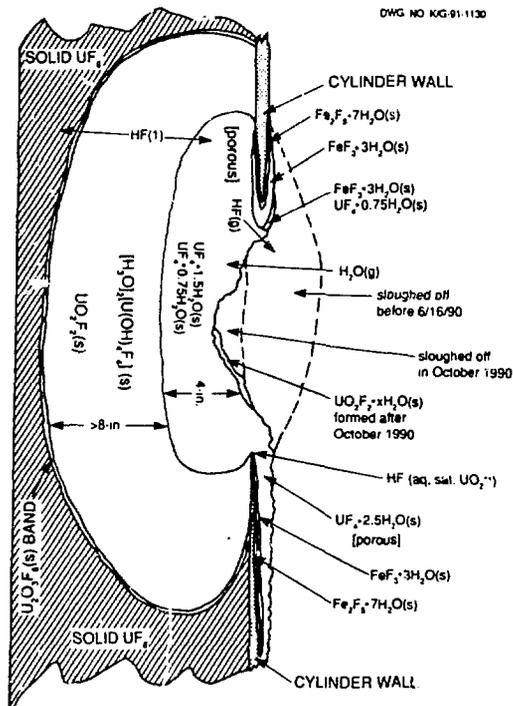
An additional 9 years of exposure (13 years after impact) may produce the effects shown schematically in Figure 12. A portion of the green UF_4 -hydrate layer sloughed off the center of the hole between the time of discovery (in June 1990) and October 1990. This revealed the presence of the deep yellow layer of hydrolysis products behind the UF_4 -hydrate layer inside the cylinder. This yellow layer extended more than 30 cm into the cylinder, indicating the hydrolysis of a significant fraction of the UF_6 in the cylinder had occurred. Some slow drainage of the acidic solution from the hydrolysis zone occurred in the area where the UF_4 hydrate sloughed off. Vaporization of this oozing solution left the yellow deposit over the green UF_4 -hydrate layer as shown.

Figure 12 - Hydrolysis and reduction reactions continue. Deposits outside the cylinder slough off. HF escapes as both vapor and solution and builds up in the village. A small amount of hexavalent uranium in solution not reduced to UF_4 hydrate escapes as UO_2^{++} from the vicinity of the cylinder. Condition shown is for 13 years after impact. The hole is now more than 8 in. across.
