**EXPERIENCE FROM UNUSUAL OCCURRENCES
IN HWP (TUTICORIN)**

**W.S.A KANTHIAH, P.A.O VAIDYAN, S.C. BHOWMICK
HEAVY WATER PLANT, TUTICORIN.**

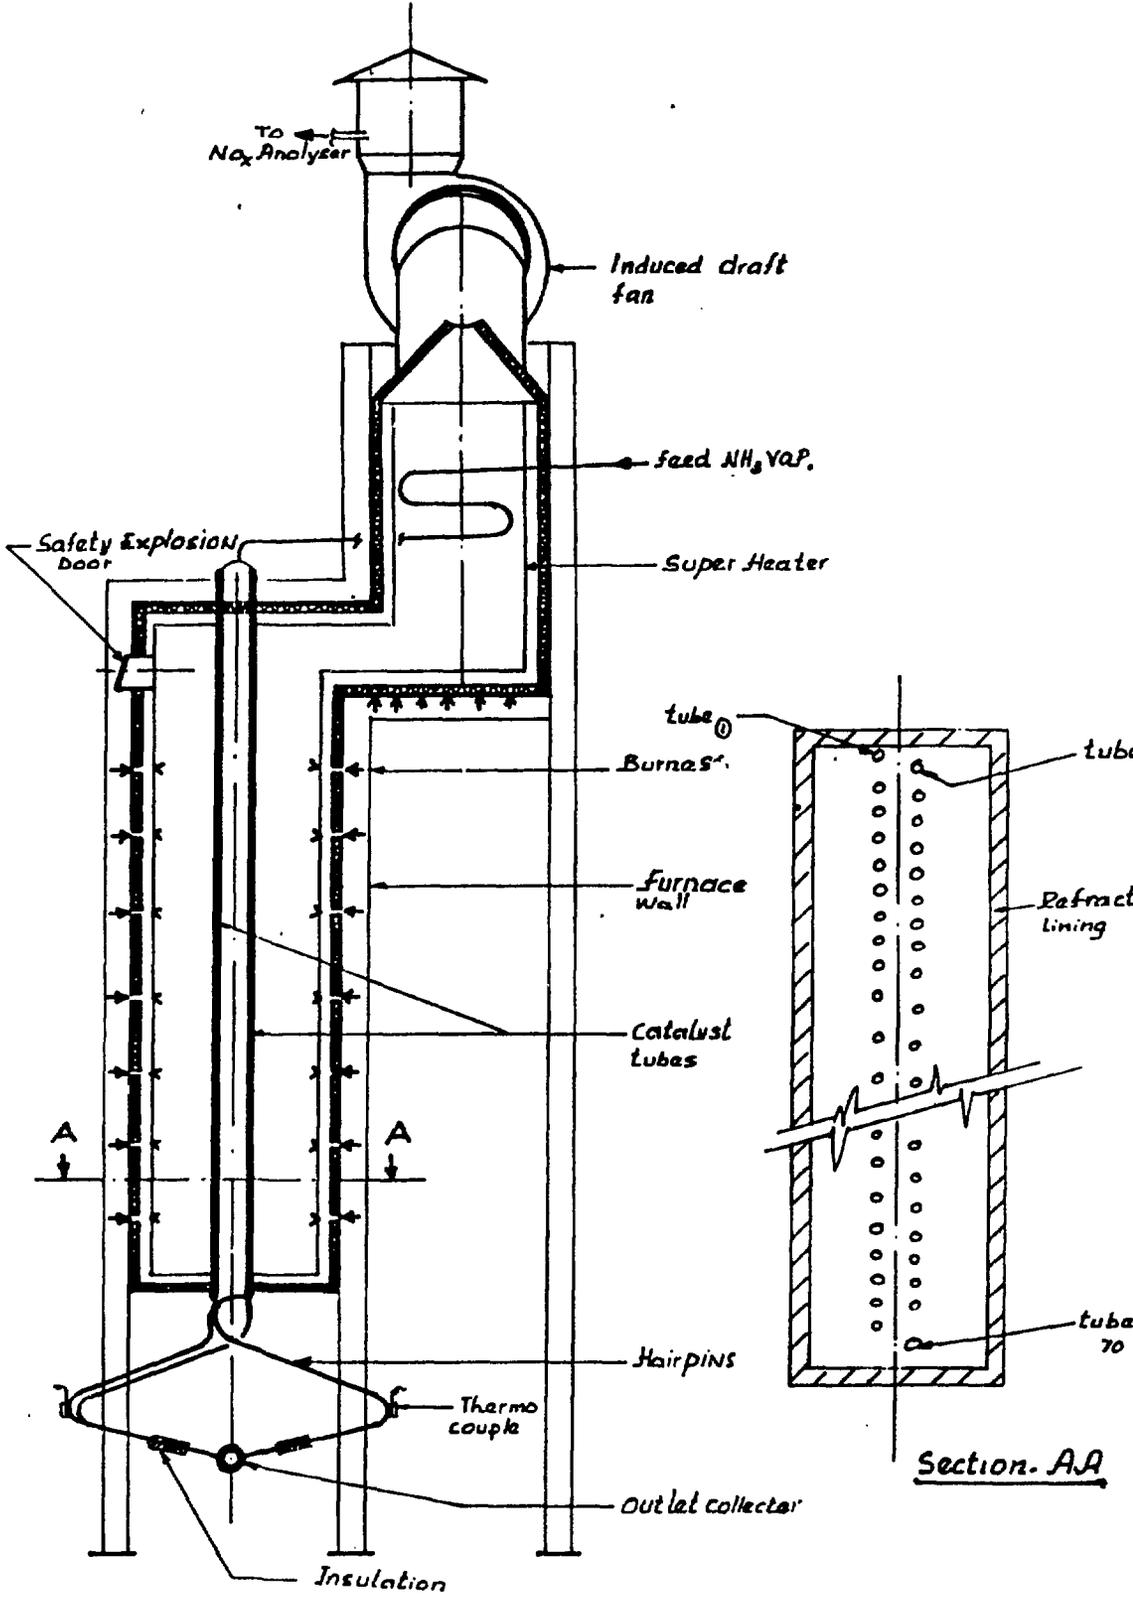
Fig. 1

Ammonia Cracker in HWP (Tuticorin) is a rectangular furnace lined with light refractory bricks. 70 Nos. of inconel tubes filled with iron catalyst are kept vertically inside the same. (Ref. Fig.1). Vapour ammonia at a temp. of 550 deg. C and 130 atm. pressure normally pass through the catalyst bed and get dissociated as per the following reaction:-

On inspection it was found that tube no. 1 and 2 were ruptured at the bottom. Whole plant was under long shut-down for further inspection, testing and repair works. Considerable production and property loss was realised. Non destructive Tests (NDT) showed that the rupture was due to creep failure. Inspectors were of the opinion that such failures can happen due to the following reasons:-

- i) There would have been a flaw in the bottom of tube No.2 at the manufacturing stage itself which failed gradually in

service. The pin hole thus developed caused more opening, damaging itself and the adjacent tubes.

ii) There might be a low feed flow to the tube No.2 due to partial blocking in the catalyst resulting in higher temperature which was not noticed as no temperature measurement provision existed for this particular tube, causing failure at the weakest point. Besides being towards one end of the furnace, the tube was subjected to higher radiant heat, adding to the temperature shoot up.

iii) One of the burners in the affected zone might have developed a long flame, touching the tube and causing the failure.

a) A new reduced limit on operating temperatures of tube skin, catalyst bed and flue gas is imposed.

b) Each catalyst tube has been fitted with temperature monitoring at the tube outlet pipe (hair pin) and monitored continuously from control room.

c) Additional temperature monitoring provision for the tube wall skin temp. has been made.

e) Online NOX monitoring instrument has been installed for flue-gas to detect tube leak.

f) Systematic NDTs like 1) Ultrasonic - flaw detection, Hardness measurement, thickness measurement (2) dye penetrant test, (3) Ovality test (4) Replica test are being carried out in every ATA.

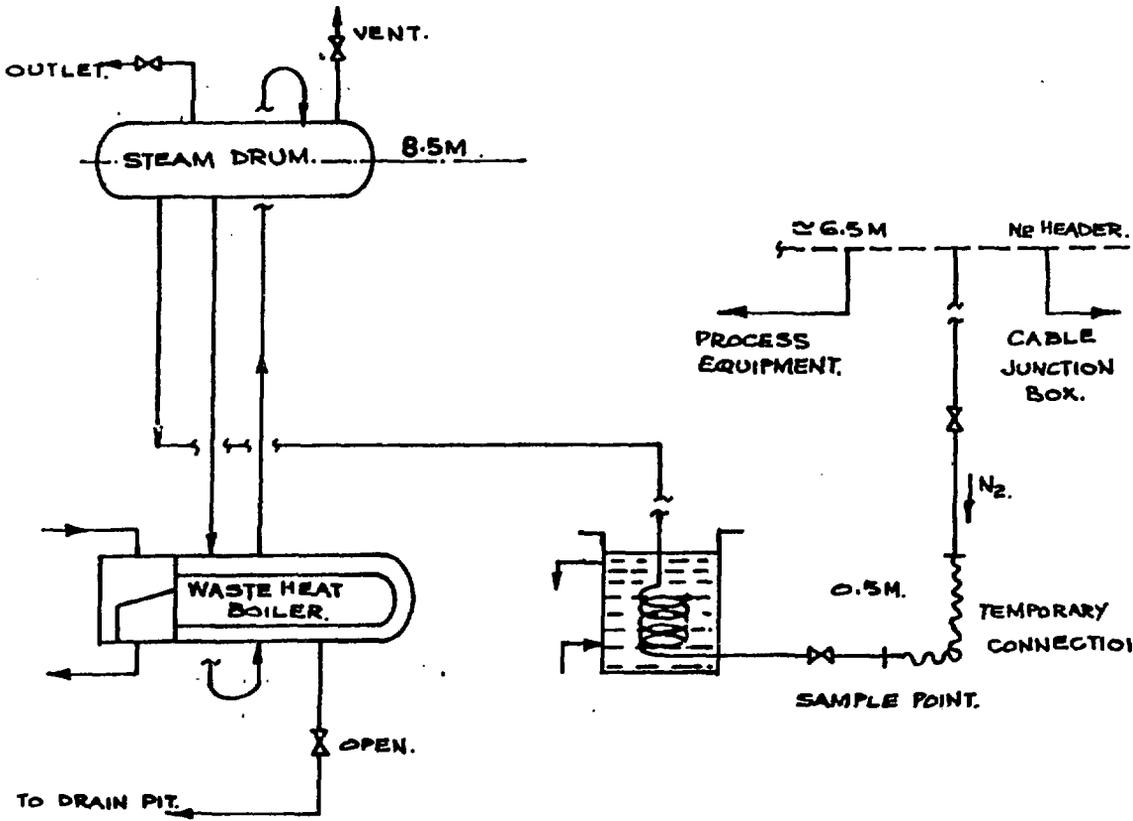
FIG. 2.

During a short shut-down of the plant, the general shift boiler operator drained the boiler and arranged a temporary nitrogen purging (as shown in the Fig-2) to prevent corrosion. The next day, nitrogen supply was not available as the unit was under shut-down. The boiler was filled with DM water by the shift personnel. Subsequently it was found that DM water entered in the nitrogen header and from there into connected cable junction boxes and process pipings.

On investigation it was found that proper information was not passed on from general shift to shift and from shift to subsequent shifts. Thus COMMUNICATION GAP was the main reason for the incident.

- a) All important information regarding operation are recorded in the log book and the detail of events are passed on from shift to shift to avoid communication gap.
- b) The practice of operation check list is followed.
- c) Nitrogen is introduced from the top point of the equipment for such purpose and not from the bottom as in this case.
- d) The practice of disconnecting temporary nitrogen connections are followed when the same is not in service.

Introducing a non-return valve on nitrogen supply line can reduce the possibility of foreign fluid entry into the nitrogen header.

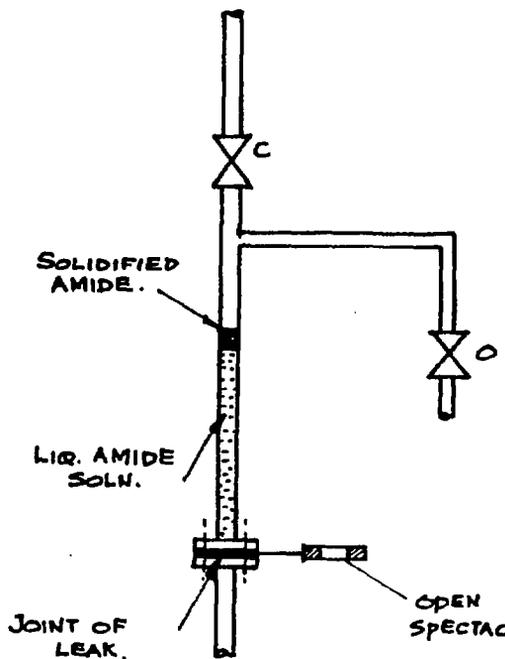
FIG. 3b.

One spectacle blind in a 1" process line handling potassium amide solution was being reversed from close to open position after due clearance from process side. While loosening and lifting the flange of the blind, amide solution splashed on a technician. In spite of his washing under the nearest drench shower immediately, he sustained first degree burn injury on his arm. The above process line was isolated and depressurised through vent points (as shown in the Fig-3a) before opening the flange. On investigation, it was understood that the splashing of the liquid was due to locked up pressure inside, though the vent points were

clear. Similar problem was faced on earlier occasions also. When vent point tappings are located away from the isolation on a vertical pipe handling cold amide solution, such locked up pressure can develop (as shown in the Fig-3b). This happens due to formation of amide solid over the hold up liquid surface during venting. This is predominant in smaller dia pipes.

- 1) The upper side vent tapping are relocated nearest to the isolations to minimise any liquid hold up above the isolation during release.
- 2) For undertaking maintenance of such job, wearing of full protective suit is enforced.
