**COMMISSIONING AND MAINTENANCE EXPERIENCE ON MECHANICAL
EQUIPMENTS IN STEAM GENERATORS OF CAPTIVE POWER PLANT
AT H W P, MANUGURU**

- R. Bhatnagar
- Ashok Sinha
- A.C.Mohan Rao

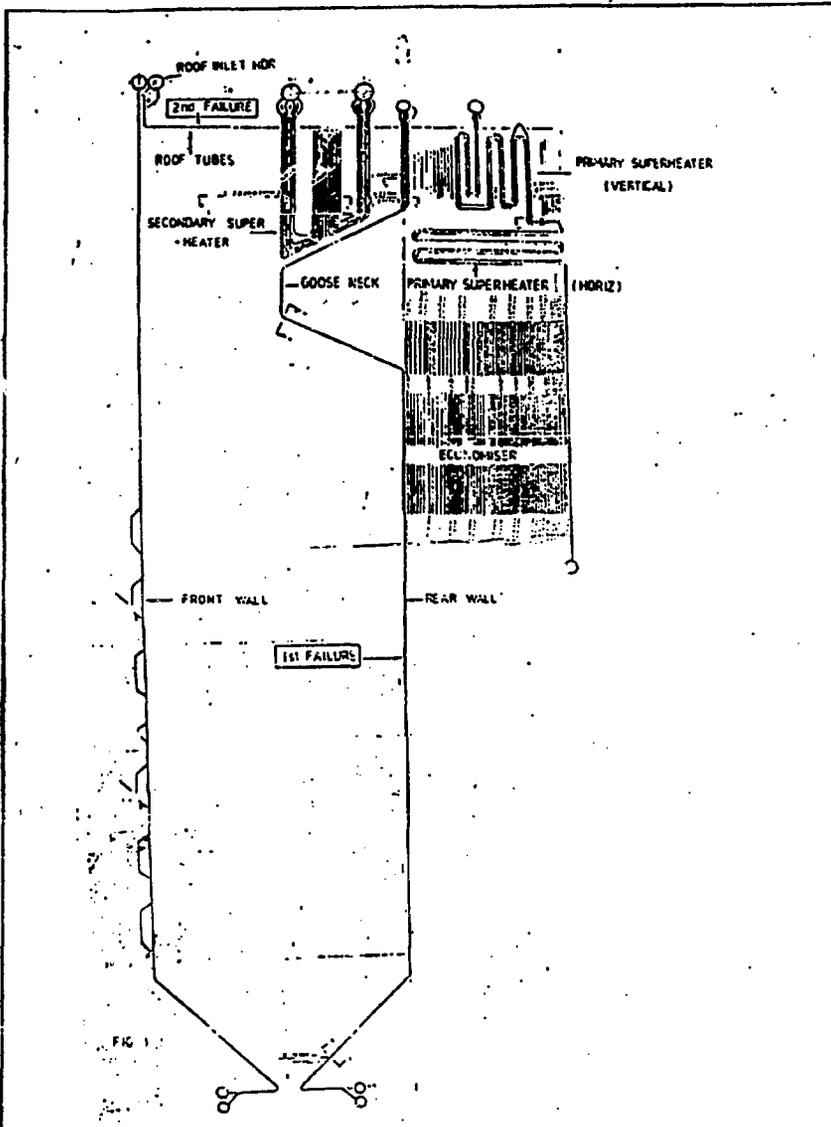
<p>FIG NO 1</p> <p>C. Gersch</p>	<p>SECTIONAL DRG OF STEAM GENERATOR</p>	<p>CAPTIVE POWER PLANT</p> <p>HEAVY WATER PLANT (M)</p>
----------------------------------	---	---

Failure of tubes had taken place in SG-1 on two occasions. Sectional drawing of the steam. Generators showing the tubes is given in fig-1. In the first occasion, water wall tube of the furnace rear wall (material carbon steel) below the goose neck (tube no. 119 from the left) had failed as a result of crack (fig-2). Filler blocks are welded with the rear wall tubes which in turn, are welded with a horizontal buckstay channel, supporting the economiser ash hopper from one side. The crack appeared to be initiated from the weld-zone of the particular failed tube with the filler block. This welding was done by M/s. ABL at site. In order to avoid such failures in future it was thought to do the random checking at the time of next overhaul of SG-1. The tube-repair was carried out by welding insert.

On the second occasion, 4 nos. of furnace roof tubes (Tube no. RF 14,47,48 and 66 from left side) had failed (Ref. Fig-

1) and started leaking profusely specially from tube no. 47 and 48. Apart from this, tube no. 46 had shown signs of external erosion. 'D' meter survey was done for adjacent tubes in the failed region. In tube no. 46, thickness was found to be 3.6 to 3.8 mm in that region as against the desired thickness of 4.5 mm. The roof tubes are meant for carrying saturated steam from the roof inlet header to the primary superheater inlet header. The roof inlet header is getting saturated steam directly the drum-top. The material for the tube is BS-3059-1978-620 commonly known as 1 cr. 1/2 MO steel.

On careful examination of the failures, it was suspected that the tube no. 48 might have failed initially at the panel welding area of the tube, probably this would have caused steam-jet impinging on the tube no.47 resulting in heavy erosion of the tube and finally resulting in rupture. Due to this, heavy leakage had taken place from tube no.47 & 48, further secondary damages might have taken place for tube no 14 and 66 and also, thinning of tube no. 46. However, it is difficult to visualise how secondary tube-failure can take place for tube no 14, 66 so much away from tube no. 47 & 48. Another possibility is of independent leakage in tube no.14 & 66. If this is so, detailed examination of thickness for all the roof-tubes need to be carried out during the next annual overhauling. In view of the urgency, the repair was carried out immediately.

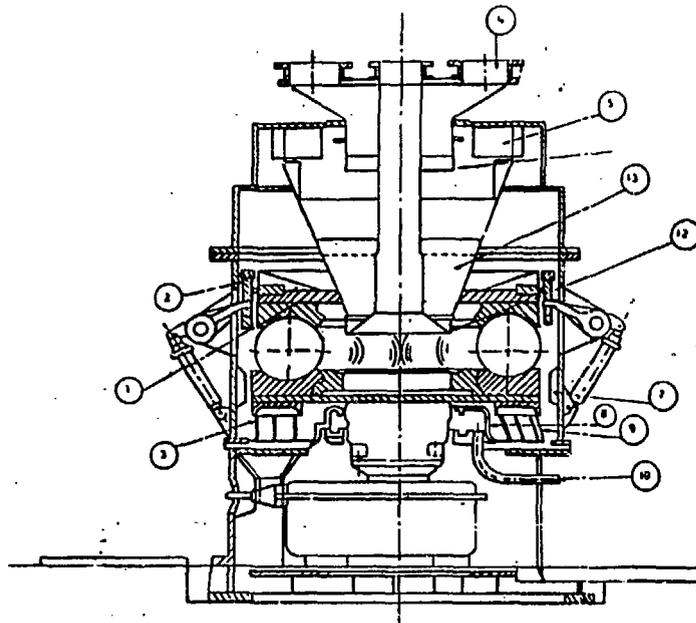
FIG NO 3

4 nos. of P.F. mills are supplied for each steam generator (8.5 E 10 Ball and race type mill) with a capacity to grind coal upto 30 Te/hr. with a fineness of 70% passing through 200 mesh (fig. no. 3). The major failures which came up during commissioning/initial run are failure of coupling, loading unit, loading cylinder and stir-up.

Coupling had failed in two of the mills namely, 2 C and 3 B. Both the failures were exactly of the similar nature. These couplings are bibby type. The mill side coupling cover in both the cases had sheared off from the right angle joint area-subsequently, the bolted covers had moved to the motor side and the grid springs had fallen. As a result of this, the motor alone was running with coal mill being stationary. On further checking, it was found that the mill-alignment got disturbed badly. The probable reason could be of the entry of foreign material coming alongwith coal, which might have caused heavy shock load to the mill, resulting in movement of the gearbox (confirmed by the coupling alignment readings). Afterwards, a thorough survey was done for all the mills regarding fixing of spring-washers in foundation bolts of mill gearbox. Wherever the spring washers were found missing, the same were replaced.

Failure of the loading units (8 nos.) and failure of stir-ups (6 nos.) had also taken place in the different mills. In almost all the loading units, the inner lever got broken. In case of such failures, complete loading unit assembly requires to be changed. The repair of the loading unit assembly is being carried out by disassembling, replacement of the broken inner lever and again assembling of the components. This is quite a tedious exercise in absence of hydraulic press. The stir-up (U-bolts) also frequently got broken in the mills. The replacement of the stir-ups is not a time consuming work but still for attending to this work, the mill has to be cooled down for a minimum period of 24 hrs. which in turn reduces mill availability. Besides the above major failures, minor problems like blockage of foreign material in the pilot reject gate, main reject gate, damage of the vertical/inclined brush ploughs etc. were also faced frequently, which are normal in case of mills.

In addition, due to the wear of the balls, in one mill, fill-in-ball was added after 2000 operating hours. The upper/lower grinding rings, balls have not been replaced in any of the mills which are operating for the last 1 to 2 years. Most of the major failures of the mills are caused by the broken crusher rings. The failure rates of the crusher rings have been abnormally high and the metal detectors located on the downstream conveyor had been working erratically, thus the crusher rings had escaped through the metal detector and reach the mills. Considering the seriousness of the problem, manual picking arrangements for broken crusher ring/foreign material has also been carried out. The root problem of the crusher ring failure is also tried by changing the material of crusher rings and by picking up stones both from the yard and also from the conveyor belt.

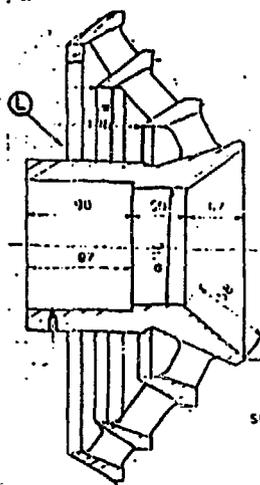
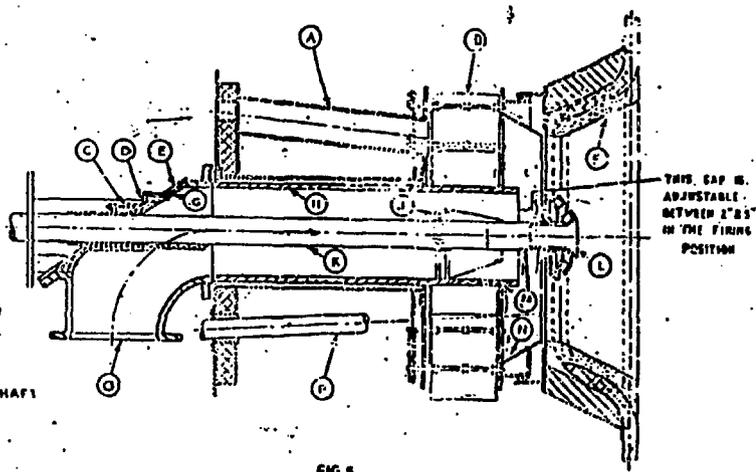
FIG 485	CIRCULAR PULVERISED FUEL BURNER	HEAVY WATER PLANT (M) CAPTIVE POWER PLANT
---------	---------------------------------	--

Air registers which are the secondary air dampers provided in the wind box (fig no. 4) for each coal / oil burners. Thus there are 12 numbers of Air-registers in each steam generator for 12 coal / oil burners.

The two Air Registers of SG-2 and one Air Register of SG-1 got badly damaged / burnt due to the fire reaching the Air

Registers. This Air register frames, vanes, SS cones, Actuator-lever/rings, igniter-guide pipe, throat plate, front plate etc. got badly damaged. As the Air Register was never expected to be damaged so soon, there was no spare available, thus some time was lost in its procurement. Two air registers assembly have already been replaced in SG-2 with all other components mentioned above. The wind box fire probably caused due to the clinker formation at the burner-mouth. In case of clinker at the burner mouth, the coal/primary air mixture in place of going into the furnace might, after hitting the clinker, reflect back into the wind box through the air register-opening thus causing fires. Care is being taken not to allow spreading of the clinker in the burner-mouth. Wind box pressure is also maintained a little higher (around 60 mm Hg.). Dripping of the oil from the gun is also attended promptly through regular cleaning of the guns and preventive replacement of copper washers near the gun-tips etc.

5. Failure of conical impellers : (fig.no 5)

Conical impellers are provided at the end of the coal pipe / nozzle. The impellers are assisting in the movement of coal and primary air in divergent manner so that the secondary air coming to the furnace through the air registers, causes enough turbulence of coal and primary air mixture. The life of the impellers has been found to be 3-4 months. The failure may be even earlier if there is clinker at mouth. Though as per M/s. ABL, this should last for a minimum period of six months. We are rotating the impellers regulating rod / impeller by 120° at frequent intervals to have uniform erosion of the impeller all around and thus increasing the life of impeller. But this has not helped much.

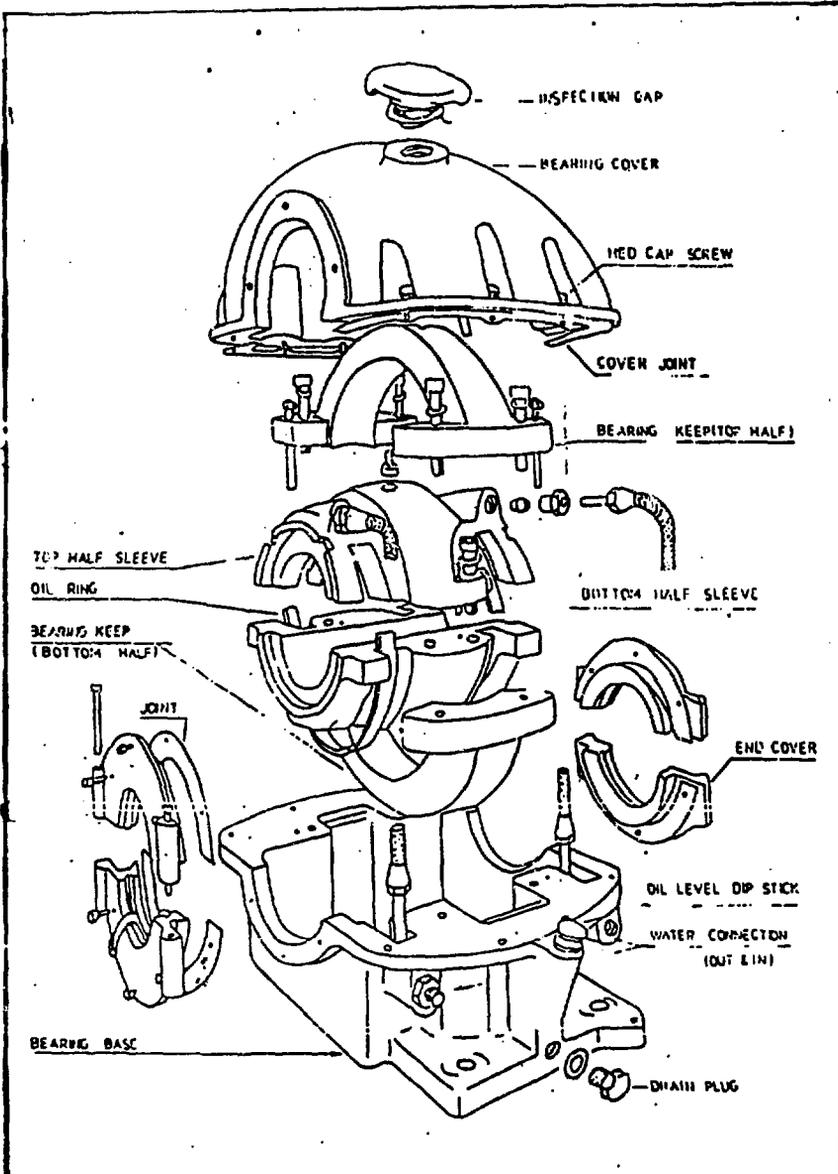
FIG - 7	GENERAL ARRANGEMENT OF FAN BEARING. (FC, ID, P7)	CAPTIVE POWER PLANT
		HEAVY WATER PLANT (M)

This problem was existing more in PA fans (fig.no.6). However, it was also occurring in forced draft / induced draft fans. All these fans are supported by white metal sleeve bearings (fig. no 7). Water mixing is more serious in case of PA fans as it was provided by external lubrication system with cooling arrangement. Complete quantity of lubricating oil tank gets contaminated with the mixing of water and the quantity of oil to be changed in such cases is very high. The leakage of cooling water into the lubricating oil circuit is taking place due to cooling water flowing from top half to the bottom half of the bearing and again to the top half through the failed parting-plane 'O' ring joint. This problem has been overcome to a great extent by getting good quality 'O' rings and applying annabond 678 at the 'O' ring joint with proper curing time.

The lubricating oil rings with lap joints were frequently failing on all the ID/FD/PA fans. It is difficult to monitor the movement of the rings all the time and a few failures of the bearings had taken place due to the failure of the lap joint of the ring. It was modified with groove type joint having two screws. Periodic monitoring of these rings along with the above modification has helped there after in reducing failures of the bearings.
