**CURRENT STATUS OF THE RUN-BEYOND-CLADDING-  
BREACH (RBCB) TESTS**

**FOR THE INTEGRAL FAST REACTOR (IFR)**

Argonne National Laboratory

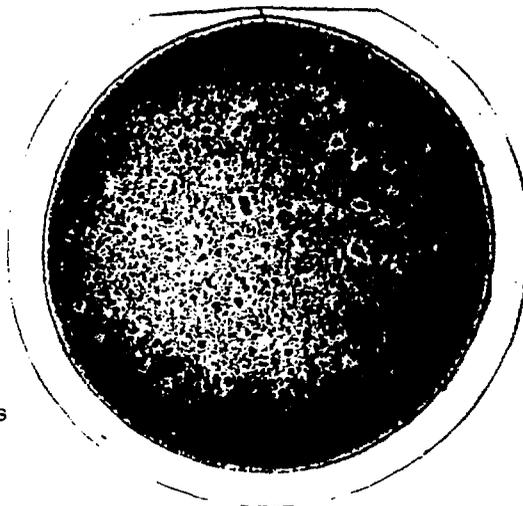
Fig. 1A. Element RT95 (MK-II, U-5Fs) XY-21A - Pre Run 139

Each Run-Beyond-Cladding-Breach (RBCB) experiment consisted of a single element test in which cladding breach was artificially-induced. This was accomplished by machining a thin area in the cladding of a preirradiated test element and allowing it to breach during further irradiation (Fig. 1A). Several tests were conducted using different ternary fuel alloys of U-xPu-10Zr (x = 0-19 wt %) clad with D9, HT9, and Type-316 stainless steel cladding materials. The initial scoping tests were designed around EBR-II MK-II driver fuel using 4.4 mm (0.174 in.) diameter fuel pins clad in solution-annealed 316 SS with the wire wrap removed. The subsequent testing used fuel pins 5.8 mm (0.230 in.) in diameter, more typical of IFR designs. The test pins were previously irradiated to a range of heavy metal burnups between 3 and 12 at.%. Steady-state irradiation and subsequent Post-Irradiation- Examination (PIE) of the RBCB tests have resulted in a large data

TRANSVERSE VIEW OF CRACK IN RT95  
DEFECT. THINNED CLAD MEASURES 2.5 MILS  
IN THICKNESS AT THIS POINT. ELEVATION  
SHOWN IS APPROXIMATELY 50 MILS FROM  
THE ORIGINAL SAW CUT AND 7 MILS FROM  
FIRST BREACH INDICATION

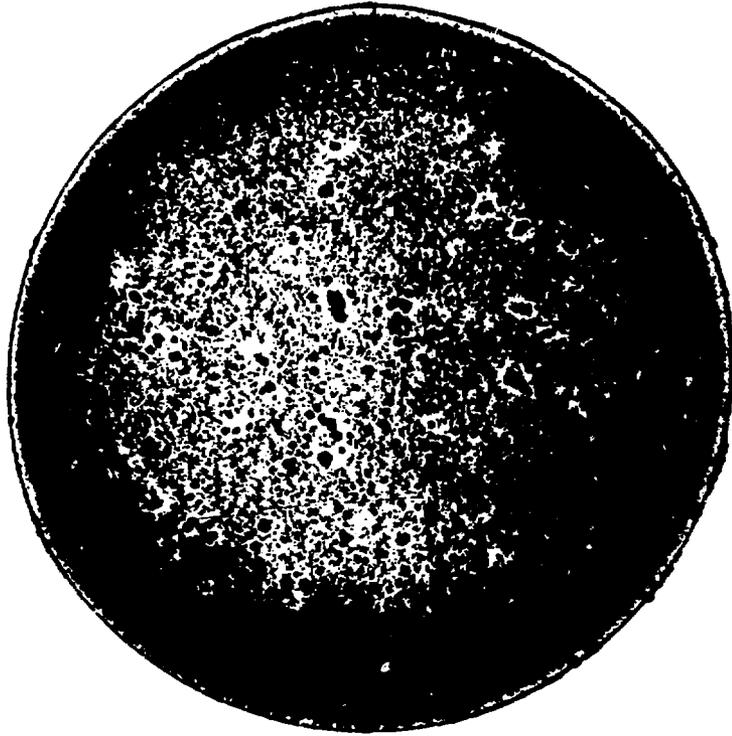
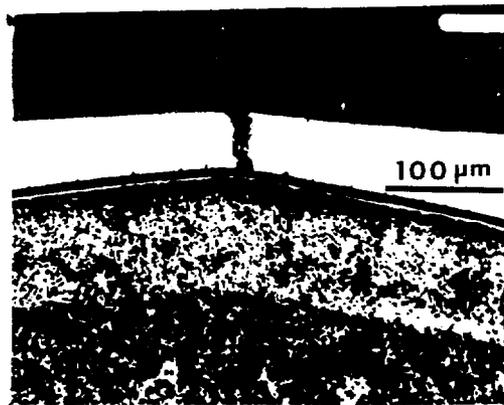
Fig. 1B. Metallographic of Exam Element RT95 Showing Crack

and associated fission products, including Cs, were indeed lost through the breach. A transverse metallographic sample taken through the breach revealed a crack through the 38  $\mu\text{m}$  (2.5 mil) thinned wall 750  $\mu\text{m}$  (30 mils) in length (Fig. 1B). Metallographic examination of the top of the fuel slug revealed that some restructuring had occurred due to the loss of the bond sodium (Fig. 2). Results of plenum analysis showed a gas volume of 1.85 cc and a pressure of 125 psia indicating that the majority of the plenum gas had been expelled from the element.

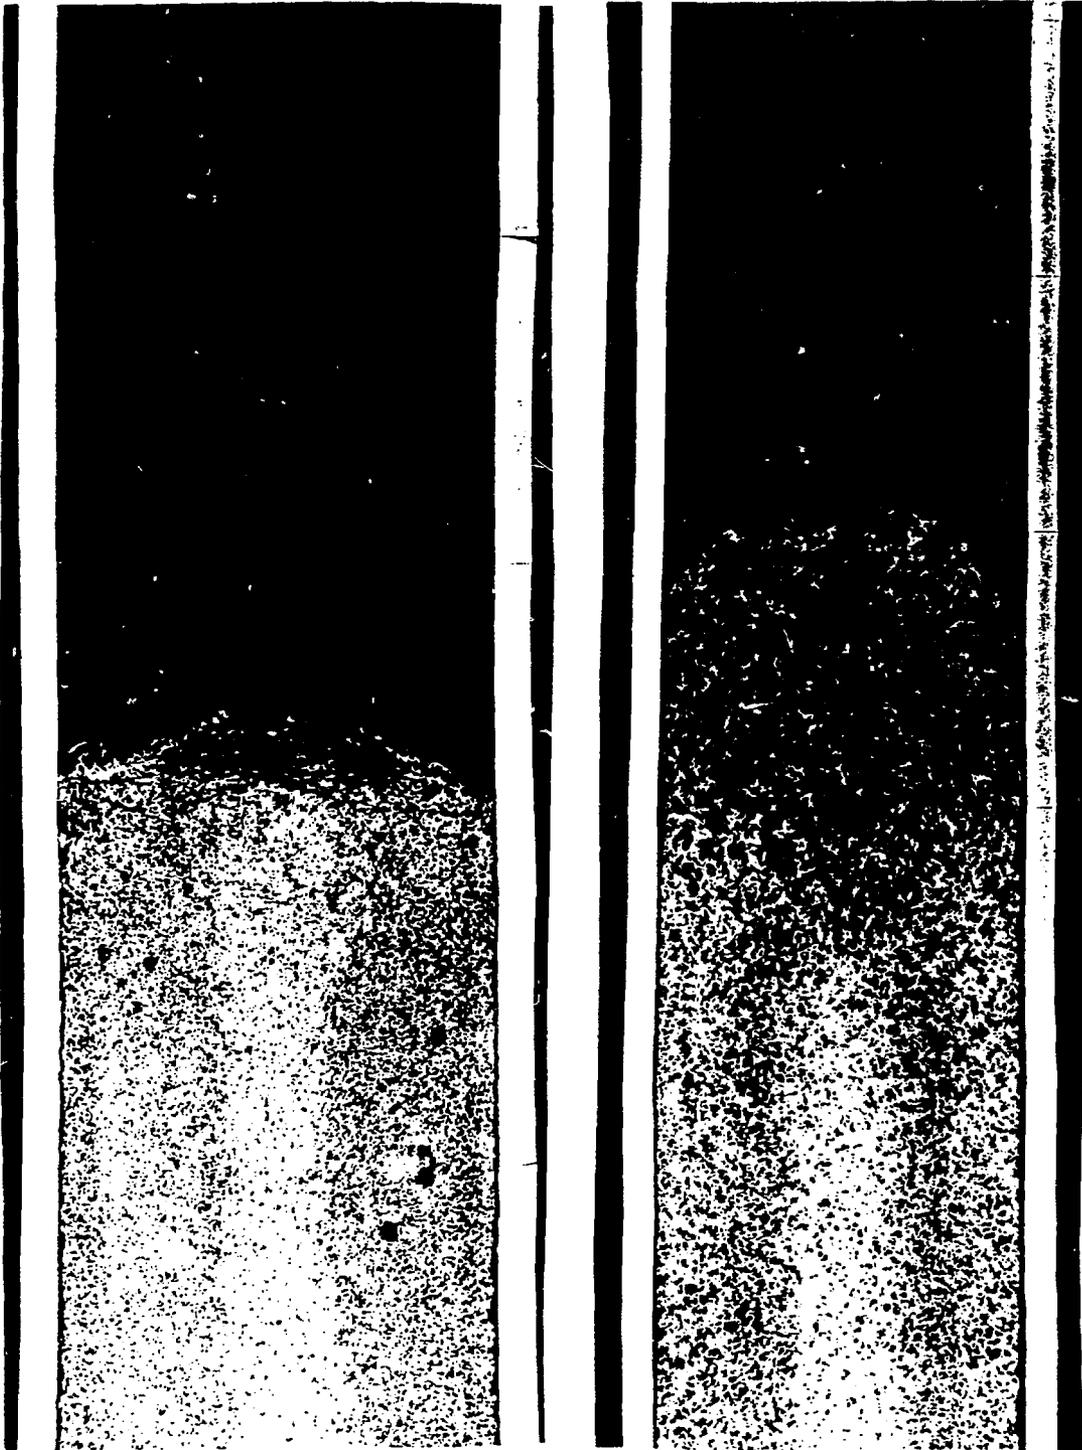
Fig. 3. XY-24: Fuel Clad Interaction and Restructuring Comparisons

The second test element, J-507 (XY-24), did show signs of breach upon visual inspection in the form of traces of sodium at the thinned area. When weighed, the element showed a loss of 2.73 grams which could be accounted for by the loss of sodium bond (2 g) and fission gases. Element J-507 achieved a peak burnup of 7.6 at.%. Plenum gas analysis showed a plenum volume of 2.39 cc with a pressure of 26 psia at room temperature. As in the case of RT-95, gamma scans revealed loss of sodium bond. Metallographic exams reveals a small pin-hole type crack had occurred on the face of the thinned area and that the top of the fuel slug had undergone some restructuring due to the loss of the bond sodium.

Figure 3 shows the difference between element J516 (no breach) and element J507 (breach) in the area of the top of the fuel column where restructuring occurred in the breached element (J507) due to bond sodium loss.

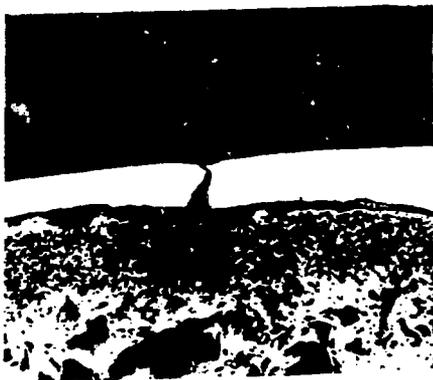
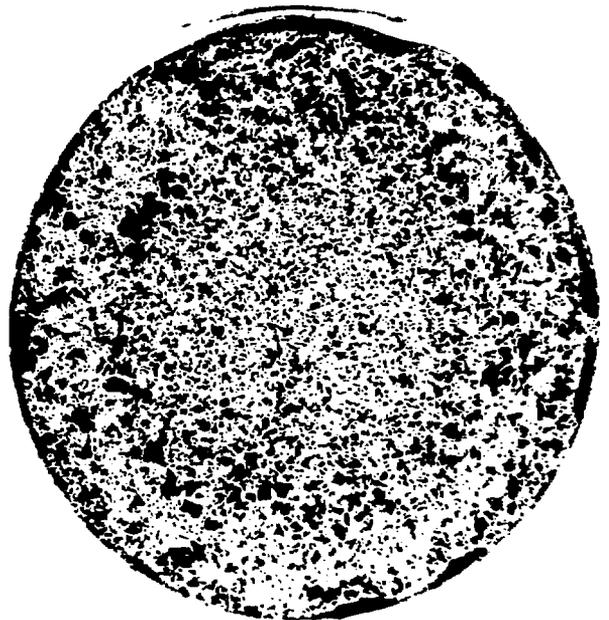
Fig. 4. XY-27 Element J432 Breach

The second U-8Pu-10Zr fuel element, J-432, had breached as well, and irradiation examination results were very similar to those of its sister element J-486 (Fig. 4). Weight loss was 2.45 grams. A plenum volume of 2.47 cc, at a pressure of 145 psia (room temperature), indicating that a breach had occurred and all bond sodium and accumulated fission gases had been expelled. Element J-432 had achieved a peak burnup of 6.7 at.%. The breach consisted of a crack, and at the top of fuel column some restructuring was apparent, as in the case of J-486.

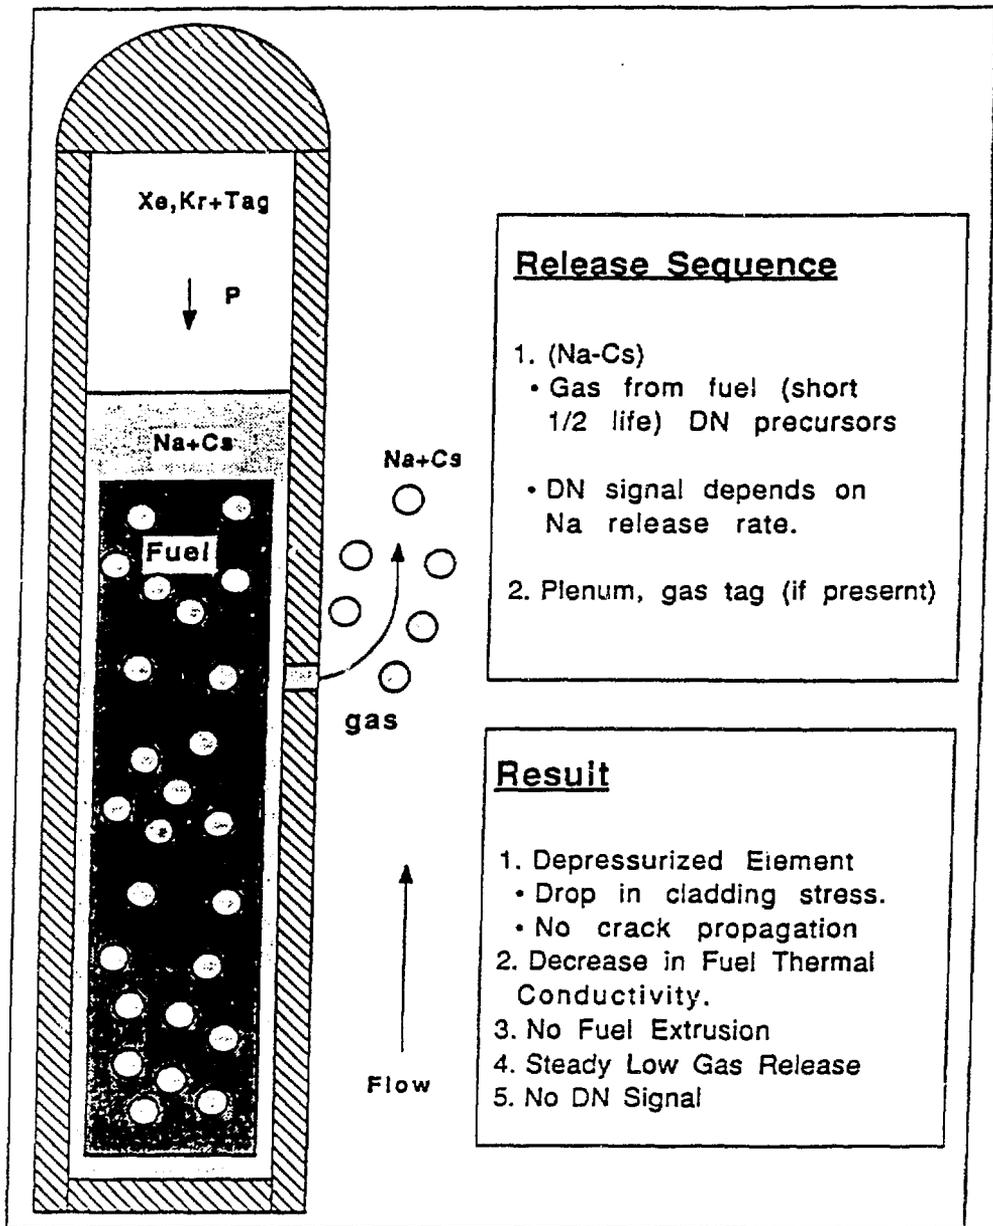
Fig. 5. Typical Release Sequence

In the case of all the IFR metal fuel scoping tests, the breach results appeared to have a definite fission product release signature. Typically, upon onset of the breach, an increase in gas activity as well as a relatively small-sharp DN signal was observed. In the case of tagged elements, the tag was readily identifiable. Figure 5 shows the release process. In the case of XY-24 and XY-27, a pattern of small gas activity pulses were observed after the initial breach activity, evidently due to a continued accumulation of fission gas "burping" out of the crack at periodic intervals. None of the breaches provided any DN activity of a prolonged nature nor a very high DN signal. Calculation of time-to-rupture using fission gas pressure appears to be conservative, probably due to the presence of a relatively dense layer at the periphery of the fuel slug. This layer may distribute the stress at the deformation site, thereby delaying the instability that normally occurs in the final stages of creep rupture under biaxial gas pressure loading conditions.

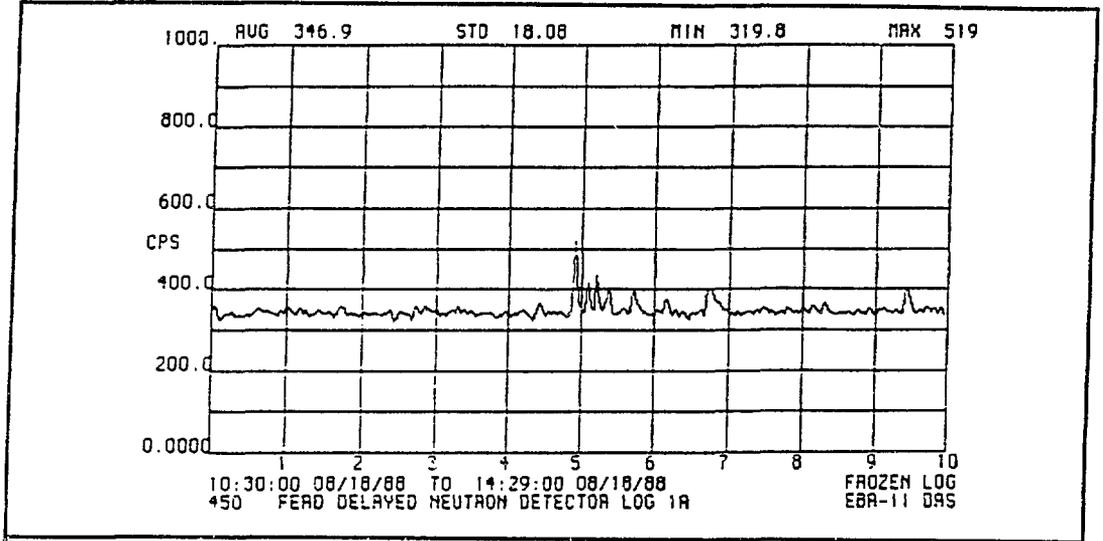
Fig. 6. X482 DN Signal During Breach

The prototypical tests performed thus far have demonstrated the same characteristic pattern as the scoping tests (see Table I). In experiments X482 and X482A, short duration DN signals of  $\Delta DN \sim 150$  cps were observed (Fig. 6). After the sodium bond, liquid fission products, DN precursors, and accumulated fission gas expulsion, activity ceased, with exception of periodic small "burps" of gas. Also, no further crack widening after initial breach takes place and negligible fuel loss is found in the prototypical tests (Fig. 7).

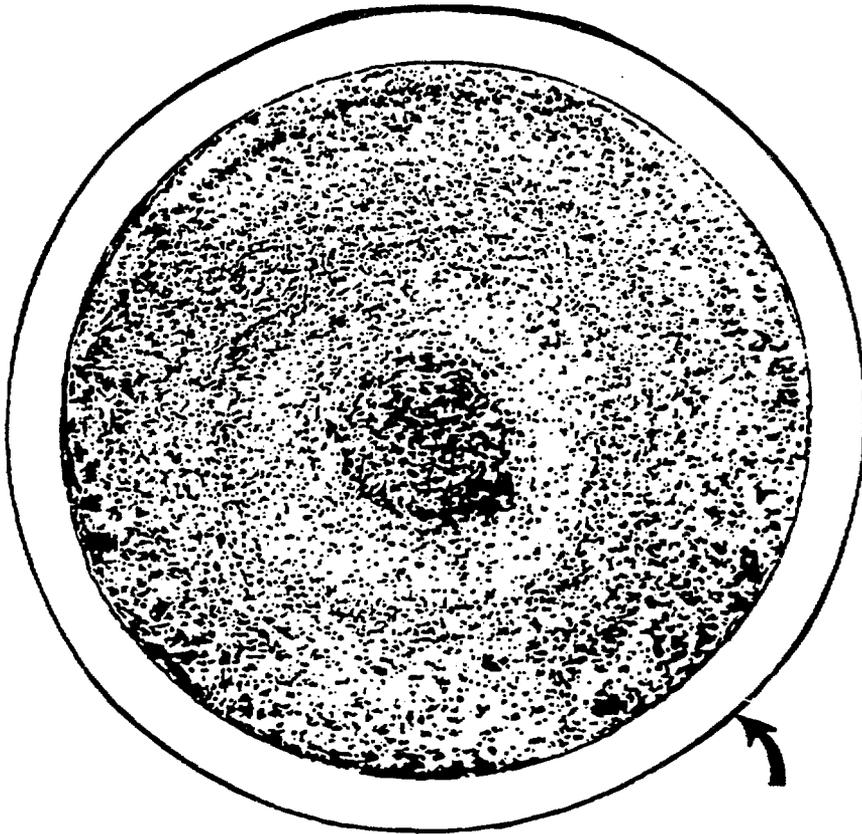
At the cladding outer surface, the crack is ~0.20 in. long by ~0.0002 in. wide and runs parallel to the element long axis (perpendicular to the cladding hoop stress). The main crack is intergranular with a few smaller cracks 2 to 3 grain diameters long clustered nearby. A shallow longitudinal "groove" could be seen on top of and adjacent to the main crack, possibly caused by abrasion with an adjacent element in this tight bundle of highly strained test elements (2/3 of the elements in the bundle has ~4% strain at this location). The crack was opposite T084's own wrapper wire at an azimuthal position where element/element interaction is maximum and tends to flatten the normal cladding circular cross-section. Laser profilometry confirmed the cladding ovality at this elevation.

The crack occurred in an area of intense fuel/cladding solid state interaction which was revealed by an oxalic acid etch. The maximum depth of interaction was ~0.15 mm (~0.006 in.) and was centered on an

azimuthal arc of increased interaction of  $\sim 30^\circ$ . Their interaction involved an interdiffusion of Ni and Fe from the cladding with the one authorized series of fission products. The fuel itself appeared to be unaffected by the breach as can be seen in the as-polished section in Fig. 8. The annular zones of redistribution were concentric and resembled sibling fuel at like burnup. It is clear that fuel loss in this type of breach is not to be expected. Microhardness values in the interaction layer showed the usual degree of hardening ( $\sim 750$  DPH higher than the unaffected cladding). However, the D9 base metal along the crack path had lower hardness values than samples  $90^\circ$  and  $180^\circ$  away (typically 50 DPH less). It would appear that based on the observations of accelerated fuel/cladding chemical interaction and the cladding softening, nominal cladding temperatures were exceeded for an indeterminate amount of time in reactor. At this high burnup, cladding dilation, and thermal bow possibly promoted local regions of distorted geometry and coolant flow. Stress rupture of the cladding would thus be promoted in areas of high cladding wastage and lowered creep strength.

Fig. 8. Transverse section through the fuel column breach site. The arrow indicates location of the crack which is not visible at this magnification.
