Metallography of Pitted-Aluminum Clad, Depleted Uranium Fuel

A document prepared for CORROSION 95-THE NACE INTERNATIONAL ANNUAL CONFERENCE AND CORROSION SHOW at Orlando from 03/26/95 - 03/31/95.

**METALLOGRAPHY
OF
PITTED ALUMINUM-CLAD, DEPLETED URANIUM FUEL**

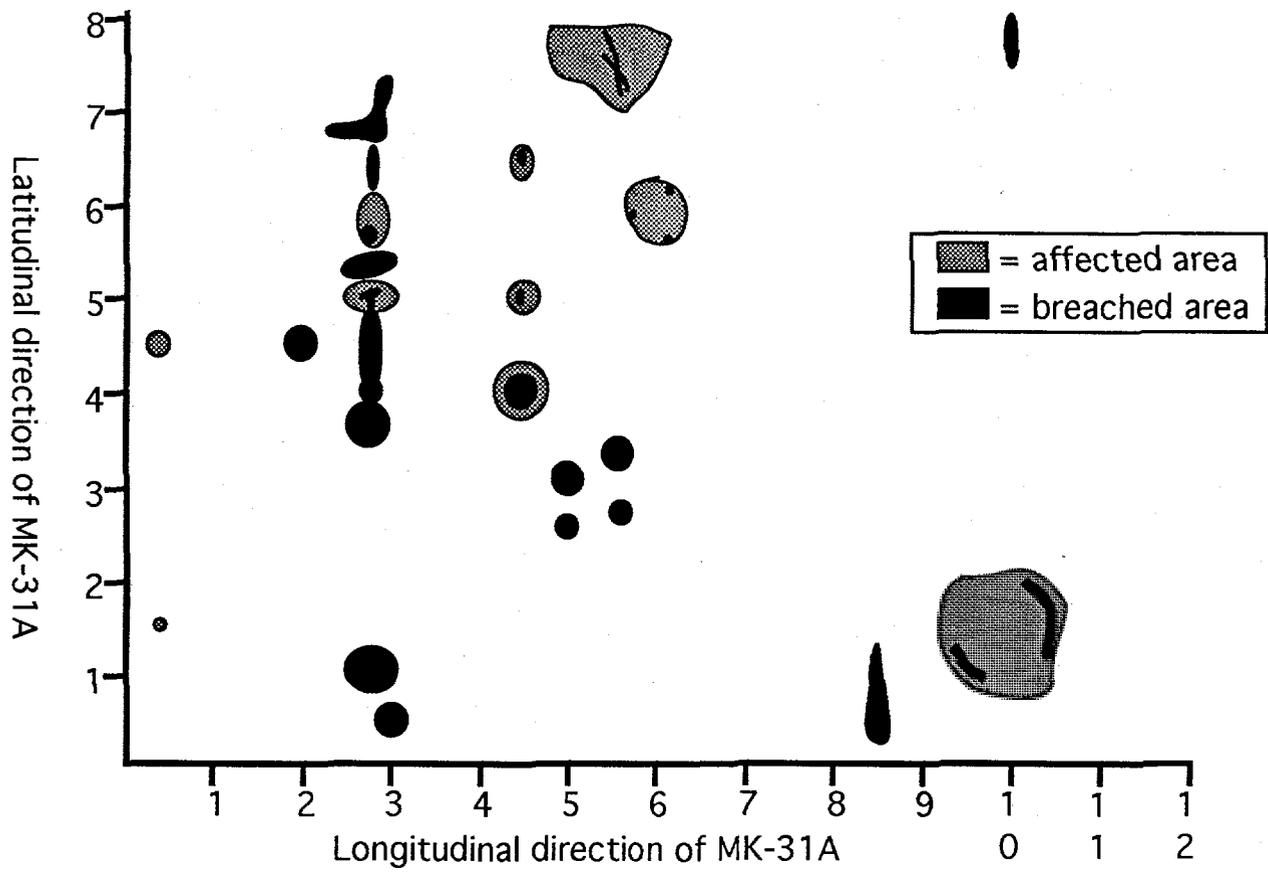
The one inch grid marked on the slugs was used to provide accurate measurements of location and size of the pits covering the surface of the outer slug. The measurement of pit locations and sizes were performed and are shown in Figure 4. This planar map shows the relative location of all pits on the outer surface of the slug and shows the linear positions of the pits in scratches. Representative pits were plotted on the map using coordinates from the grid on the sample. Sizes of the pits were measured and the breached areas of the aluminum clad were calculated. In many cases, the total area of the uranium corrosion was significantly greater than the area of the aluminum opening. This was visually obvious and usually resulted in a blistered or raised area surrounding the hole in the aluminum. The size of the aluminum pits and the total effected area of the uranium corrosion is shown in Table 1. The total breached area of the aluminum was found to be about 3.2 in^2 (20.65 cm^2) with a corresponding area of uranium affected of 7.7 in^2 (49.68 cm^2). With a total cladding surface area of over 172 in^2 (11 cm^2) for the outer slug, the percentage of the uranium surface affected by corrosion is calculated to be about 4.5%.

FIGURE 4 - Mapping of corrosion sites on outer target

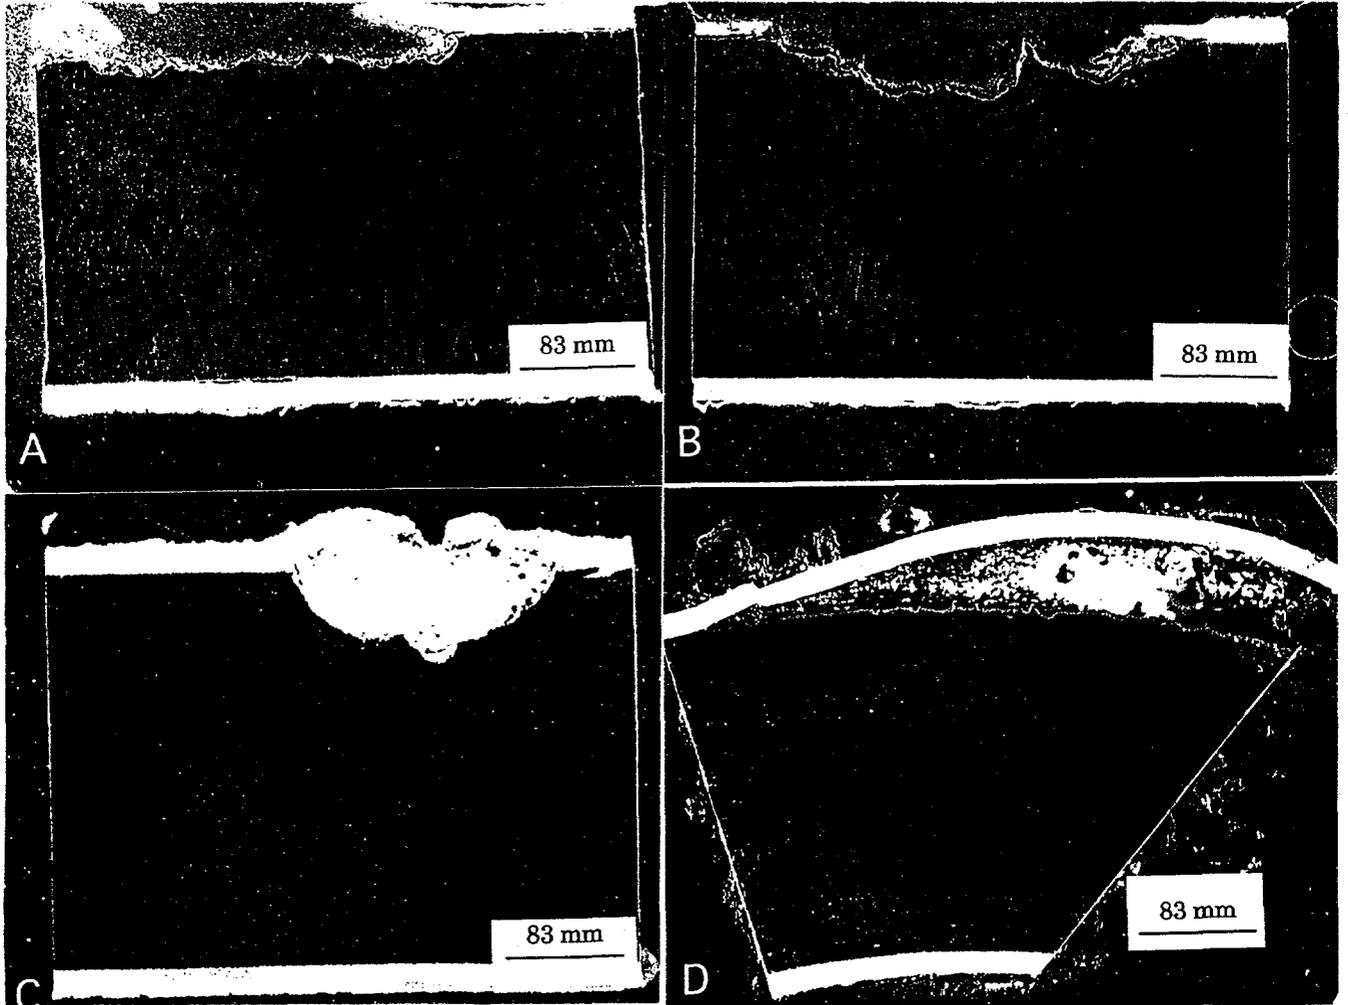
Pits on the outer surface of the target slugs were generally classical in nature and most appear to follow the explanation provided in the previous corrosion discussion. Although the proof of hydride attack was not absolute, the location of blisters at some distance from any breached areas indicate a strong possibility that this mechanism, as well as, water attack on the uranium is responsible for the pits that are readily visible. Metallography on sections taken from the slug revealed four types of pits present in the slug. Although, some may look slightly different, most of the pits examined in this investigation looked like those shown in Figure 5. The pit shown in Figure 5(a) is a shallow pit that runs horizontally beneath the clad. The aluminum cladding has been completely corroded away to a size slightly smaller than the affected uranium core. The uranium core has superficial corrosion on the surface and only extends to a depth of 0.04 in. (1.02 mm). The uranium oxide has been dissolved away and no longer is present in this pit except for a very thin layer. The shallow corrosion of the surface of the uranium core may be due to a weak cladding bond to the core in this region allowing some undercutting of the aluminum by the uranium corrosion.

The second type pit is shown by Figure 5(b). This pit is similar to 5(a), but the uranium corrosion has penetrated to a depth of 0.09 in. (2.29 mm). The aluminum cladding has been completely corroded away and the uranium core is completely exposed in this region. Due to the loss of the aluminum cladding, the corrosion product has been washed away and is no longer present. Penetration of the uranium core is deeper in this area because of a strong bonding in the region forcing its direction downward. Whenever the oxide growth is not strong enough to break the bond of the aluminum /nickel /uranium layer, corrosion appears to continue vertically into the uranium.

Figure 5(c) shows a breach in the aluminum cladding smaller than the affected area of uranium corrosion. Generally, the increased corrosion of the uranium with the aluminum cladding still present will cause a bubble to form around the breach from the expansion of the oxide product. The uranium corrosion has a "V" shaped appearance and the depth of penetration of this pit was found to be 0.12 inches (3.05 mm), the deepest pit found on this slug. Because the aluminum cladding is still present except for the smaller breached area, the corrosion product is still present. Again, the growth of the pit in a vertical position may occur because of a better bond of the aluminum cladding to the uranium in this region. In other regions where the aluminum bonding is not as strong a larger bubble occurs and the corrosion runs in a lateral position like that shown by the pit in Figure 5(d).

Figure 5(d) shows a bubbled area where most of the aluminum cladding is still present. This may have been caused by hydride attack, or could have occurred by a small pinhole breach in the aluminum allowing exposure to water. However, the breach was not large enough to allow the uranium oxide to escape. The uranium oxide caused a 0.09 inch (2.29 mm) bulging of the aluminum cladding with little penetration of the uranium metal. All of the oxide is deposited directly under the aluminum cladding. The corrosion of the uranium continues horizontally with very little penetration into the uranium metal because of a weaker bond in this region.

FIGURE 5 - Four typical pit types found on target: (a) shallow corrosion penetration of uranium core, (b) deeper penetration of uranium core, (c) vertical penetration of uranium core, (d) bubble formed under aluminum cladding

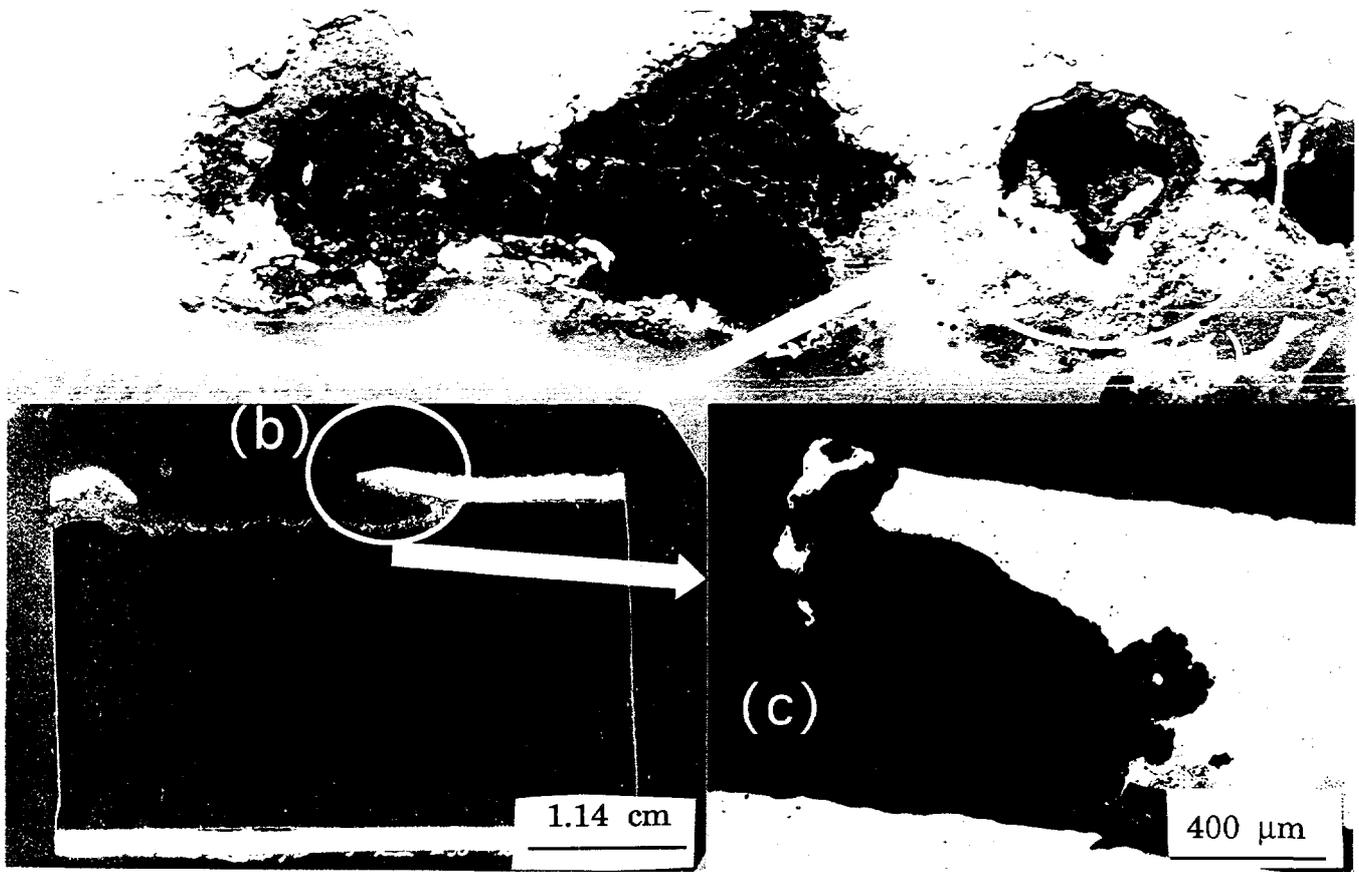
Figure 6 examines a series of pits which originated in a scratched area of the outer slug surface. This pit has a large opening in the aluminum cladding. As shown by Figure 6(b), there is a large area of uranium exposed, as well as the underside of the aluminum. Because the aluminum cladding is exposed to the basin water on both sides, corrosion occurs on the underside that was bonded to the uranium, as well as the outer surface as shown by Figure 6(c).

FIGURE 6 - Corrosion morphology of shallow pit

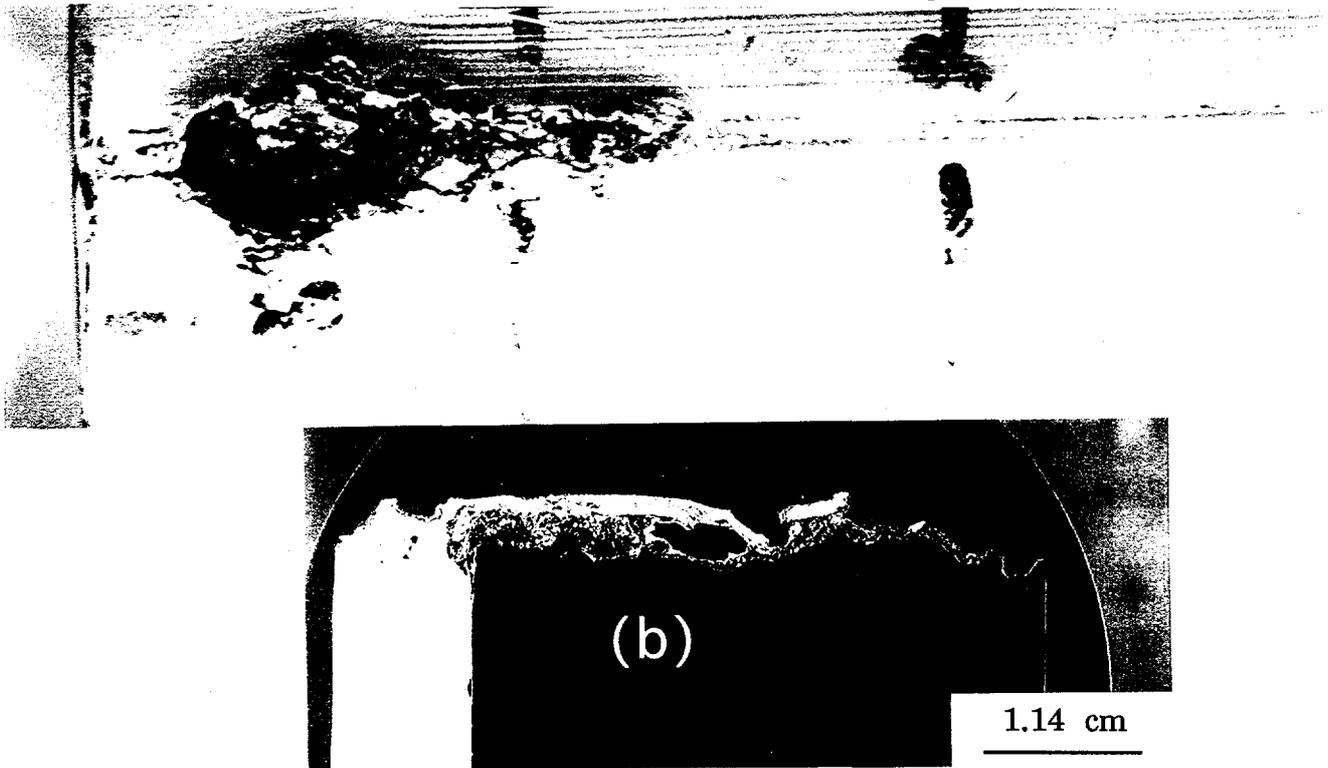
Figure 7 shows a large pit located near the end of the slug. Not only was the cladding affected, but also corrosion of the end cap was present. General corrosion of the uranium is present. Corrosion of the aluminum cap is taking place on the outer edge as well as in the region

of the cap that is in contact with the uranium core as can be seen in 7(b). Due to a crevice that is in this region, accelerated corrosion may be due to crevice corrosion attack in this area.

FIGURE 7 - Corrosion pit affecting aluminum end cap

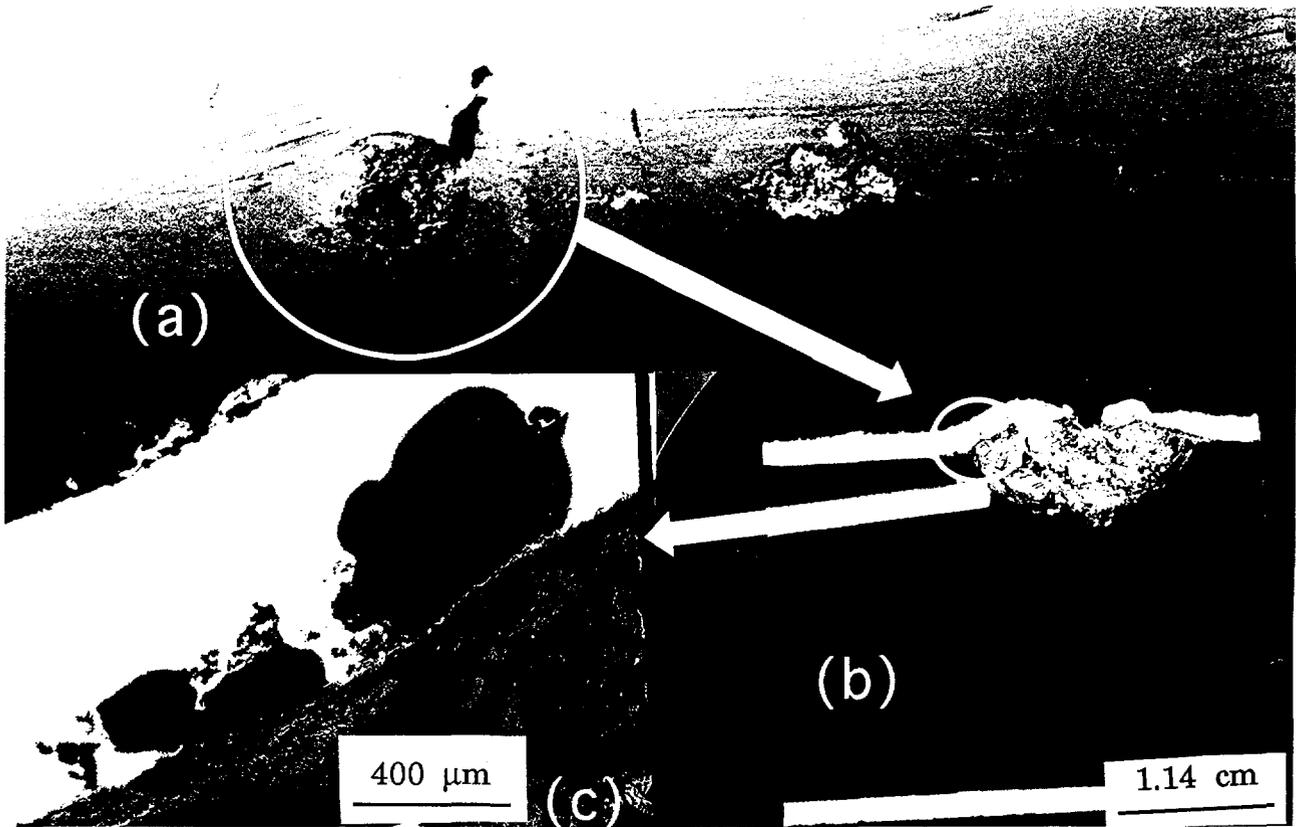
Figure 8(a) shows a large pit on the outer surface of the slug. The pit in this area is shown penetrating deeper into the core than most of the pits examined. The depth of this pit may have been influenced by the strength of the cladding bond. A strong bond outside the bubbled region could cause the corrosion of the uranium to penetrate the core instead of extending along the surface between the cladding. When the aluminum cladding is breached and oxide is formed, the uranium oxide holds aggressive ions in this region close to the underside of the aluminum cladding. This may be responsible for the aluminum corrosion on the outer, as well as, the inner surface of the aluminum cladding.

FIGURE 8 - Pit showing bubble and corrosion product still present

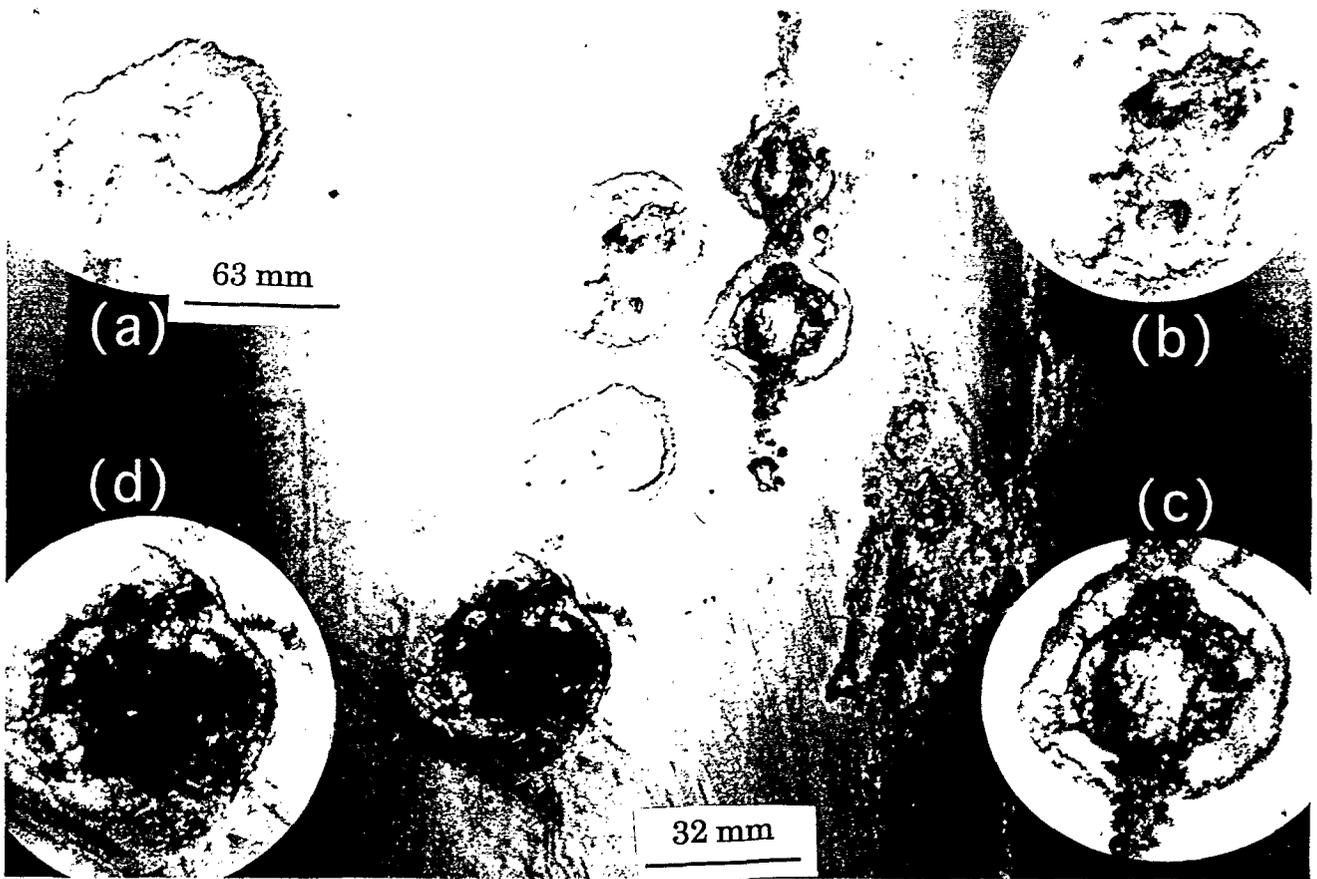
Figure 10 represents one area of the slug which contained a number of unusual corrosion sites. These sites show four stages in the development of pits, ultimately, leading to full penetration of the aluminum cladding into the uranium core. In 10(a) a circular shaped grooving in the aluminum is seen. Figure 10 (b) shows similar circular shaped grooving, but a small breach of the cladding is seen in the middle of the circle. Figure 10(c) shows a slightly more advanced stage of uranium corrosion, follow by a total breach of the aluminum leading to full exposure of the uranium core to the basin water as shown in Figure 10(d). The exact mechanism responsible for this unusual corrosion appearance is not known. As the slugs were totally covered by aluminum and uranium oxidation products for several years, the potential exists for oxygen concentration cells to be established, local anodic and cathodic sites to exist, or for crevice corrosion attack to initiate.

FIGURE 10 - Different corrosion morphology, (a) (b) (c) (d) shows different ages of particular corrosion morphology
