# Waste Site Characterization Through Digital Analysis of Historical Aerial Photographs at Los Alamos National Laboratory and Eglin Air Force Base

Ed Van Eeckhout, Paul Pope, Bob Wells, Cheryl Rofer, and Brad Martin  
MS C335, Los Alamos National Lab, Los Alamos NM 87545 (e-mail: emvan@lanl.gov)

**Fifth Annual**  
**Major Range and Test Facility Base Environmental Workshop**  
*"Environmental Compliance--Part of the T&E Manager's Job"*  
May 23-25, 1995

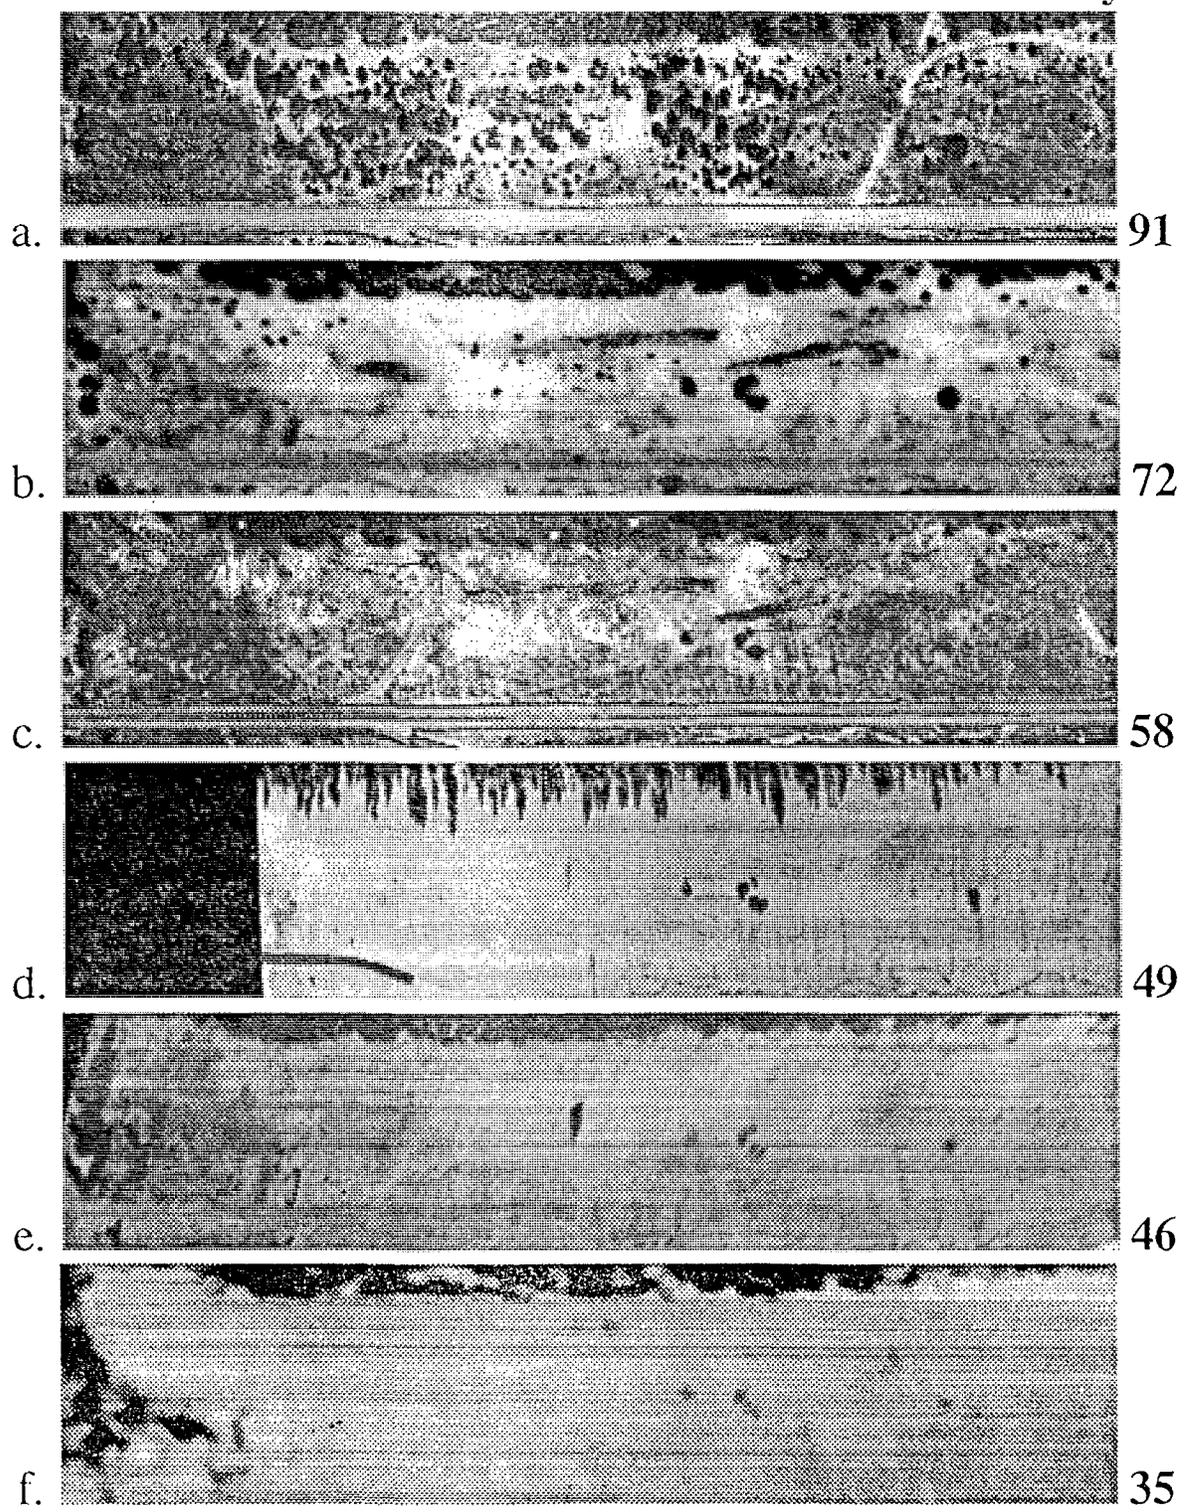
Large changes in the site can be seen by comparing the 1935 and 1946 images (Figs. 2f and 2e). The 1935 image captures the mesa when it was being farmed extensively. Structures and furrows can be seen in this image. Magnified stereoscopic viewing of overlapping photos from the 1935 survey was used as an aid to interpret this digital image (Fig. 2f) because of the coarse spatial resolution incurred by the small scale of the original photo and the 600 dpi digitization limit of the scanner. The structures appear to be cabins, corals, pens, and small garden plots of a homestead. Three shrub oak thickets are also visible. These thickets are present in every image studied and serve as good reference features. The 1946 image shows areas of disturbed soil, a large mound, two open pits, and unimproved roads. The aerial photograph from which this image was derived was taken November 1, 1946, just after disposal activity was documented to have started on May 15, 1946. Thus, this image provides excellent indications of early disposal activity.

Minor changes in the site can be seen by comparing the 1946 and 1949 images (Figs. 2d and 2e). The timbered pit has been filled in, probably after being filled with waste material. The areas of disturbed soil, the large mound, and unimproved roads can still be seen. The main road has been partially paved from the west. Five circular anomalies just west of the large mound were found in

Fig. 2. Digitized and transformed historical aerial photos of the MDA-F site (year shown at the right of each figure).

The 1958 image (Fig. 2c) was taken more than six years after the date of the last documented disposal at MDA-F. The large mound can still be seen, as well as areas of disturbed soil common to both the 1949 and 1946 images. Access roads into the area are clearly visible as well-defined tire ruts. The most interesting features are several dark rectangles. The dark appearance of these rectangles is probably due to vegetation growing on the refill over the disposal trenches. It is interesting to note that the appearance of this vegetation indicates growth and not stress over these waste sites. Vegetation stress, not growth, is mentioned most often in the literature as an indication of the presence of hazardous waste sites. Growth of vegetation as an indicator of hazardous waste is often associated with organic liquid waste such as raw sewage. In this case, the indication of a waste site is more like the anomalous vegetation signatures used to identify archeological sites. The causes for this growth is likely associated with increased moisture content within the loose refill material. The highly geometrical shape of these features is strong evidence that they were man-made.

Two of these dark rectangles are clearly visible on the 1958 image. However, the 1972 image (Fig. 2b) has better contrast and shows these features as well as two more on the western side. One of these dark rectangles corresponds to the timbered pit. The other three are suspected trench boundaries. The suspected trench north of the timbered pit could also be identified in the 1958 image by on-screen animation of the 1958 and 1972 images. Small, young ponderosa pine can be seen over the central portion of the 1972 image.

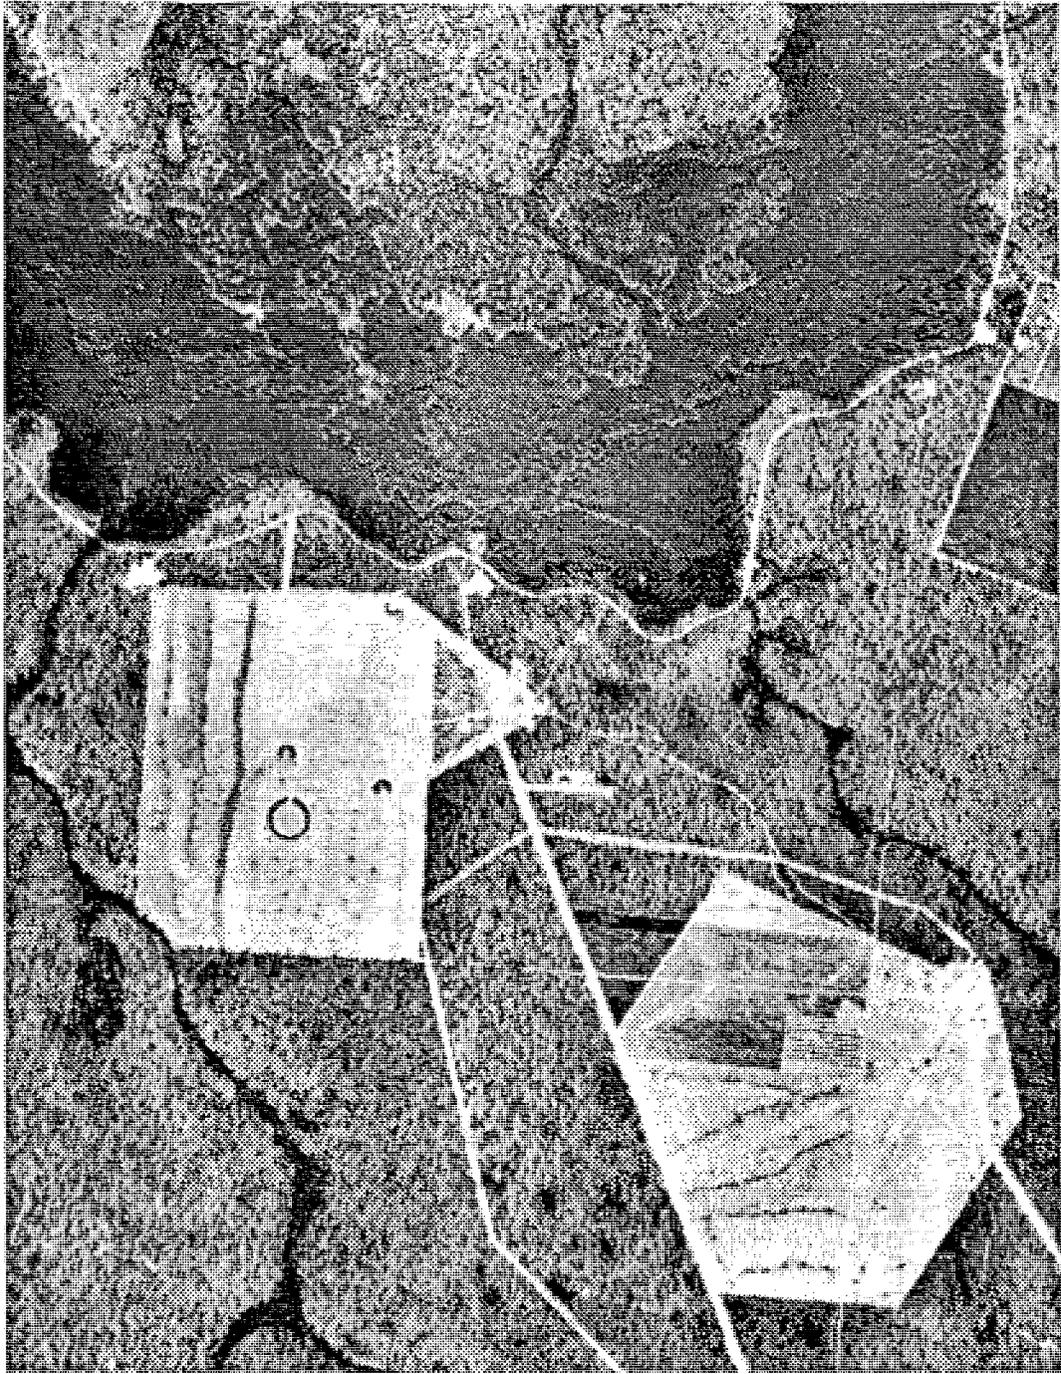
Fig. 6.

The first aerial photo of Eglin we had access to was an enlarged view of the C-64 test complex as it existed on February, 1969 (Fig. 6). The light-colored rectangular complex left of center in the image is Test Area C-64, while the irregular polygon-shaped area in the lower right corner is Test Area C-64A. The upper part of the latter area (i.e., the darker gray area) is now known as Test Area C-64C. Note that, while C-64 shows target range features in place, there are no obvious signs of military use (e.g., no construction nor any ground targets) in the C64A/C area, which shows evidence of agricultural use, as suggested by the furrowed linear features in the center of the area. Titi Creek runs along the upper part of the photo.

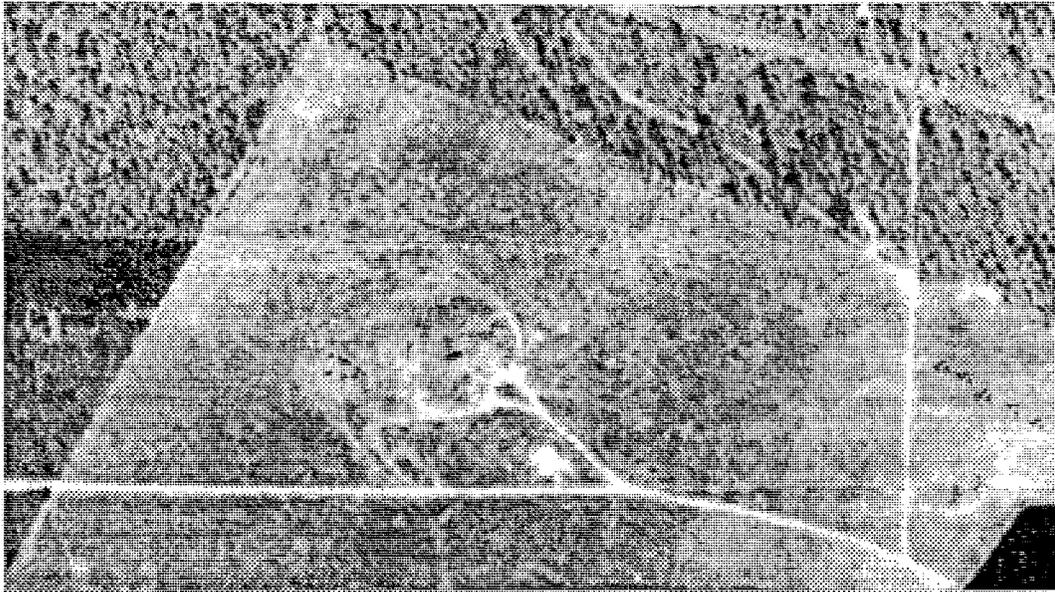
Fig. 7.

An aerial photo from 1974 (Fig. 7) includes several aircraft in an area farther to the east (right side) that may also have been used as a staging area for targets. Specifically, there are no runways or parking aprons in Test Area C-64A/C; further, Eglin is not a surplus aircraft storage facility (like Davis-Monthan AFB in Tucson, Arizona). Therefore, it is probable that these were surplus aircraft to be used for some sort of ordnance testing, most likely as targets for canon experimentation. Thus, as with the area containing cylinder objects further to the west, it likely that this was a staging area where aircraft were stored pending relocation to firing ranges such as Test Area C-64. Using measurements derived directly from the georeferenced aerial images, and the aircraft in the lower center of the image appears to be a North American F100 Super Sabre.

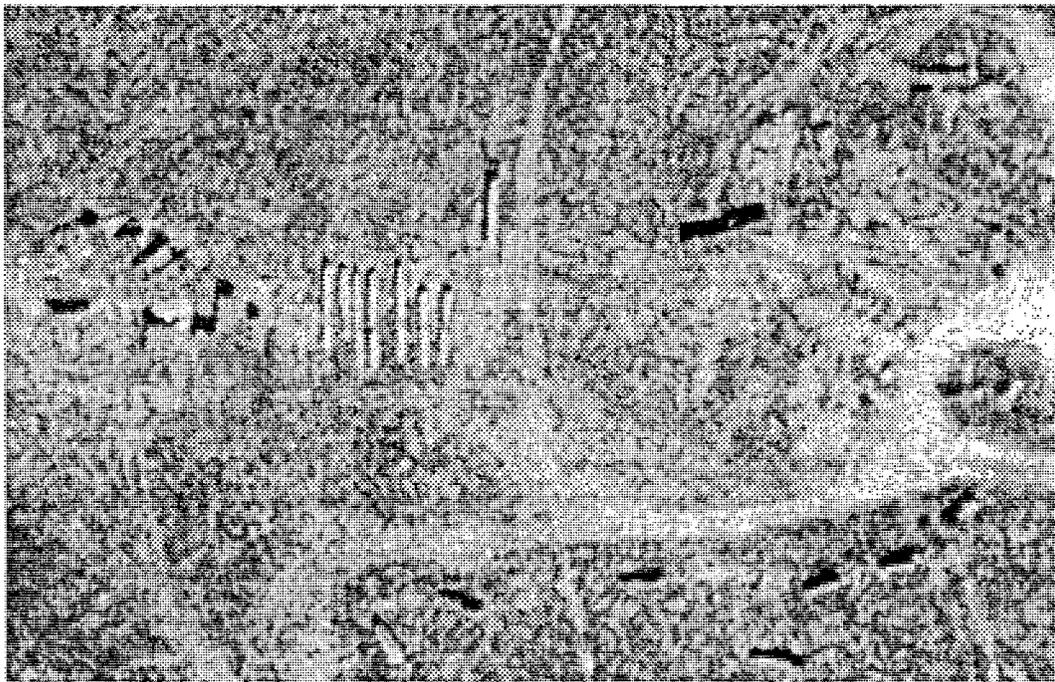
Fig. 8.

By 1978 the aircraft had been removed; however, the primary area of interest continued to show the type of staging activity evident in 1974. Specifically, as reflected in Fig. 8 (of the same area of the 1974 Fig. 3 photo, but enlarged for the area of interest), the pipe-like objects are in essentially the same area; however, there are three more "pipes" in the area (i.e., eleven, as opposed to eight in 1974).

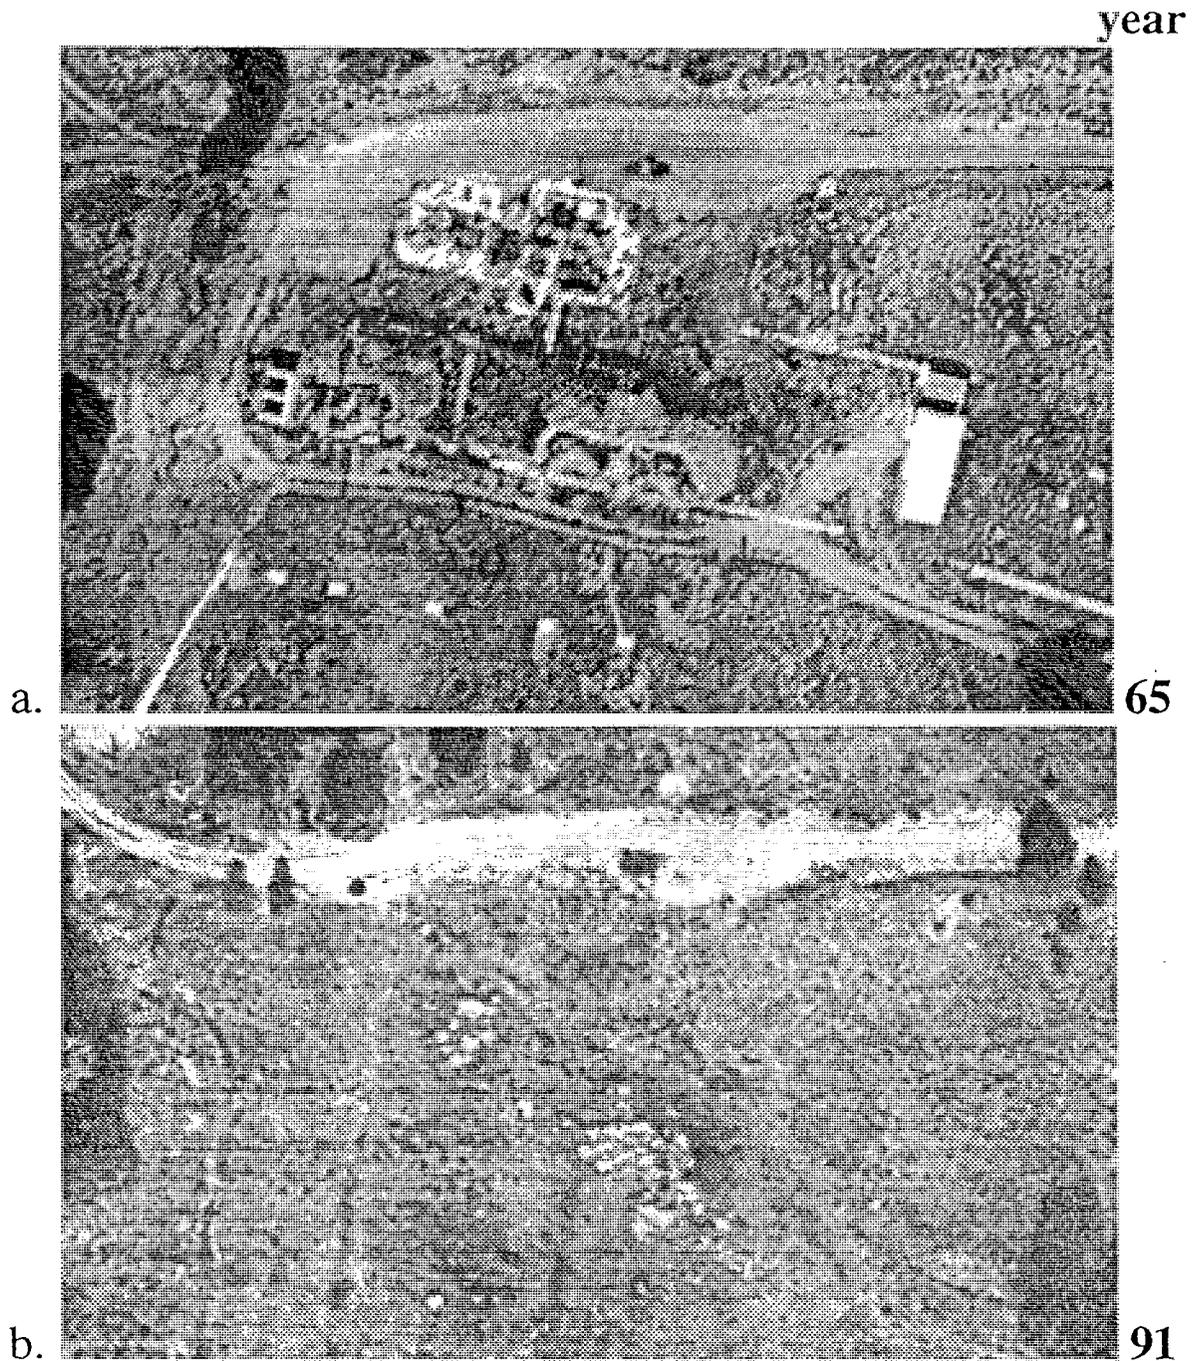
Fig. 11. Aerial photos taken in 1965 and 1991 of the GMX-2 site. The sumps are clearly visible in the 1965 photo (6 rectangular objects in the lower part of the image). These particular photos have similar scales and are of the same area, but are not registered pixel by pixel as were the photos in Fig. 2.

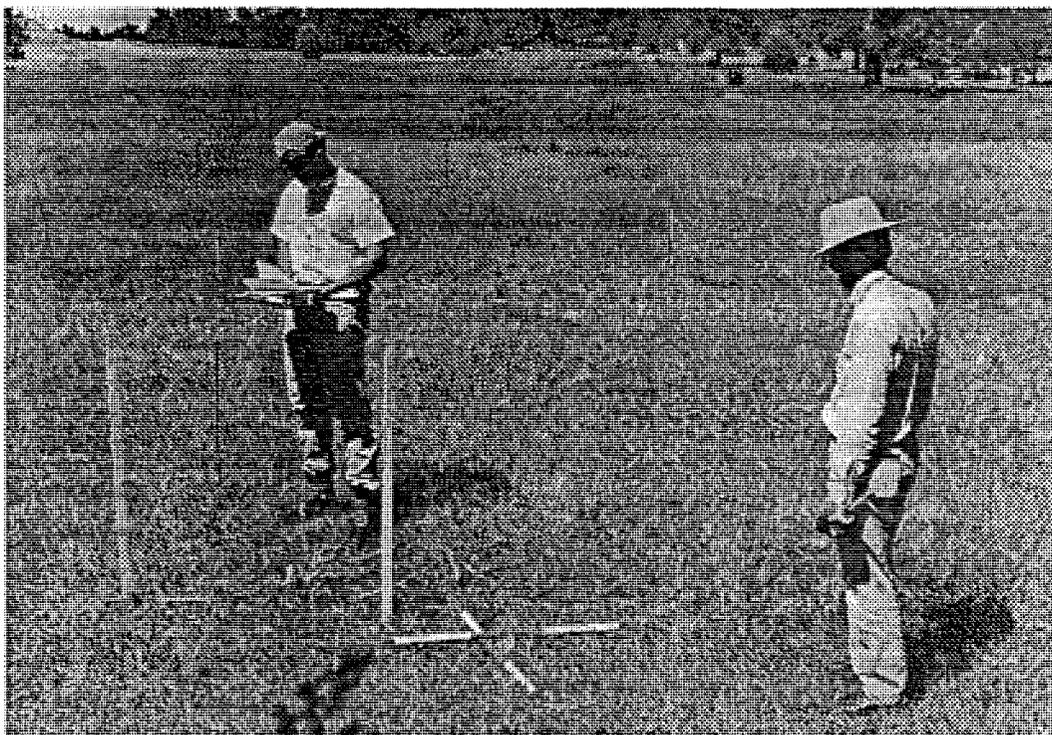
After performing the coregistration and field surveying the results, the average deviation of the six sump centers relative to where the depressions were in the 1991 image was found to be 2.7 feet, with a maximum of 4.7 feet. An example location is shown in Fig. 12.

Fig. 12. Example sump location errors (the depression left from the sump is marked with a cross).
