SPECIALIST MEETING ON
CRACKING IN LWR RPV
HEAD PENETRATIONS

PAPER: "SPANISH RPV HEAD PENETRATIONS. REGULATORY STATUS"

"SPANISH RPV HEAD PENETRATIONS. REGULATORY STATUS"

The paper presents the actual status of inspection results on the spanish PWR RPV CRD head penetrations (CRDH's), after two years of a whole program of inspections in all affected plants.

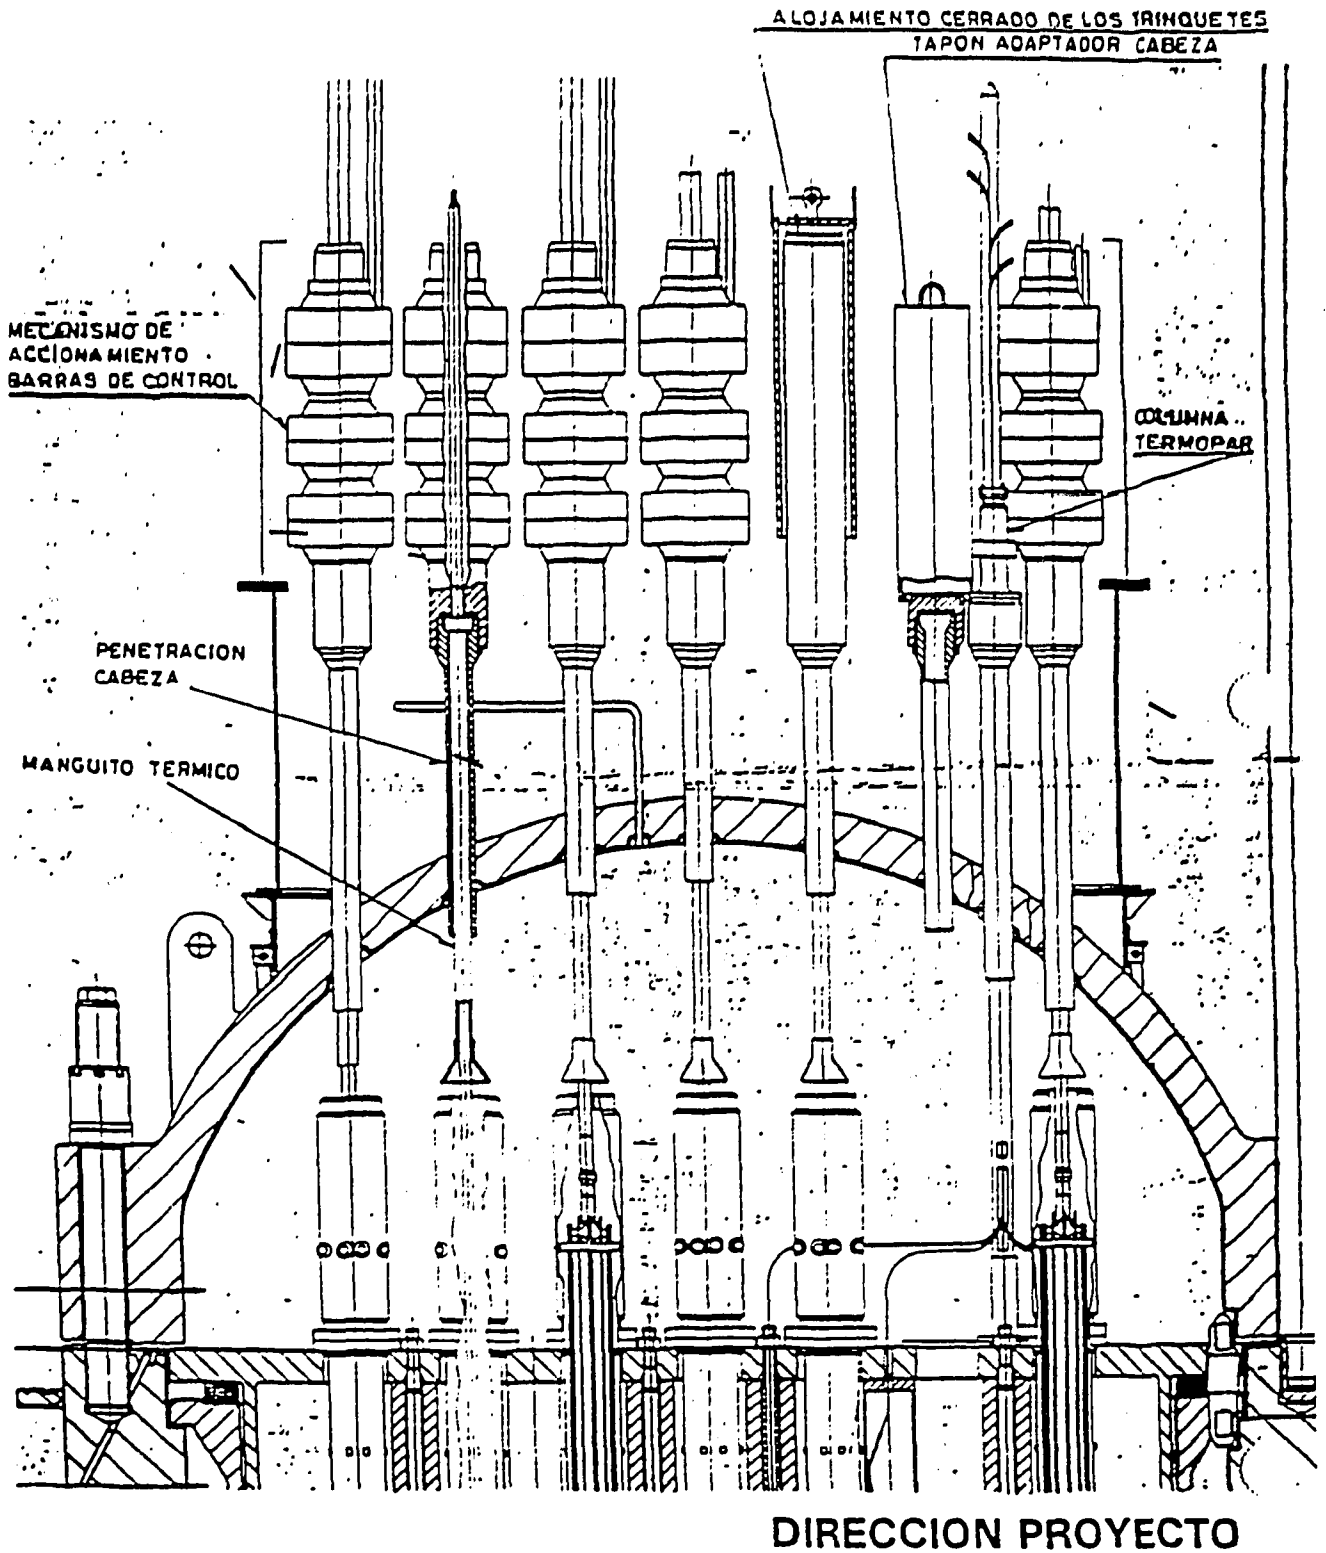
Fig. 1

FIGURE 1: ASCO & ALMARAZ RV HEAD PENETRATIONS

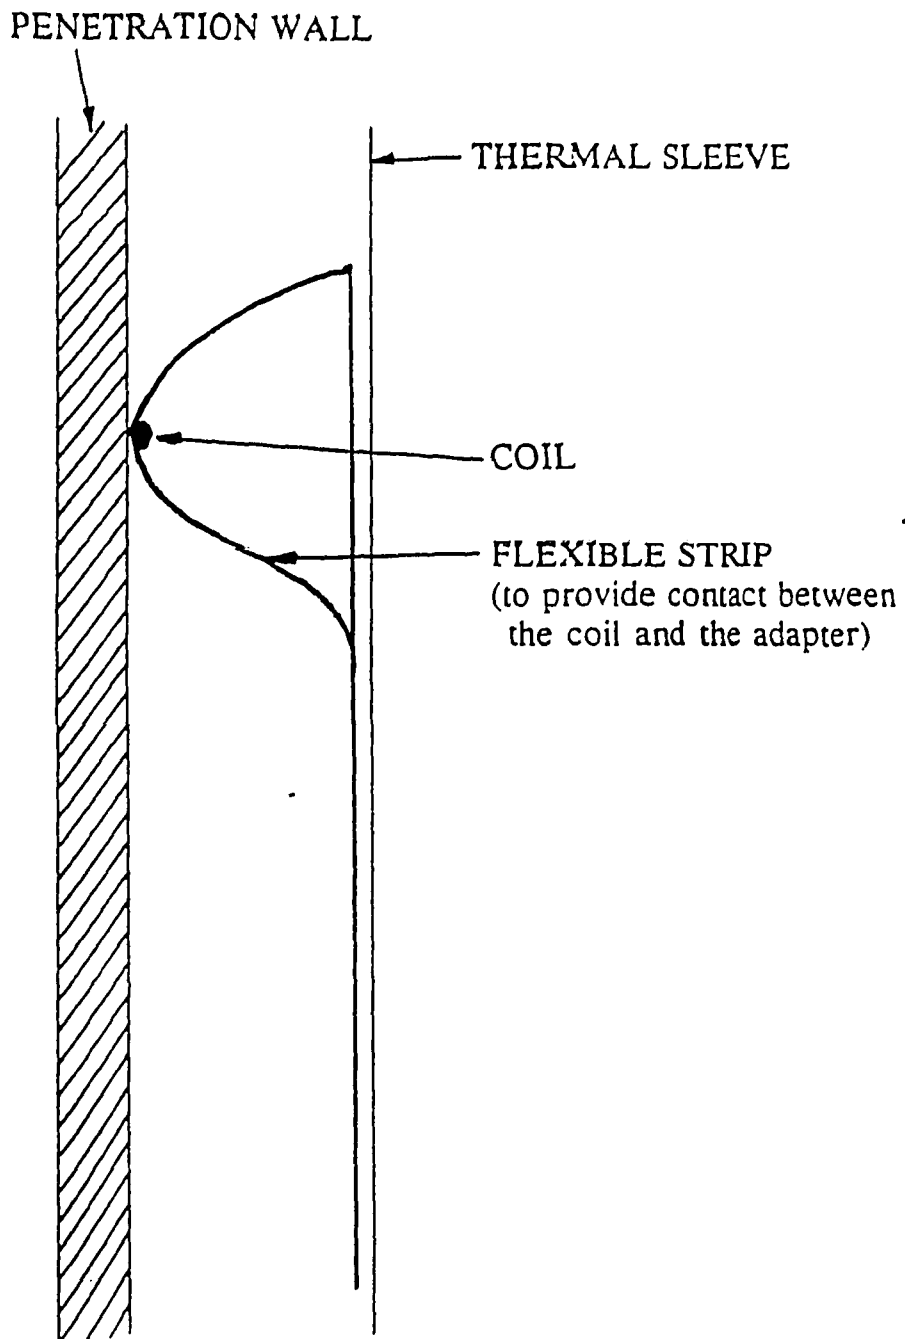
FIGURE 4 Bis: GAP SCANNER PROBE (ASCO NPP)

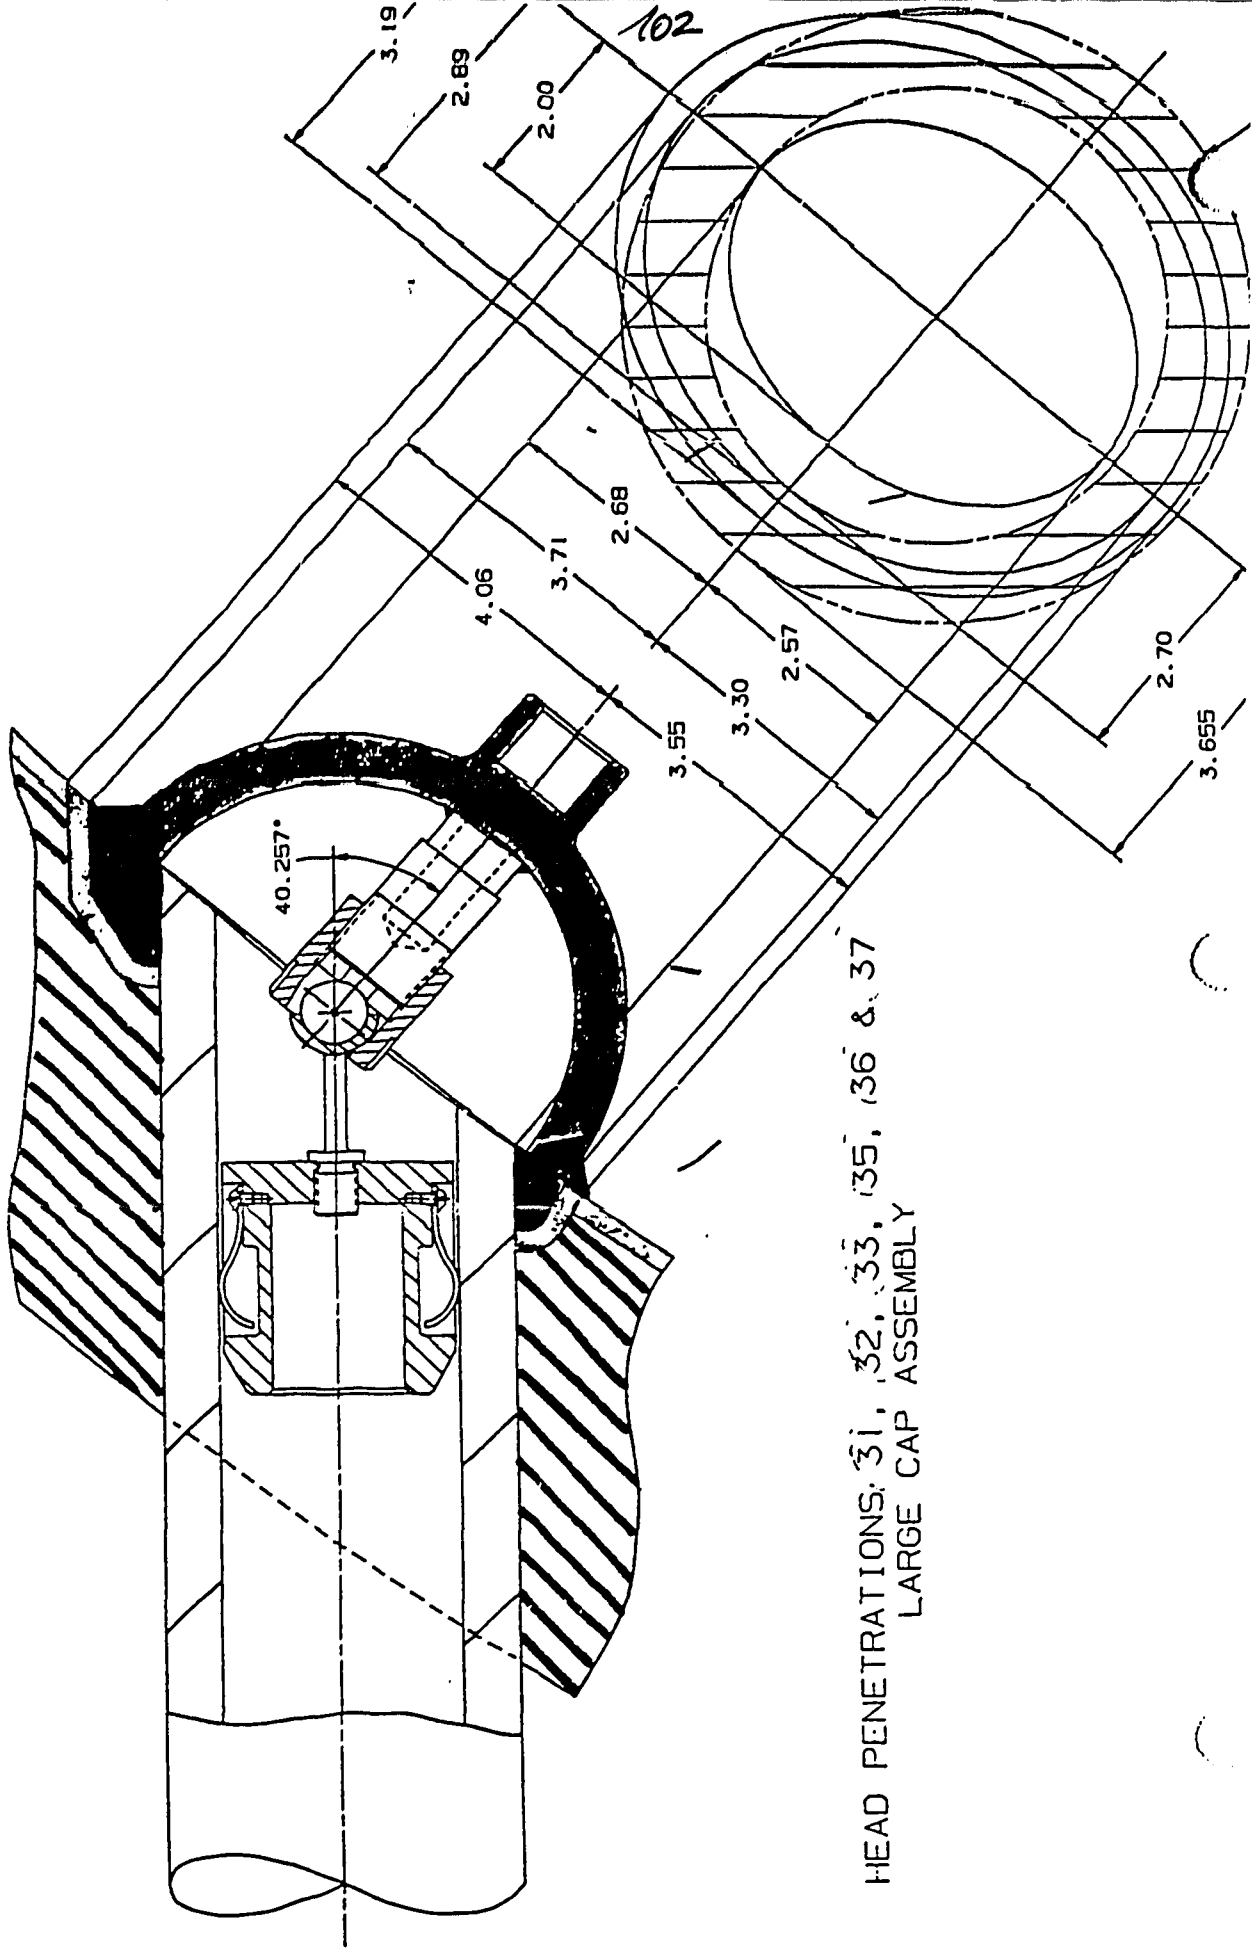
HEAD PENETRATIONS: 31, 32, 33, 35, 36 & 37
LARGE CAP ASSEMBLY

INSTALLED HEMISPHERICAL CAPS ATTACHED TO THE "OLD" WELDMENT

CAPS AND "NEW" WELD ACT AS PRIMARY PRESSURE BARRIER

CAP MATERIALS: INCONEL 690 TT (SB-166), INCONEL 182

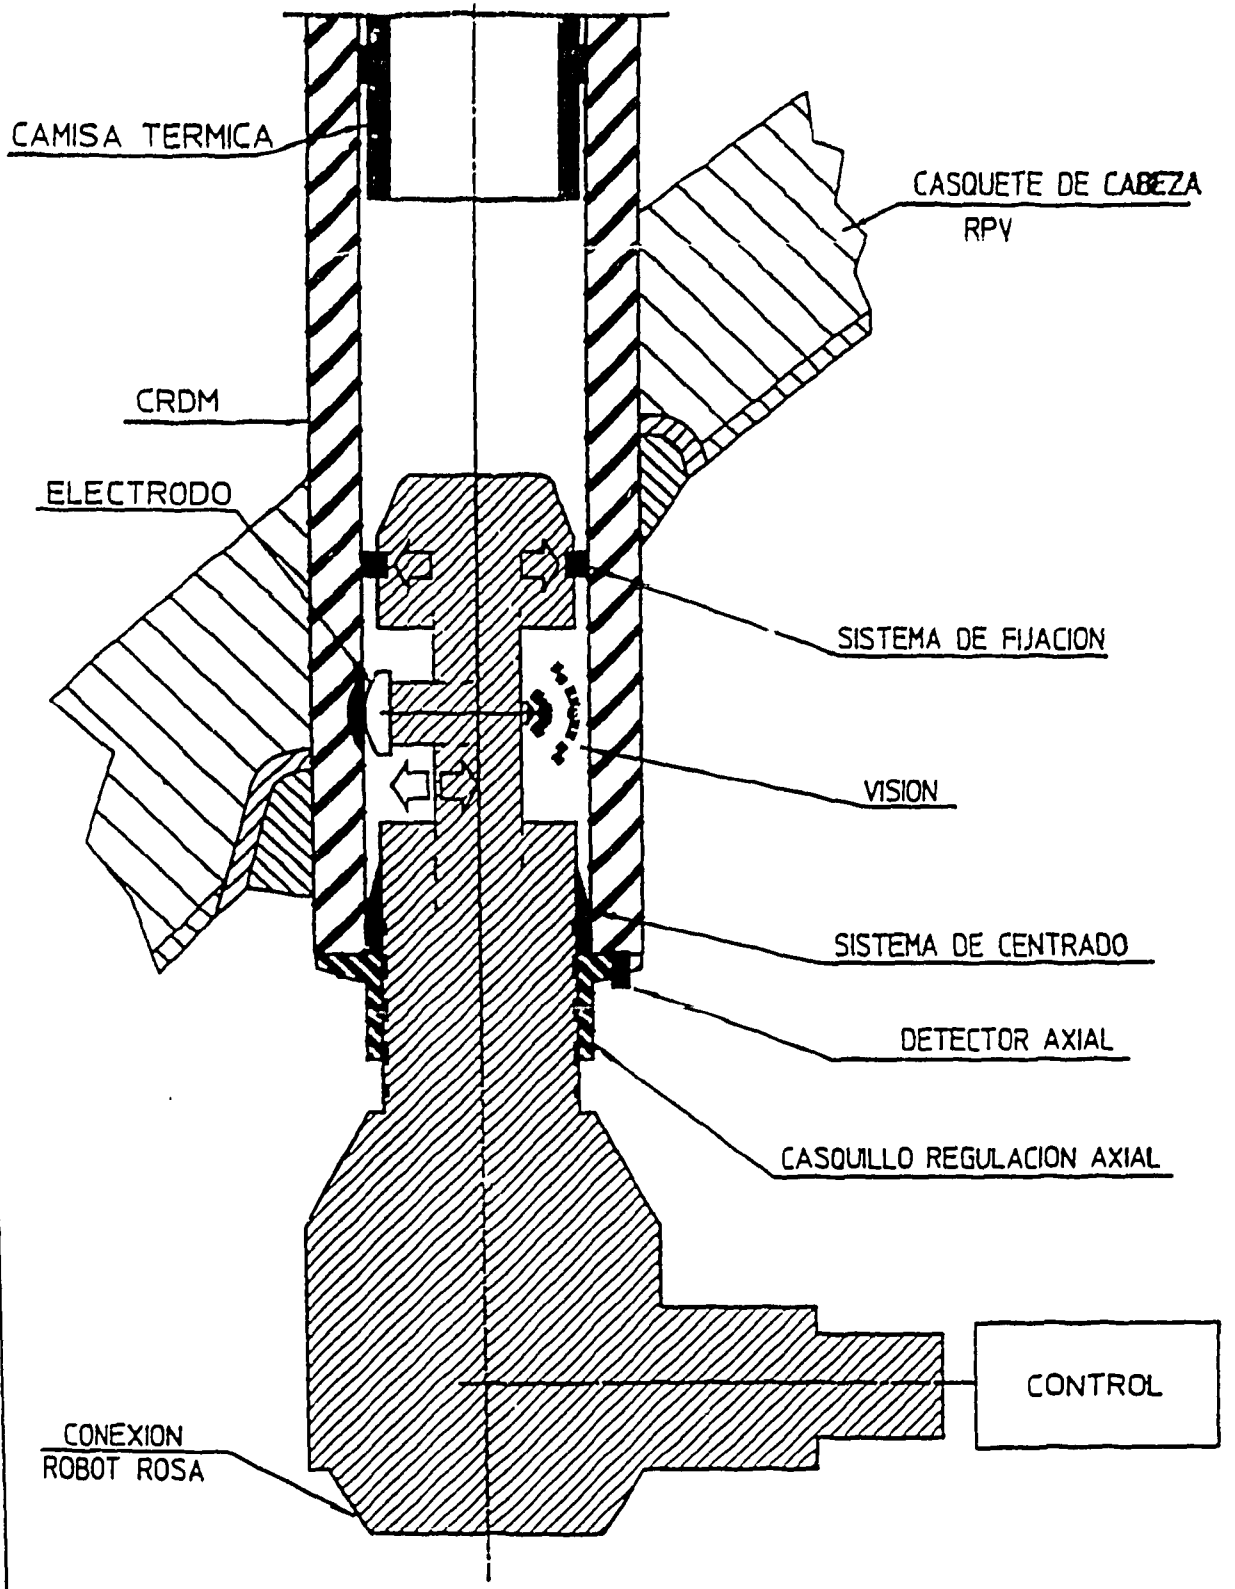
Fig 5

PENETRACION N° 17

ELIMINATED CRACKS BY ELECTROEROSION (EDM)

- CRDH NO 10: DEPTH 6,53 MM.; 49 MM.(AX.) BY 590 (ARC)
- CRDH NO 15: DEPTH 5,70 MM.; 59,5 MM. BY 1090
- CRDH NO 17: DEPTH 7,90 MM.; 41,6 MM. BY 44,50
DEPTH 6,30 MM.; 47,7 MM. BY 1020
- CRDH NO 30: DEPTH 6,85 MM.; 86,6 MM. BY 690
