# Condensate Induced Water Hammer in a Steam Distribution System Results in Fatality

H. L. Debban  
L. E. Eyre

Date Published  
February 1996

Presented at:  
Utility Business Operations in the 90s  
Palo Alto, CA  
February 21-23, 1996

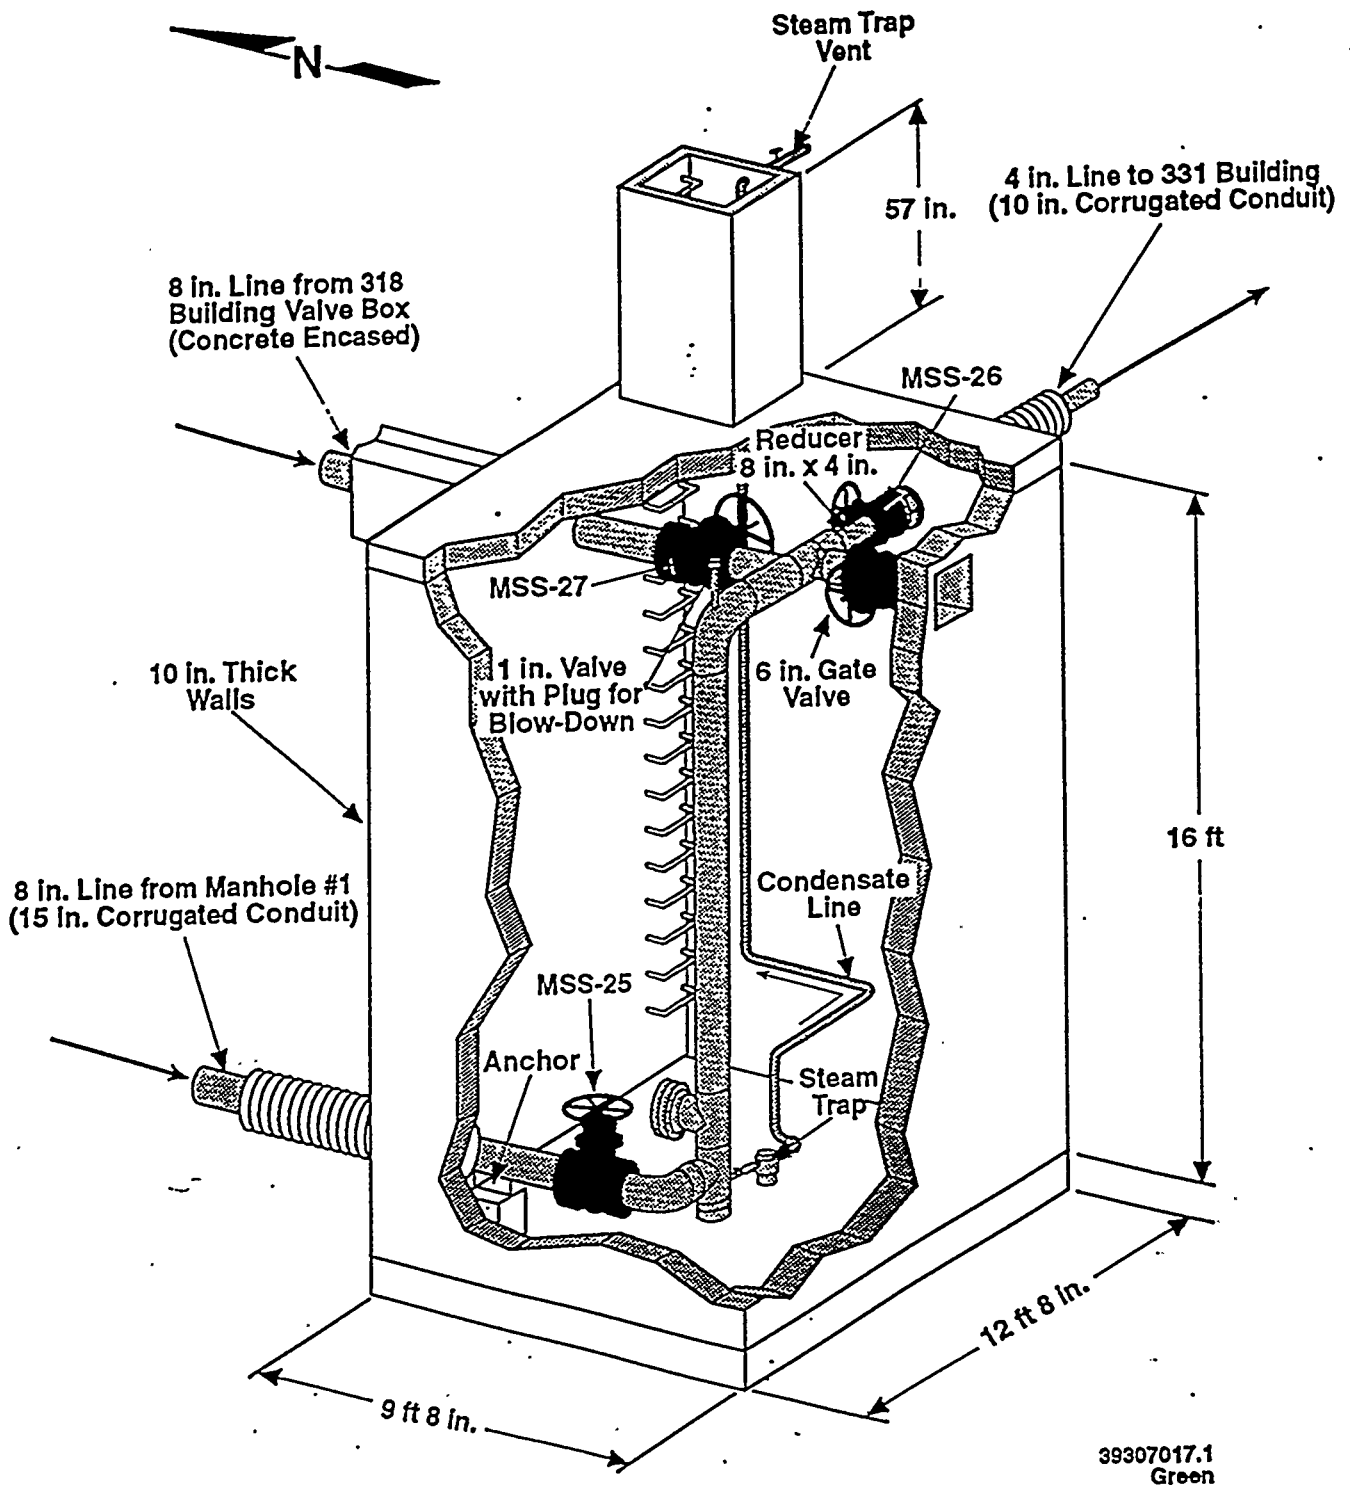
**FIGURE 1**

On June 7, 1993, at about 7:00pm, a Westinghouse Hanford Company Journeyman Power Operator received critical steam burns and lung injuries while opening an 8-inch main steam line isolation valve, MSS-25, (see figure 1) in the steam valve (U-3) pit in the 300 Area of the Department of Energy Hanford Site. The U-3 pit is a part of a process steam supply system using steam at about 350 degrees fahrenheit and 120 psi.

Conditions in the steam system included a large quantity of condensate (approximately 1500 gallons) backed up in a 840-foot run of the main steamline between valve MSS-25, which is the lowest point in the system and the next isolation valve. The condensate was fairly cool since this portion of the piping system is underground and had been inactive for 8 months. Steam was on the downstream side of MSS-25 with a functioning steam trap in this section of the line. The upstream side of the valve was also pressurized to allow steam flow to the 331 building. The operator entered the pit, unlocked and opened the 8 inch isolation valve, MSS-25. Indicators are that he opened the valve over 50 percent in 1 to 2 minutes. Condensate rushed into the steam filled downstream piping, filling the vertical leg and when sufficient quantity had entered the next upper horizontal section a water hammer ensued. This initiated a severe thermal-hydraulic transient, resulting in a condensate induced water hammer with pressures up to about 2300 lbf/in<sup>2</sup> in the pit piping. The transient was terminated quickly by a rupture of a 6-inch cast iron, blind flanged isolation valve in the upper section of the pit. The rupture created an instantaneous release of high pressure water and steam into the pit.

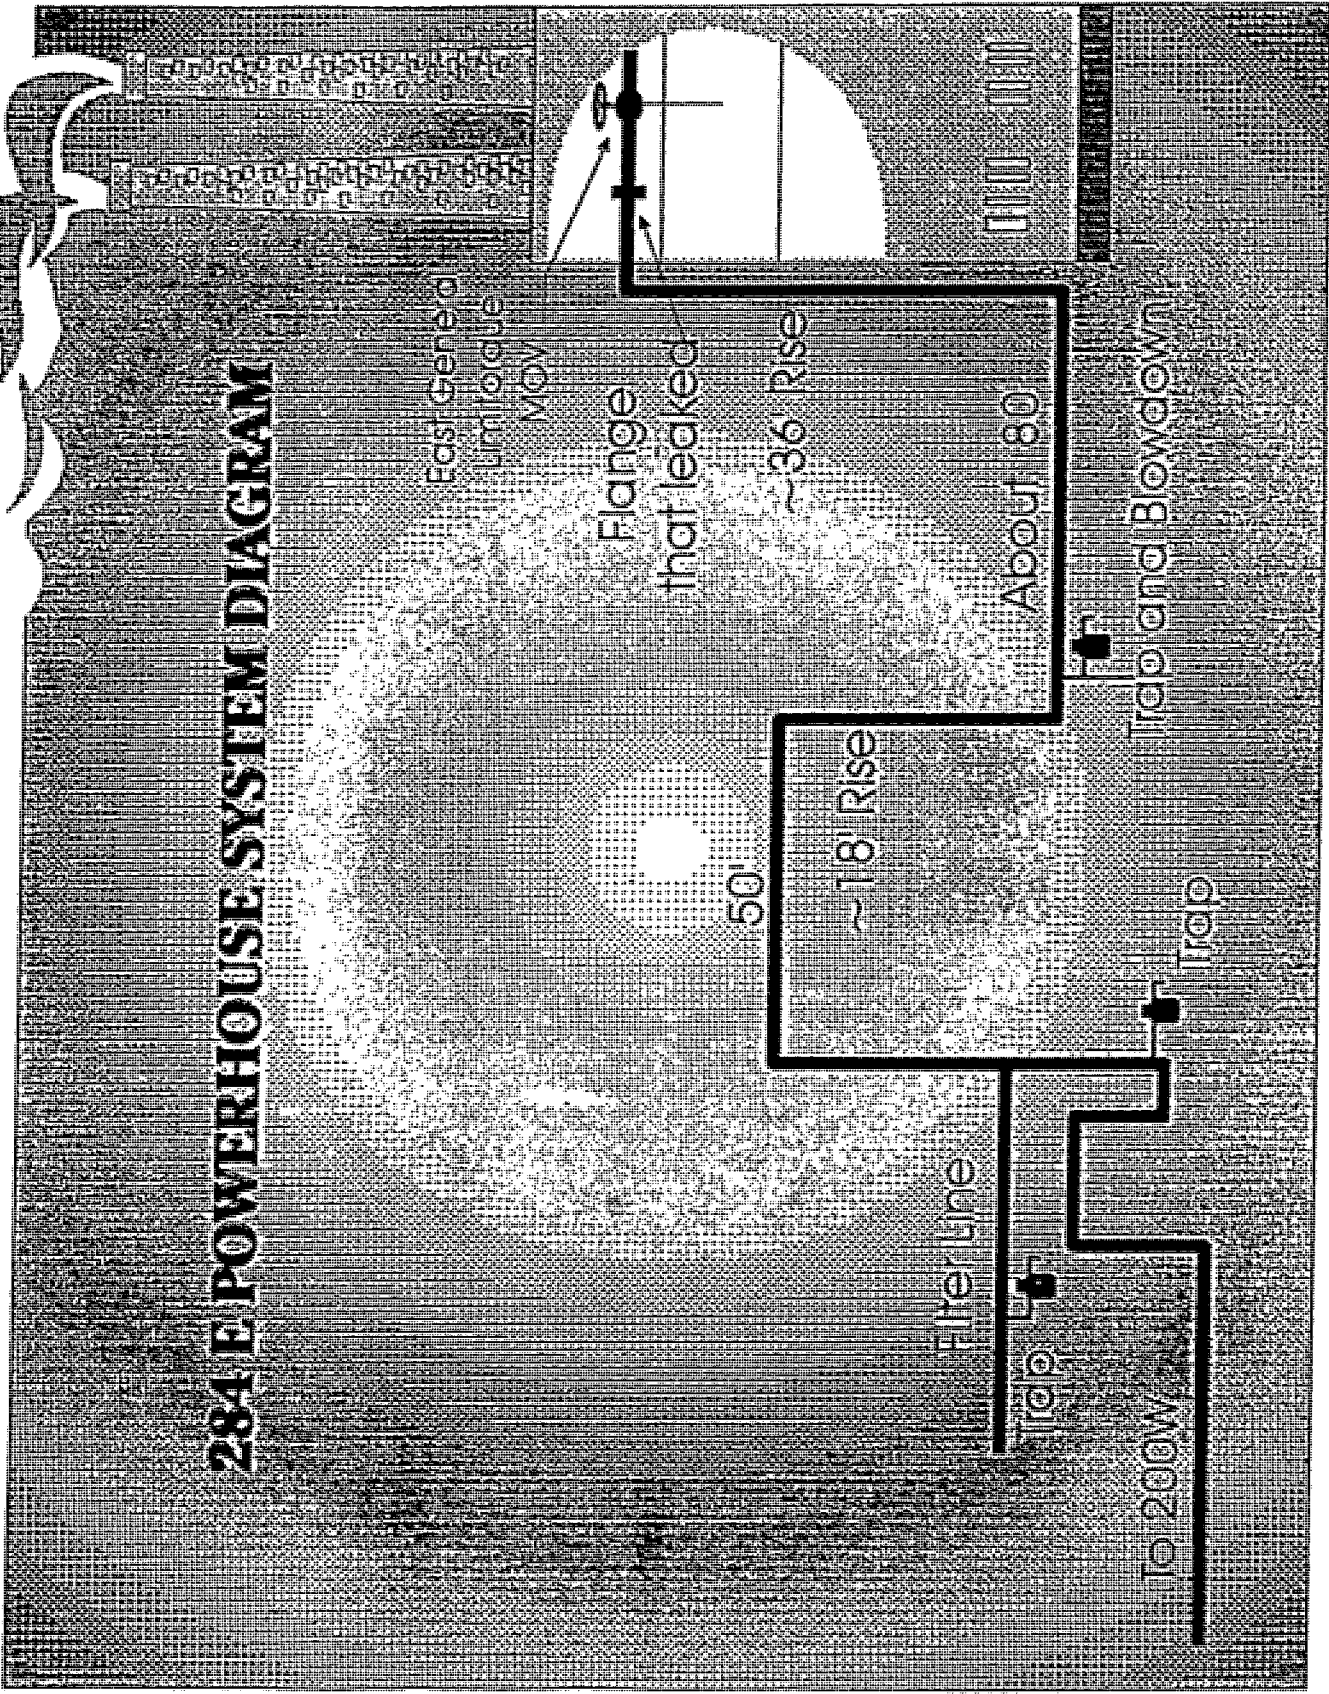
**FIGURE 2**

Significant accomplishments were made in implementing the action plan. However, on June, 16, 1994 (one year after the fatality), another condensate induced water hammer was experienced at Hanford. At a site, 20 miles North of the previous water hammer, during a steam restoration evolution at the 284E powerhouse a condensate induced water hammer occurred when the operators began to "crack open" the main 12" limitorque valve (see Figure 2), which would initiate steam flow and begin the heat up process. A horizontal section of piping from the road riser, up to the East general limitorque valve, filled with condensate, during a two week outage. Approximately 700 gallons of condensate collected in the pipe. No personnel were injured, but moderate damage was sustained by the piping supports and three elbows on the 12" steam line exceeding their yield stress. Also, a 12" flex gasket failed due to

stressing of the flange bolts, breaking system integrity, which caused water and steam to be discharged.

When the limitorque valve was cracked open, condensate, under steam pressure of 225 psig, flowed into the powerhouse piping system. When the level in the lower horizontal section decreased to create a void between the condensate surface and the top of the pipe steam flowed into this space and set up the condition for the condensate induced water hammer, which lasted between 5-6 minutes.

Investigation later revealed that the condensate build up was due to a 15 psi trap being installed in the 225 psi system. The trap could not function to discharge condensate in this condition.
