REMOTE INSPECTION OF THE IFSF SPENT FUEL STORAGE RACK

INEL-95/00410

EVERT D. ULDRICH
LOCKHEED MARTIN IDAHO TECHNOLOGIES
P. O. BOX 1625
IDAHO FALLS, IDAHO 83415-3760

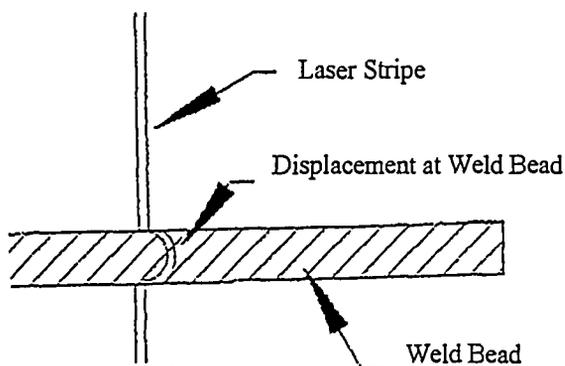
Offsets along the axis of the video camera lens can be measured. An example of this would be the height of a weld bead. An offset is actually a change in range from the camera to the object, which causes the laser stripe to move right or left on your screen (Figure 2). The offset is measured by clicking the offset tool icon and then stretching a line between any two points on the laser stripe. The VideoRuler computes the difference in range (offset) of the two points indicated on the stripe. A similar technique is used to measure length of welds. Accuracy of measurements at a greater range can be improved by increasing the distance between the camera and the laser. For this inspection, a spacing of 6-in. between the camera and laser, was used.

Figure 2. Measurement of a Weld.
