WSRC-MS-96-0356

**MATERIALS PERFORMANCE IN A HIGH-LEVEL RADIOACTIVE
WASTE VITRIFICATION SYSTEM (U)**

**KENNETH J. IMRICH
&
GREGORY T. CHANDLER**

SAVANNAH RIVER TECHNOLOGY CENTER

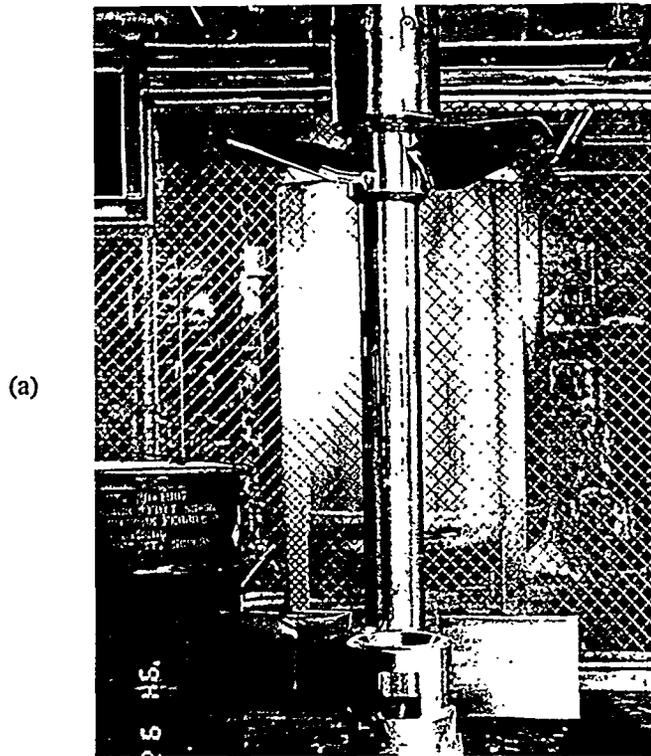
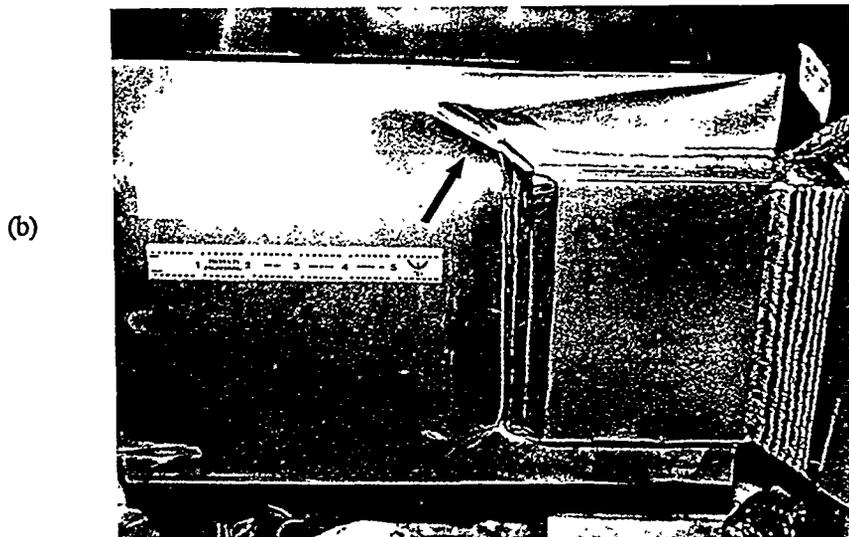
Agitator blade assemblies from the major feed process vessels were inspected after approximately twelve months of operation. Figure 3a shows a picture of the agitator blade assembly (constructed of alloy C-276) used in the SME tank. The assembly has four lower rectangular blades and four upper hydrofoil blades. The lower blades are connected to the hub by a connecting tab. Significant erosion was observed on the backside of the lower blades at the step change between the connecting ear and blade. Wear patterns, approximately 50% through wall, were observed emanating from the corners of the tab on all four blades (See Figure 3b). Similar wear patterns, but less severe, were also observed on the MFT lower agitator blades. No significant erosion was observed on the SRAT agitator blades.

Erosion was also observed on the bottom cooling/heating coils and coil supports in the SME and MFT. The erosion was adjacent to the bottom agitator blades. The maximum wall thinning that occurred in the coils was approximately 40%. No significant erosion was observed on the bottom floor or side walls of the SME tank. No significant erosion was observed on the SRAT coils.

Figure 3. Photograph of SME Agitator, (a) Entire Assembly, (b) Back of Lower Blade (arrow indicates wear scar).

In general, very little evidence of significant corrosion was observed in the feed processing vessels and related equipment after twelve months of processing nonradioactive simulated waste solutions. This is consistent with results obtained from a corrosion coupon evaluation in the feed preparation system of a 1/10 scale vitrification system (4). Significant erosion was observed on the SME agitator blades and cooling/heating coils. High wear areas on the SME coils have been repaired with alloy C-276 weld filler metal and hard faced with Stellite to increase wear resistance. The SME and MFT agitator lower blades have been redesigned to minimize the step change between the connecting tab and blade. The lower blades have also been hard faced with Stellite.

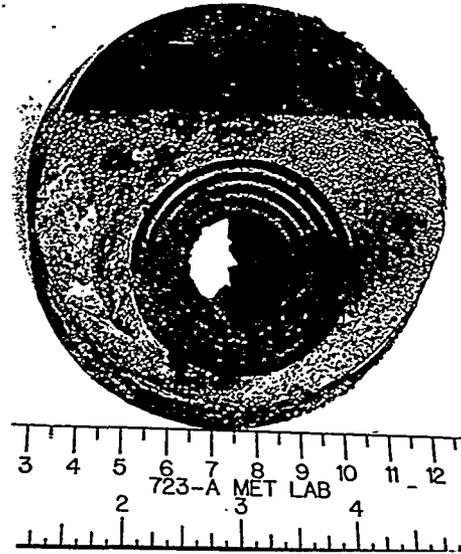
Borescopes: Two melter borescopes were visually examined after approximately five months of service. The borescope outer housing protrudes approximately 25 cm into the melter vapor space (Figure 4a). Both borescopes outer housings were in similar condition containing a thick scale and deep pits. The largest pit near the bottom of the outer housing was approximately 75 mm wide and 4.8 mm deep (nominal wall thickness 9.5 mm) (Figure 4b). Deposits containing sodium chloride and potassium sulfate were removed from the surface and identified by X-ray Diffraction (XRD). Sulfate and chloride concentrations were quantified by Ion Chromatography (IC) and found to be approximately 20,000 ppm and 9,000 ppm, respectively. Numerous small pits were observed along the entire length of the outer housing. The orifice below the camera lens, where the purge air exits, was also covered with a thick scale. In some areas the scale had spalled off revealing the metal substrate. Radial cracks in the substrate were observed emanating outward from the inner diameter of the orifice in all directions (Figure 4c). Point scans performed with Energy Dispersive Spectroscopy (EDS) indicated a severe depletion of chromium in the near surface region around the orifice. Internal void formation characteristic of high temperature oxidation was also evident in this region. The inner diameter of this tube, except for the portion around the orifice, did not show any signs of oxidation (spalling or chrome depletion) or corrosion. The original machining marks were still visible on this surface.

Figure 4. Photograph of DWPF Melter Borescope, (a) Outer Housing, (b) Large Pit, (c) Orifice.

Results from the metallurgical evaluation of the borescope outer housing indicated that the spalling around the orifice resulted from high temperature oxidation. The significant depletion of chromium deep into the metal substrate, internal void formation, and thick loosely adhering scale are characteristic of high temperature oxidation. Normally alloy 690 would form a stable chromium oxide (Cr_2O_3) layer which would protect the metal from further oxidation or corrosion. However, thermal fluctuations caused by frequent purges of steam (once every half hour) and the constant flow of air through the orifice accelerated spalling of the protective chromium oxide layer and further oxidized the metal. Chloride and sulfate containing salts also contributed to the degradation of the protective oxide layer. Furthermore, elevated temperatures, approaching 900°C , in the melter vapor space during idle mode, accelerated the diffusion of chromium from deep within the metal substrate to the surface.

The large pit observed on the side of the outer housing near the core end piece resulted from Type II hot corrosion. The morphology in this region was dramatically different from that observed around the orifice only inches away. This type of corrosion results in a non-uniform pitting attack with little or no chromium depletion from the metal substrate (5). Here internal void formation was minimal indicating that only the chromium close to the surface had sufficient time to diffuse to the surface and combine with oxygen to form Cr_2O_3 . The extremely high concentrations of chloride and sulfate bearing salts combined with thermal cycling of the outer tube contributed to the degradation and spalling of the Cr_2O_3 layer. A corrosion rate in excess of 7.5 mm/yr was estimated (6).

Oxidation around the orifice of the borescopes may be minimized by reducing the amount of air passed through the orifice and by minimizing the frequency of steam purges. Both solutions would require redesign of the borescope. Oxidation in this region could also be eliminated by using an inert gas purge such as argon but the effects of the gas on the glass chemistry, off gas, and system integrity would need to be evaluated.

Chlorides are known to cause severe "breakaway" corrosion in chromium and nickel based alloys (7); however, small additions of aluminum to Ni/Cr alloys have been shown to increase the chlorination and oxidation resistance (8, 9). A duplex chromium and aluminum diffusion layer was applied to one of the replacement borescope outer housings and an inspection was performed after several months of service. Although a thin loosely adhering scale containing alumina was detected, severe pitting was not observed on the housing. The service life was conservatively estimated at one year. Another inspection is planned to assess its performance after one year of service. Alternate alloys containing 2 to 3 wt% aluminum or silicon (VDM alloys 602 CA and 45 TM and Inconel 690 modified with 3 wt% Al) have also performed well in scale glass melter and incinerator coupon tests and are being considered for use on this and other DWPF melter components (10-12).

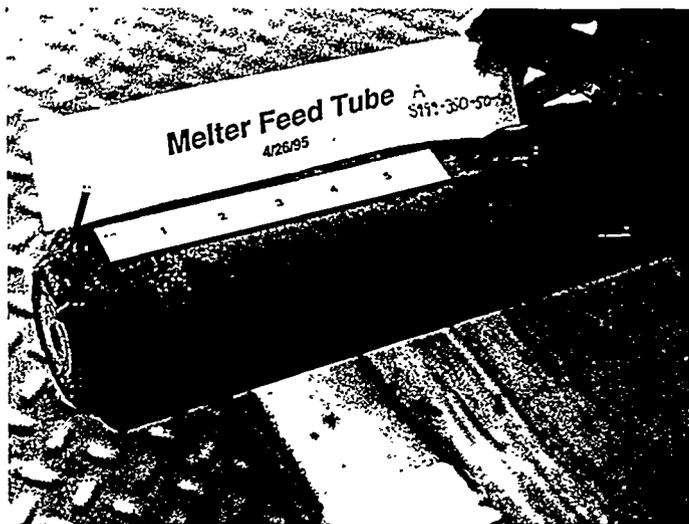
Feed Tubes: Feed tubes consist of a center tube which is surrounded by a water cooling jacket. Severe degradation of the beveled edge at the bottom of the feed tube was observed (Figure 5). Material loss in this region appeared to be significant, approximately 2.3 mm deep. Several small metallurgical pieces were removed from the outer housing and the bottom area around the orifice adjacent to the bevel. No evidence of intergranular attack was observed in either of the specimens. The area surrounding the feed outlet was in excellent condition and showed no evidence of pitting. Similarly, the entire length of outer housing, including welds, was in excellent condition.

Figure 5. Photograph of DWPF Melter Feed Tube Showing Severe Degradation Around Core End Piece (see arrow).

Degradation of the feed tube core end piece resulted from pitting attack of the beveled region which is between the main outer tube and the bottom flat orifice plate. No significant attack was observed in the outer tube or around the orifice plate. Metallurgical specimens sectioned from the orifice plate and the main tube adjacent to the beveled region did not show any evidence of intergranular attack. Exposed end grains in the beveled region and the lack of adequate cooling may have contributed to the observed localized attack. The degraded regions of the tubes were weld repaired and machined to original specifications. Spare feed tubes were also buttered with matching filler material. A visual inspection of a weld repaired feed tube after approximately 5 months of continuous service indicated a significant improvement in performance. The repaired feed tubes are expected to perform satisfactorily for their two year design life.

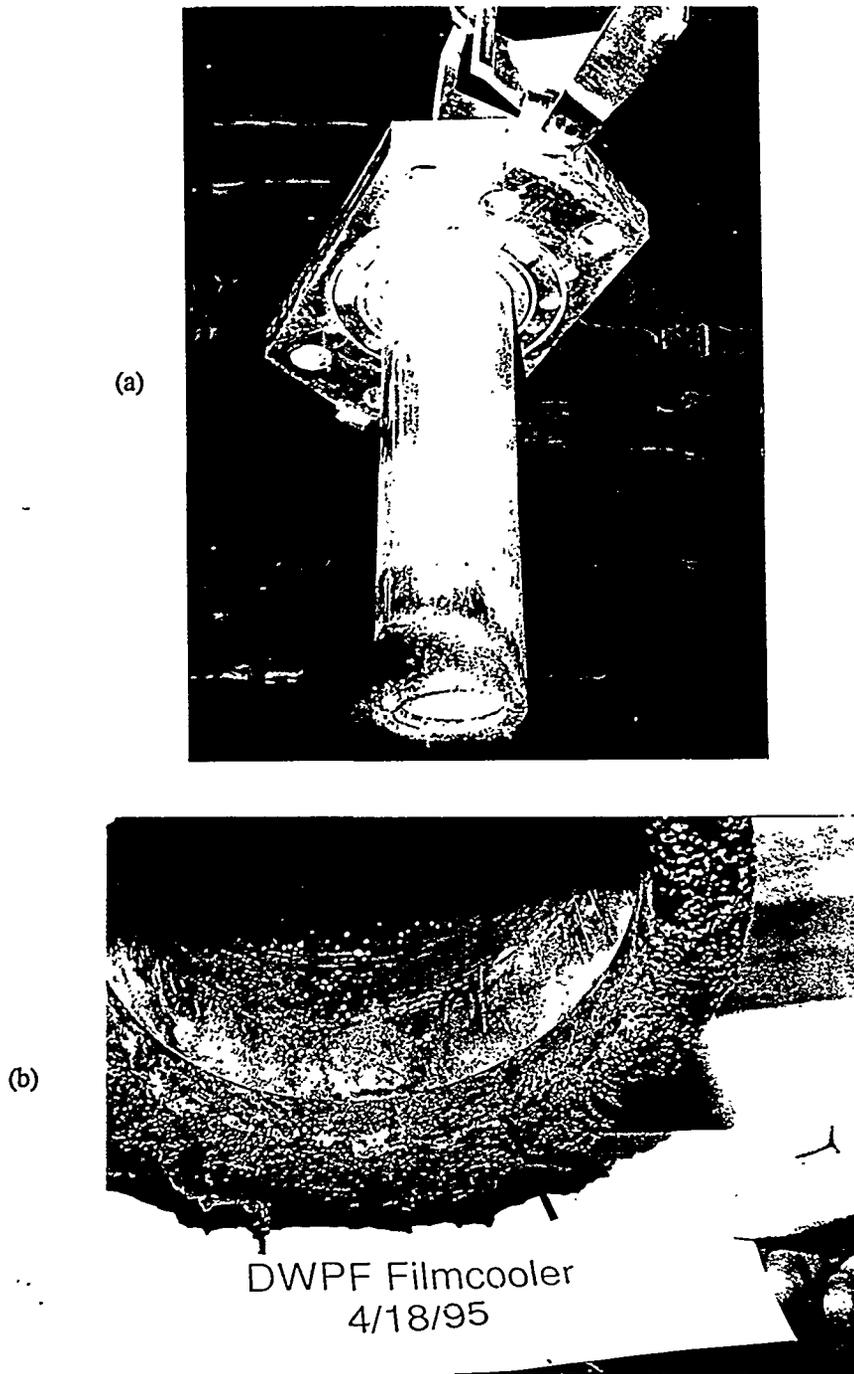
Film Cooler: Visual inspection of the primary film cooler showed oxidation of the lower portion of the outer lip. Oxidation was most severe in a region encompassing approximately 1/3 the circumference of the outer lip (Figure 6a and b). Internal components including the baffles and second lip were in excellent condition. A thin grayish black film was observed on the inner surfaces and contained only sulfates. The outer diameter of the film cooler was in excellent condition i.e., free of pitting or general corrosion, with only light deposits observed.

Figure 6. Photograph of DWPF Film Cooler, (a) Film Cooler and Flange, (b) Degradation of Lip (see arrow).

Degradation observed on the end of the film cooler most likely resulted from a combination type II corrosion and oxidation. Metallurgical sections were not removed from this component and therefore, the exact corrosion mechanism could not be determined. Approximately 30% of the bottom edge of the film cooler was affected; however, the degradation was not severe enough to warrant removal at this time. The film cooler will be operable for its intended design life although its efficiency may be reduced. Alternate materials will be evaluated for this component.

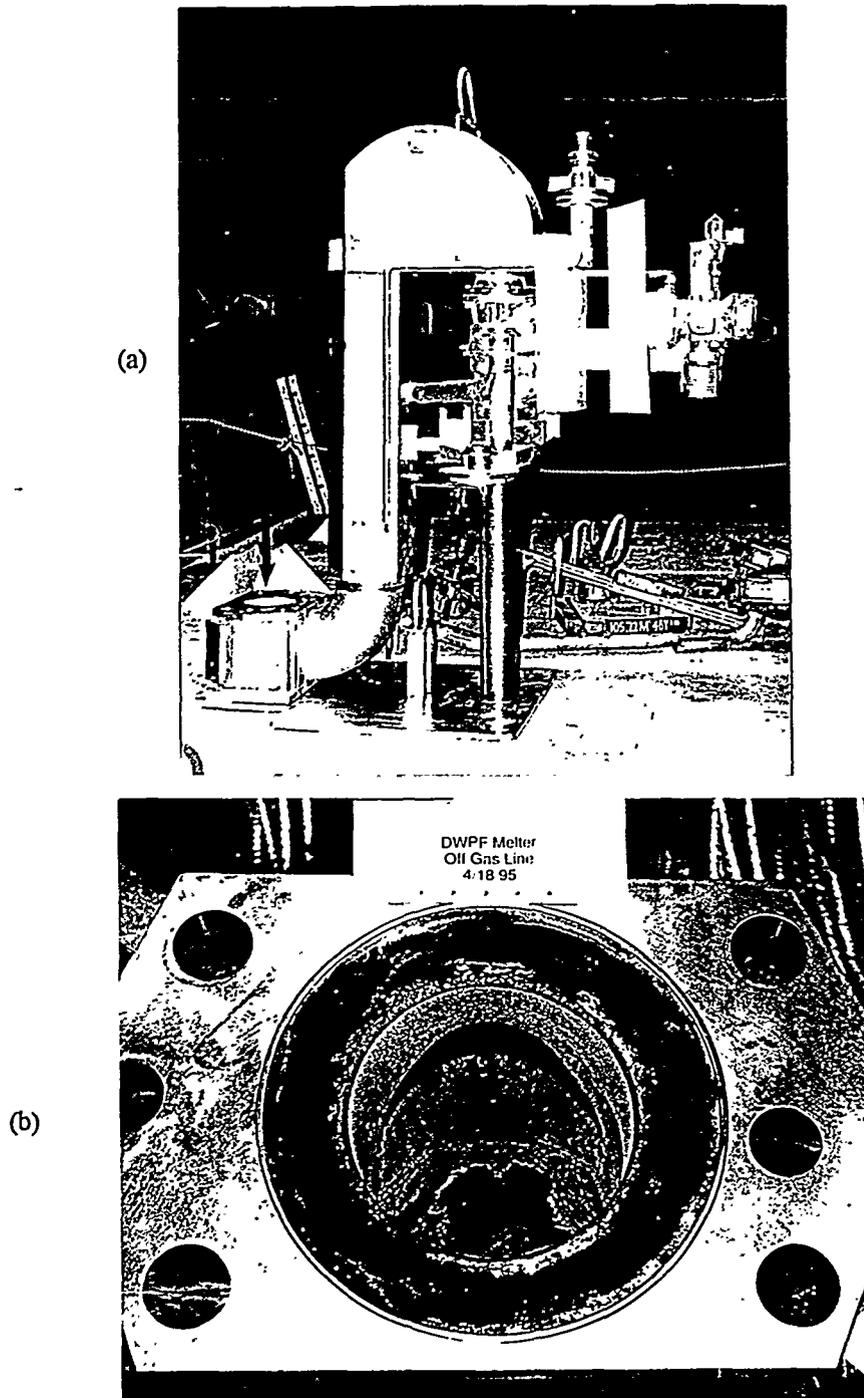
Primary Off Gas Line: The melter off gas (MOG) line from the film cooler to the isolation valve was visually inspected for evidence of degradation and deposit build up (Figure 8a). Severe pitting was observed in the 8 inch diameter pipe just below the film cooler brush flange (Figure 8b). The pits were numerous but generally less than 1.5 mm deep. The metal surface in this region was covered with a very thin, light gray deposit. Metallic scrapings taken in this region were analyzed using XRF and indicated a chromium concentration of 12 wt%, which is significantly less than that specified (30 wt%) for the Inconel 690 DWPF melter components. Deposits from this region were found to contain high concentrations of chloride and sulfate bearing salts. Some minor pitting was observed up to the isolation valve. The isolation valve, which is fabricated from CW7M (a cast version of Hastelloy C-276), exhibited no evidence of pitting or corrosive attack. Deposits collected from the off gas line outlet contained chlorides and sulfates in excess of 9000 and 28000 ppm, respectively.

Figure 8. Photograph of DWPF Off Gas Line, (a) Off Gas Line Showing Flanges Where Film Cooler Brush Would Be Installed (see arrow), (b) Off Gas Line Below Film Cooler Brush With Severe Pitting (see arrow).

Pitting of the off gas line inlet just below the film cooler brush may have been due to the evolution of MoO_3 from the film cooler brush, and therefore, may be mitigated by the current operating procedure described above and possible redesign. Pitting attack past the dilution air nozzle was minimal and was attributed to the reduction of temperature to 350 °C. The off gas line, isolation valve, and the primary quencher should perform satisfactorily for their two year design life.
