# Main Examination Results of VVER-1000 Fuel After Its Irradiation in Power Reactors

## 1 Introduction

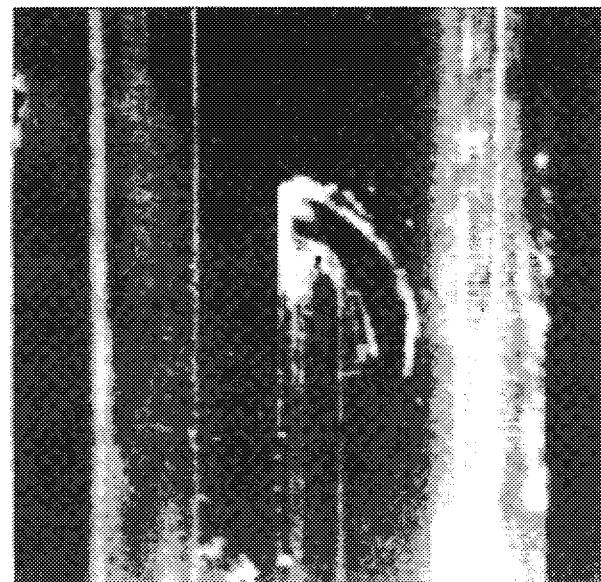
**Figure 1** Fuel assembly (a), fuel element (b), fuel cladding defect (c) and nodular corrosion (c).

The visual inspection testified that there were no substantial changes in the fuel assembly design nor defects or configuration modifications of its structural members. The surface of cladding and wrappers was of dark color, typical for the autoclaved zirconium alloys (Fig. 1). The failed fuel rods were found to have defects caused the interaction of cladding with solid coolant particles. Moreover, some fuel cladding defects were observed which could be explained by spacer grid fretting-corrosion effect (Fig. 1). The nodular corrosion was found on the fuel rods of the South-Ukrainian assembly which was discharged after the disrapture of the main circulating pump and penetration of graphite into the coolant (Fig. 1). It could be caused by the specific microenvironment formed under the deposits of graphite compounds on the cladding.

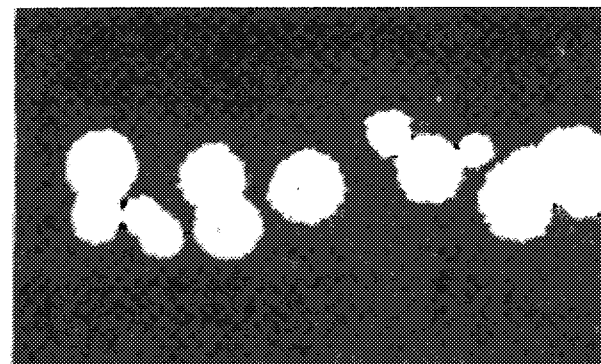
(d)

Ukrainian NPP is caused by the graphite compounds deposited on the fuel rod. Those depositions were a result of the circulating pump damage and beard an accidental, non-typical character. Some of the fuel rods were found to have a small cladding "fretting" of the spacer grid cell material.

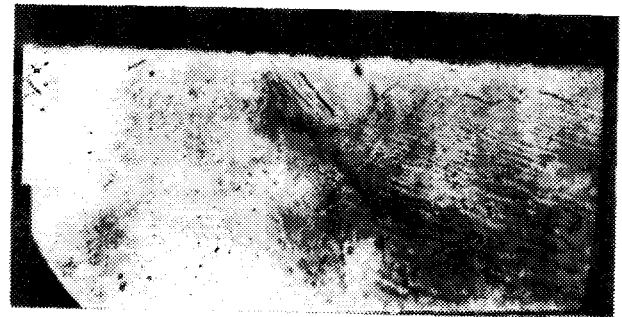
Figure 5 The oxide film on the outer (a) and inner (b) surfaces

As a rule, after operation the inner surface of the VVER-fuel rod claddings was covered by dark uniform oxide film of  $4$  to  $8 \mu\text{m}$  thick which increases by  $1 - 2 \mu\text{m}$  in the upper part and practically does not depend on burnup (Fig. 5a). On the inner cladding surface the oxide film thickness modifies in the range from  $0$  to  $10 \mu\text{m}$  and it can be essentially changed along the cladding perimeter (Fig. 5b).

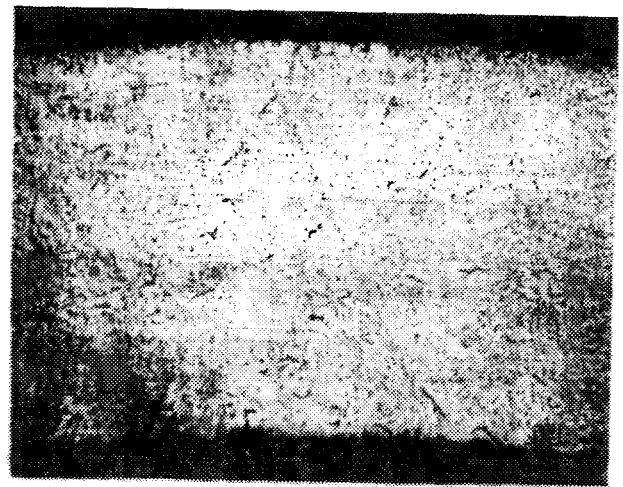
Figure 6 Characteristic structure of irradiated claddings

Sometimes claddings are found to have small quantities of lamellar form hydrides, the size of

which does not exceed  $50 \mu m$ . In this case the arrangement of the hydrides has random or tangential orientation (Fig. 6). The hydrogen content in claddings does not exceed  $(5 - 6) \cdot 10^{-3} \text{ mass\%}$ .

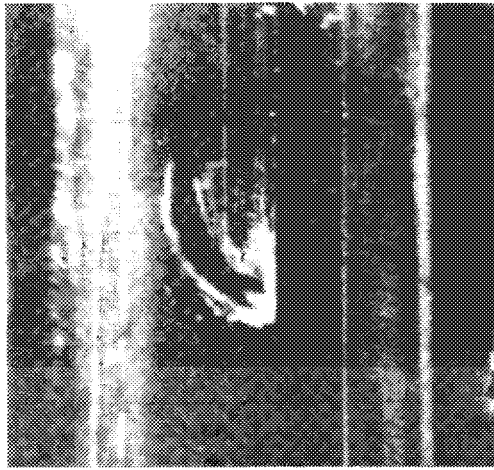
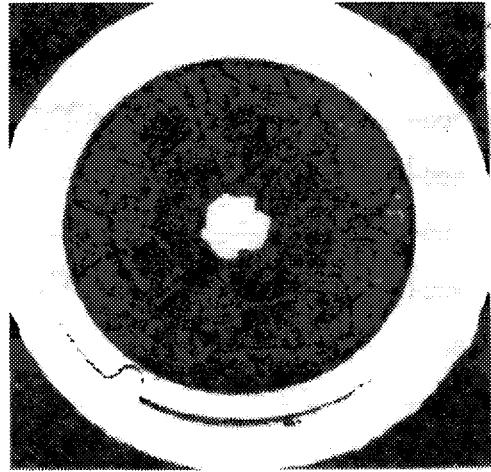
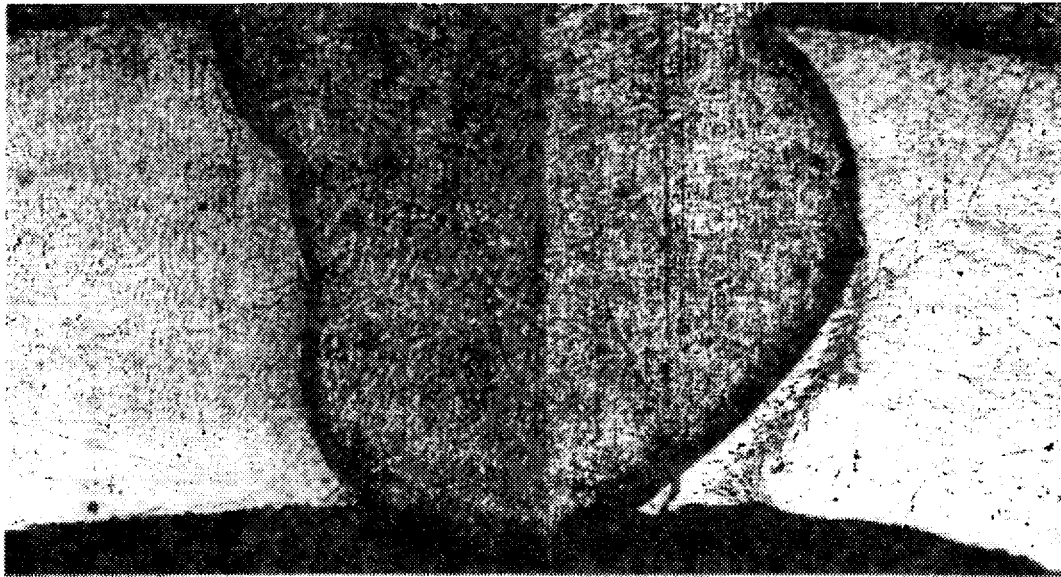
**Figure 7 Cladding defect**

All types of VVER-1000 cladding failures which caused the premature discharge of fuel assemblies can be referred to the interaction of fuel rods with solid foreign particles. Some fuel assemblies were found to have essential cladding failures that did not result in fuel rod unsealing (Fig. 7).

The examination results suggest that the VVER-1000 fuel spent at steady-state operating conditions up to 50 MWd/kgU of burnup is in satisfactory condition. The examination of all the types of the significant fuel cladding failures indicates that the reason lies in the interaction of cladding with coolant solid impurities. The nodular cladding corrosion of fuel assembly discharged from the South-
