STUK-B-YTO 154  
FEBRUARY 1997

# Operation of Finnish nuclear power plants

Quarterly report,  
3rd quarter 1996

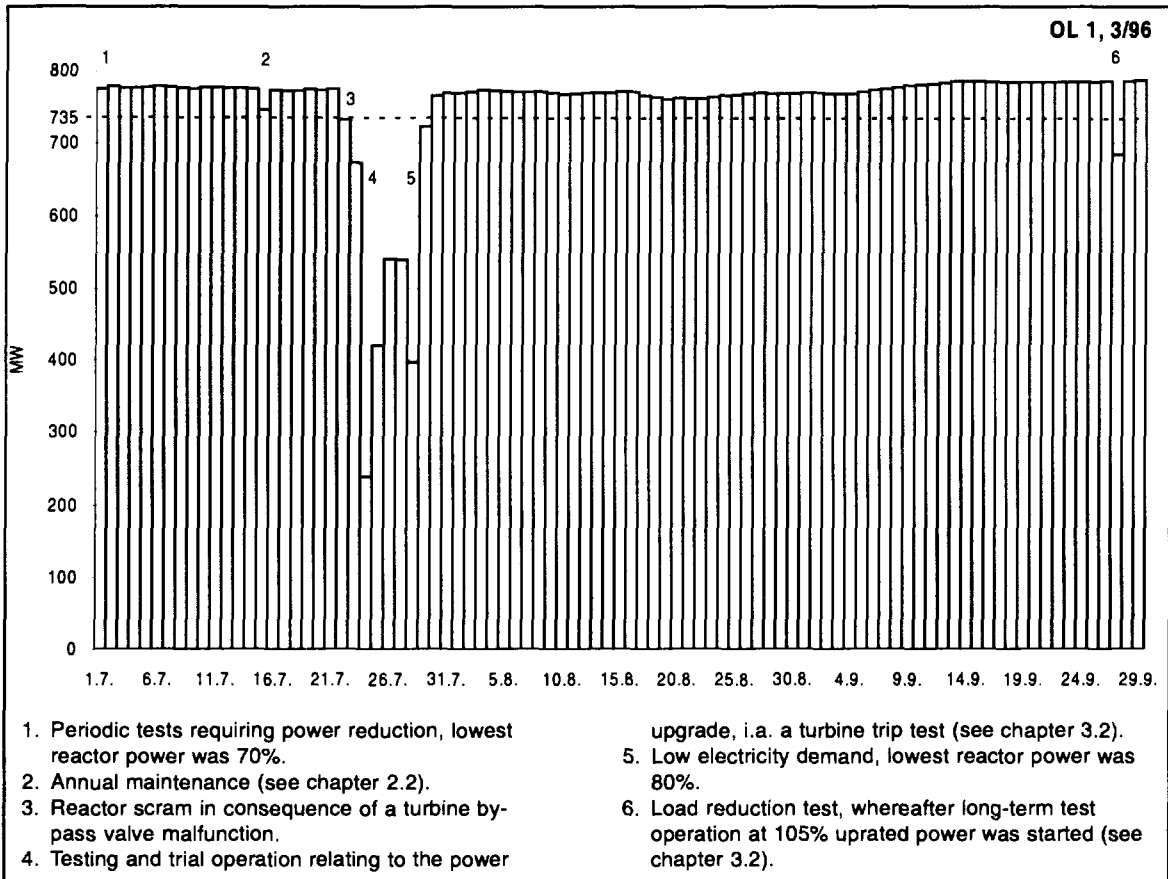
**Fig 3.** Daily average gross power of Olkiluoto 1 in July–September 1996.

One of four high pressure control valves closed for about a second on two successive days, 22 and 23 of July 1996, while the reactor was operating at 105% power. In consequence of the inadvertent closure, the reactor protection system reduced reactor power to about 62%. Valve adjustment and the control circuits were checked

but no reason was found for the valve closure of 22 July. However, after the event of 23 July, the reason was found to be a defective sealing of the control cable from the controller to the valve actuator. The defect caused a shortcut in the control circuit's switching connector which resulted in the valve's closure. Teollisuuden Voima Oy fixed the wiring of the switch case and checked the corresponding control cables and their connectors of three other control valves. These were found to be acceptable.

On 25 July 1996, at 85% reactor power, the same control valve abruptly closed again. Operation of the plant unit was continued and steam was directed to a high pressure turbine via three lines at 76% reactor power. The plant unit was shut down on 28 July 1996 to identify and repair the fault and to open the valve actuator. In the inspection, the cable of the position sensor of the control valve inside the actuator was found defective. The cable and its connectors were replaced and the valve operated acceptably in tests. The plant unit was connected to the national grid the same day.

The cables of the valve actuators are due for inspection by the utility at some appropriate time, not later than during the 1997 annual maintenance, however.

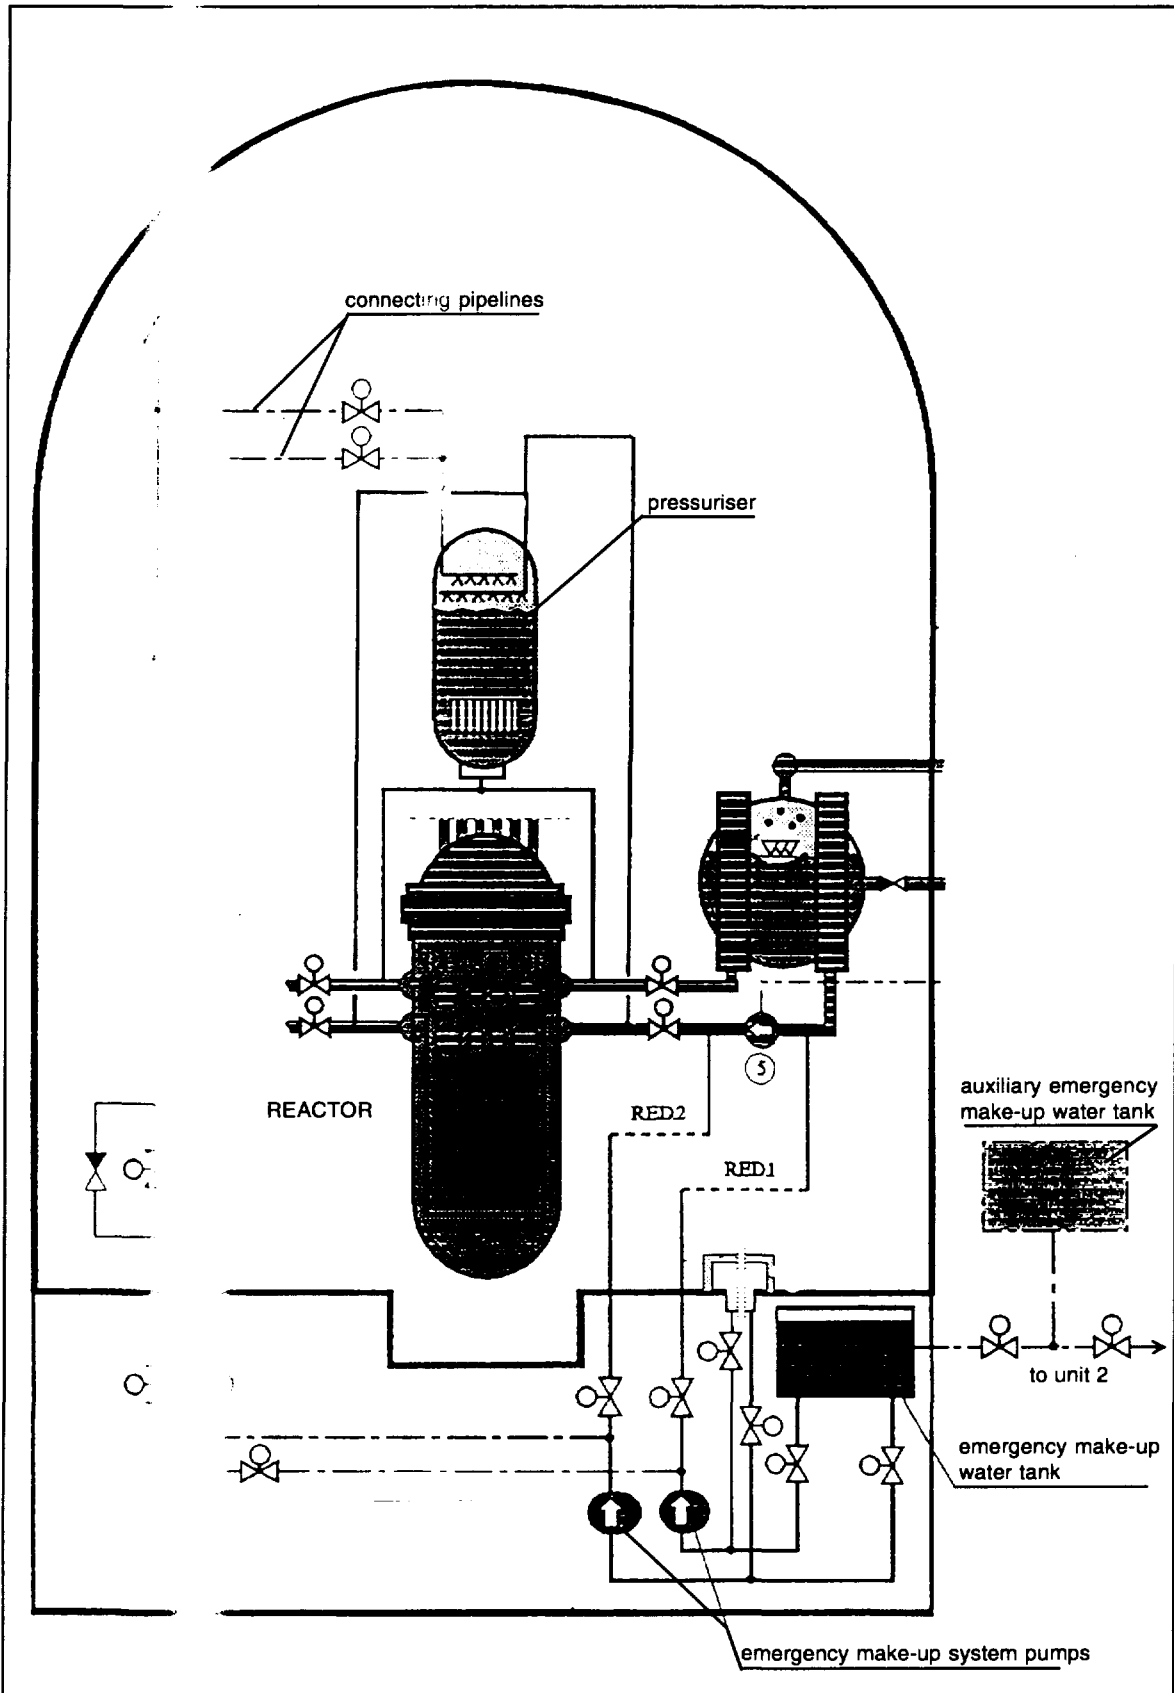
Figure 5. The pressuriser emergency spray system and the emergency make-up water tanks.

Pressuriser emergency spraying by the emergency make-up pumps was made possible by the installation of two connecting pipelines (fig. 5). This modification enhances primary circuit pressure reduction to minimise a potential leak and speeds up reactor cooling. The installation was made during the Loviisa 1 annual maintenance. At Loviisa 2, the installation was made already in the 1994 annual maintenance.

A new auxiliary emergency make-up tank shared by the units and piping (fig. 5) were installed at the Loviisa plant units. This ensures supply of cooling water long enough to cool down the primary circuit to cold unpressurised state even if water is lost to outside the containment building in consequence of a primary to secondary leak in the steam generator and a stuck-open secondary circuit safety valve.
