EXPERIENCE ON RELIABILITY OF INSERTION OF CONTROL ROD WITH PWRs IN JAPAN

H. Nakata

Nuclear Power Engineering Corporation, Tokyo, Japan

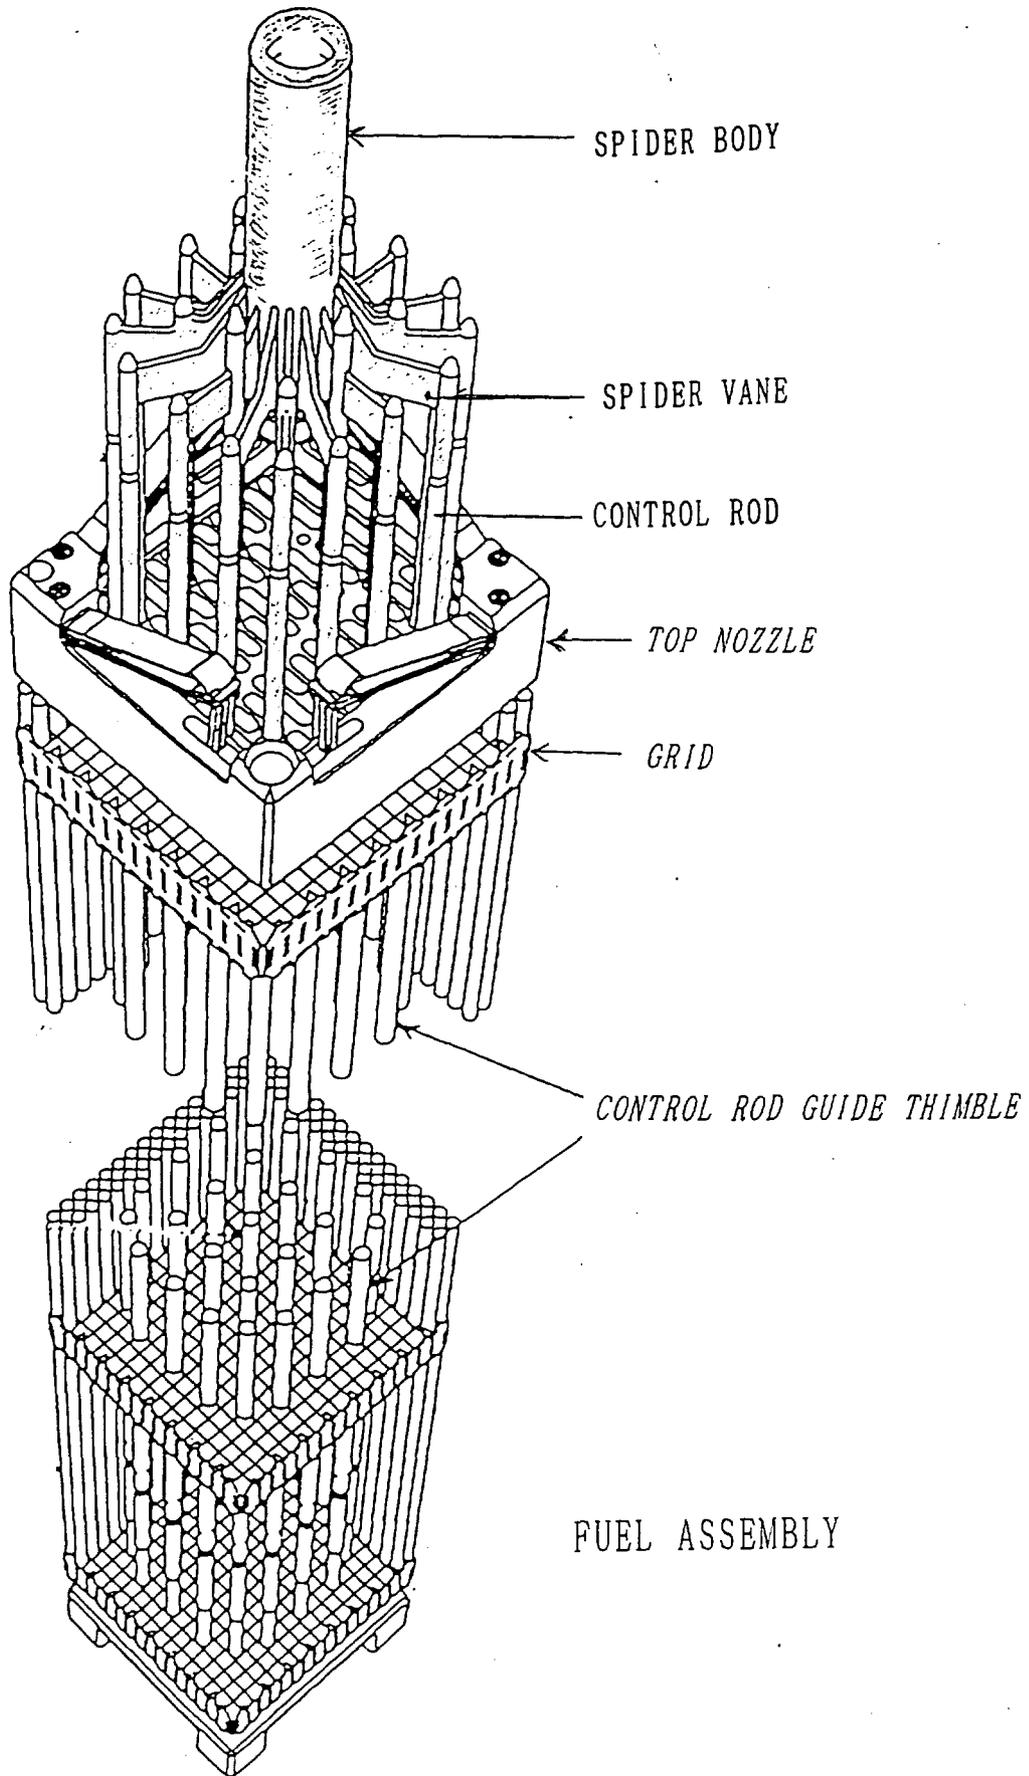
Fig-1 FUEL ASSEMBLY AND CONTROL ROD CLUSTER

- 1) There was a case in 1985, that the spider vane and spider body of a control rod cluster was separated at the blezed (soldered) joint.

During shutdown operation, any particular behaviour of the control rod movement was not recognized. (Fig-1)

After removing the Reactor Vessel Head, the upper part of the fuel assembly was inspected visually prior to the refueling operation. Inspection revealed that one of the spider vane was separated from the spider body.

The defective part was investigated, and any dimensional defect was not identified in any part of the vane, and the fracture surface between the spider body and the vane indicated that some excessive force would had been applied to the vane to body joint.

It could be considered that an excessive force which separated the vane to body joint was caused by to the interference between Control Rod and Guide Tube by invasion of some foreign material between them.

The dismantled spider vane with two control rods, found on the top nozzle of the fuel, was stored properly in the fuel control rod guide thimble, and insertion of the control rod cluster was not affected, fortunately.

For Item 2 above, inspection and control of foreign material or loose parts are more strictly implemented. Even though the quality of the joint between the spider vane and spider body was not attributed to the problem, recent manufacture of spider body eliminates the blazed joints by applying precision casting or wire cut from the forging.
