CNIC-01143

蒸汽发生器二次侧清洁度检查的现场经验

FIELD EXPERIENCE OF CLEANLINESS INSPECTION FOR  
SECONDARY-SIDE IN PWR STEAM GENERATORS

# **Field Experience of Cleanliness Inspection for Secondary-side in PWR Steam Generators**

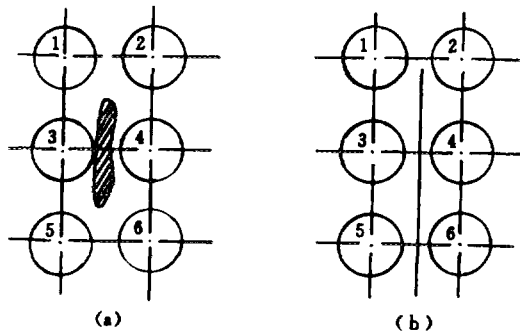
Fig. 5 Loose foreign objects

Usually we define foreign objects as any objects that geometry is larger than 5 mm (i. e. about half distance between two tubes). These scattered foreign objects on tubesheet are manufactured and installed residuums (that is to say grinding and welding residue, metal particles, welding rod etc. ), loose parts, bodies from system, sludge deposits etc. One vacuum cleaner and four special tools are used to do it. The foreign objects in the outer tube lane and central tube lane must be removed. Cleaner is supplied with compressed air. Four special tools include alligator forceps, snare, retrieval magnet, four-prong retrieval. Foreign objects removal is carried out under video monitoring. Place the grappling tool or vacuum cleaner as close as possible to the foreign object to be removed. Open tool jaws and grapple the object once in touch with the object, remove it (use vacuum cleaner to remove it, if it is possible). All removed foreign objects will be localized and photographed. Foreign objects between tubes include two kinds: the loose objects and wedged objects (see Fig. 5 and Fig. 6). The loose objects can move freely between the tubes. When cleaning with high-pressure jet, high-speed water will carry them to somewhere, or they may damage heat transfer tubes. The wedged objects are mainly grapping within two or more tubes. They may also damage the tubes.

(a) welding sludge;

(b) metal wire.

After an unsuccessful attempt of removal, a loose part may be left in place. However, at the next shutdown, ensure it is no longer in its original position and retrieve it from its new location.

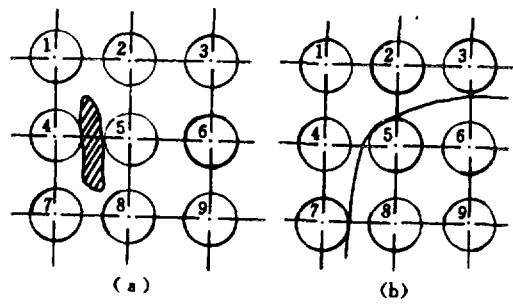
Fig. 6 Wedged foreign objects

(a) welding sludge;

(b) metal wire.

After an attempt of removing a wedged object, the following should be carried out:

- If the attempt was successful, the tubes that were in contact with the object, together with adjacent tubes, should be eddy current tested.
- If it cannot be removed, it may be left in place and its presence shall be checked after scheduled shut down, and together contact tubes, should be eddy current tested.

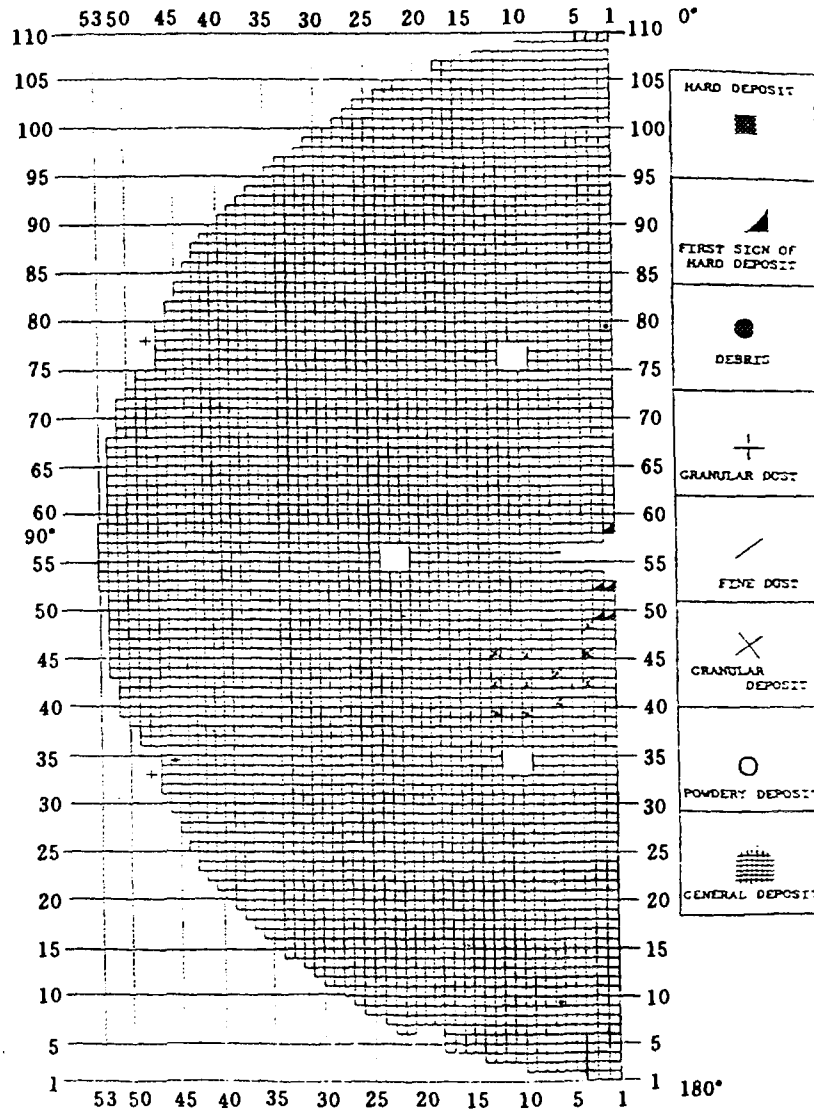
Fig. 7

Three foreign objects were discovered in outer tube lane. They were removed by grapping tool. They are: metal wire (Line 33~34, Column 13~14 hot side), welding slag (Line 20~21, Column 6~7 hot side) and metal scrap in outer lane (cold side, Line 13~14, Column 2~3).

lane. Hard deposit was discovered in hot side of central tube lane.

The hard deposit and first sign of hard deposit were discovered in central part of the intertube area and each side of central tube lane. According to the distribution of dust deposit, the conclusion is: They exist in each side of central tube lane, they exist in hot side more than cold side. In hot side the highest dust deposit should appear at Line 6~8, Column 57~62.

A few dust deposit remain in inter-tube area. The lancing is efficient. It conform to the cleanliness standard. Some hard deposit and first sign of hard deposit can not be removed by lancing. Some different kind of foreign objects and dust remain in the tube sheet.

According to the procedure, four foreign objects were discovered ( $\geq 5$  mm) in

hot side, none in cold side. One is metal wire and others are weld slag. The weld slag (Line 1~2, Column 7~8) is removed. Other remain in the SG due to no suitable grapping tool. We consider the metal wire (Line 9~10, Column 53) can not hurt the tube because it is very light. The weld slag may hit its nearest tube in the S. G. operation.

The whole process include the reinspection of two metal foreign objects remained in the S. G. discovered during last periodic inspection. Their positions are Line 33~34, Column 23~24 cold side (metal scape), Line 24~25, Column 36~37 cold side (weld slag). We inspected two positions and its near area. None foreign objects was discovered. But one removed foreign object is very similar to the metal scrap in the Line 33~34, Column 23~24 of remain.

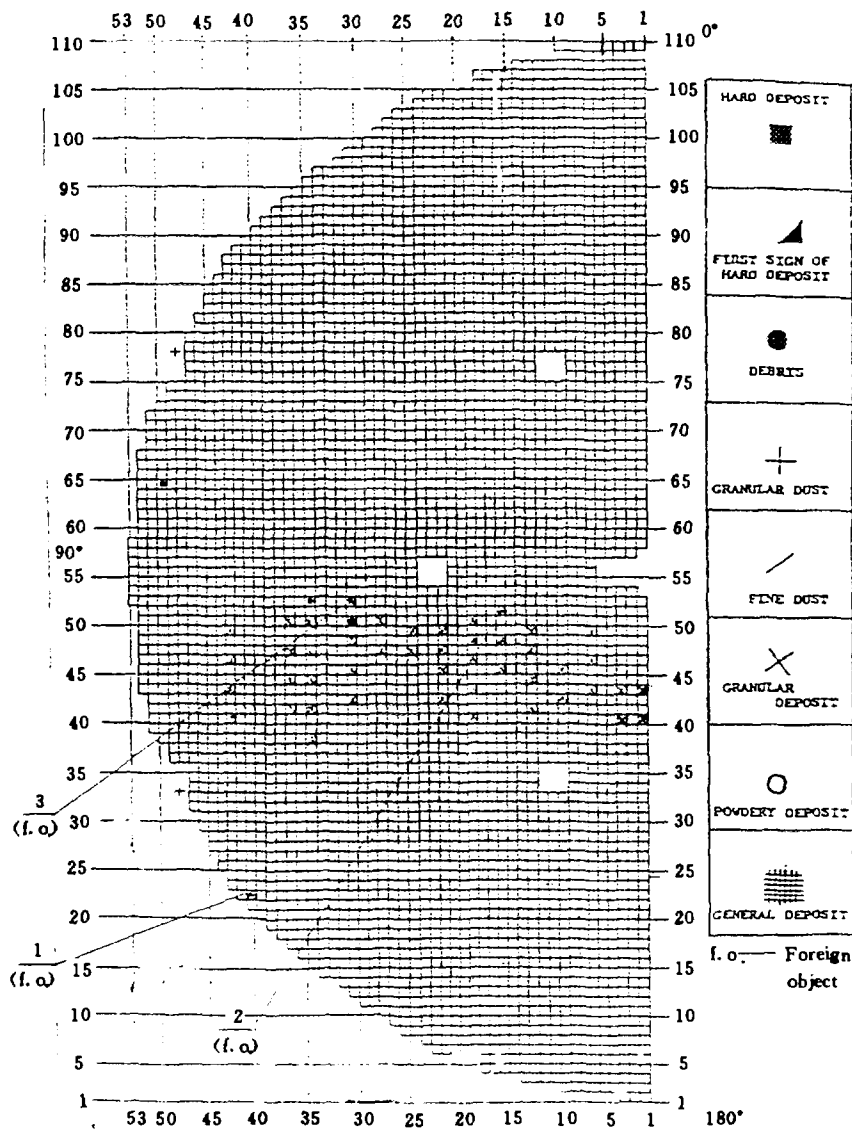
Fig. 9

The outer tube lane and the adjacent area. Both cold side and hot side were clean, but there were obvious sludge deposits near the tube, especially on the area of Column 1~20, Column 90~110. The sludge deposits were also found on the tube sheet under to 90 degree and 270 degree eyeholes, and the sludge deposits were removed with vacuum cleaner.

There were 2 foreign objects on the hot side, Line 52~53, Column 64 and Line 20~30, Column 10~11, they are both welding slag.

On the area of cold side Line 34~35, Column 14~15 found a metal scrap, it is about 45 mm long and 10 mm wide. The three foreign objects were removed with vacuum cleaner and grapping tools.

on some place and welding rod about 125 mm,  $\phi 2 \sim 3$  mm on the hot side Line 1~2, Column 59~64. It was so long that took 70 minutes to remove it out with grappling tools.

The hard deposit and first sign of hard deposit show that sludge deposits mainly distributed above the center on the hot side. It was estimated that the height of the most deposits left on tubes was over 30~40 mm. Across bridge was very seriously along the column, and the height was above 6 mm and  $\phi 6.1$  mm probe couldn't pass (as Line 6~7, Line 5~6, Line 4~5, Line 3~4). It was mainly relative with the operation time and the limitation of the mechanical lancing.

There were 3 foreign objects on cold side and 2 on hot side. Two of them was

removed. The one on cold side Line 40~41, Column 22~23 is an iron wire, 35 mm long. The other on hot side Line 36~37 is a weld wire, 210 mm long. The three foreign objects couldn't removed because of their place and without suitable tool.

Inspectors checked two metal objects discovered during first outage inspection. They are a metal scrap on Line 42~43, Column 58~59 and a welding rod 54 mm long, on Line 30~32, Column 33~34. Now they don't be there. But the one removed from cold side outer tube lane Line 34~35, Column 14~15 is very like the metal scrap on shape, can be considered being the same one.

Video tape judgement of intertube area inspection: The sludge deposit in 002GV is worse (special in hot side). Although the local height of sludge is over 10 mm, to the whole tubesheet cleanliness of 2RCP002GV is still up to standard con-

sidering the limitation of criterion. Three discovered foreign objects have not been taken out. We suggest that to do ET inspection to their adjacent tubes and to check their position in next refuel duration are necessary.

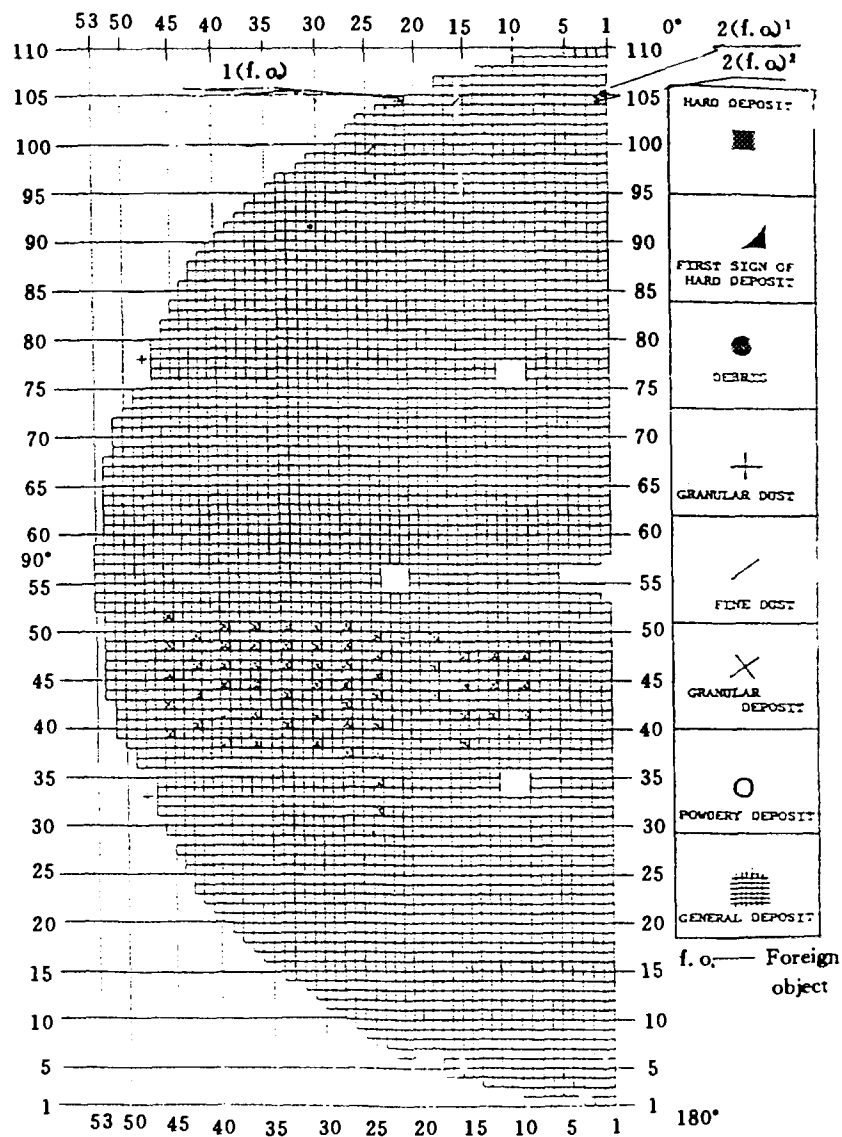
Fig. 11

Two foreign objects (both welding slag) were found in outer tube lane. Fine dust existed near 0 degree and 180 degree handholes. This fine dust had been removed by vacuum cleaner.

Fine dust also was found in central tube lane. The deposit mark of hard deposit can be seen on hot side. No foreign object was found.

During one-third intertube inspection, hard deposit and first sign of hard deposit were found on tubes and tube sheet. From these phenomena, we can conclude that sludge deposit area on SG tubesheet lie in hot side center of tube sheet, and the height of deposit may be more than 40 mm. In the direction of column, across bridge was serious, and the width of bridge was so small that the  $\phi 6.1$  mm probe can not pass.

Sludge agglomerates were also distributed on tubesheet (e. g. hot side Line 24~25, Column 78). These sludge agglomerates being compact and solid in texture may be damage to the tube.

Nine foreign objects among which 3 distributed on cold side and 6 on hot side were discovered during one-third intertube inspection. One in cold side and three on hot side were taken out. Two on cold side and three on hot side were still remained on tube sheet because of their inaccessibility. Among these remainder there were 4

welding slag and 1 sludge agglomerate. Being hard and sharp, they should be monitored although they are not metallic foreign objects.

Conclusion: Although hard deposit existed and height of hard deposit in some local place exceeded 40 mm, the sludge remaining on tubesheet was less. If we can conduct periodic lancing to steam generator, the increase rate of hard deposit will be small and the life of steam generator can be prolonged. Of course, it is necessary, to monitor the tubes in sludge area (e. g. Eddy Current Inspection).
