**DARLINGTON NGD FUEL HANDLING  
HEAD EIGHT ACCEPTANCE PROGRAM**

**P.H. SKELTON (DNGD)  
T. SIE (DNGD)  
J. PILGRIM (GE-CANADA)**

**ABSTRACT**

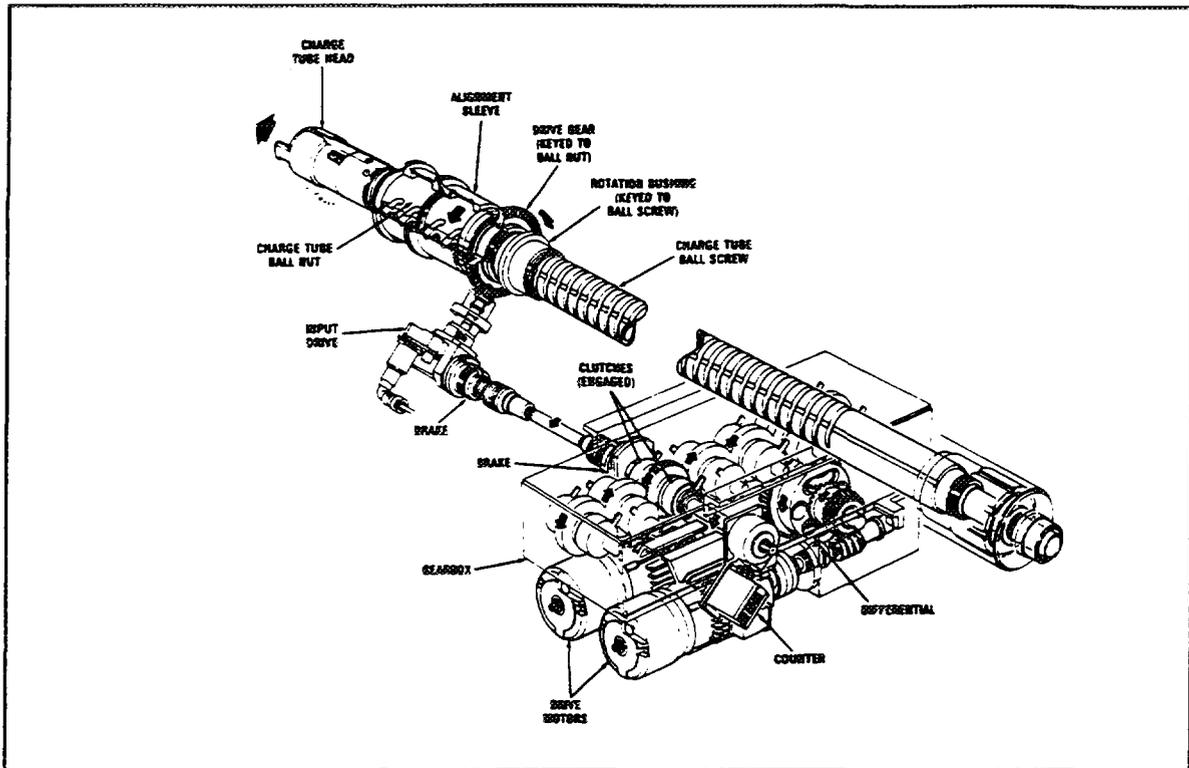
Figure 3: Schematic of Darlington Fuelling Machine Charge Tube Drive Mechanism.

Ontario Hydro Technology was contracted to perform a series of tests on Head 8. Accelerometer probes were located at several points along the outer housing of the charge tube axial drive (see figure 3<sup>(1)</sup>). Torque profiles were also generated. A series of thirty two tests were completed. Sixteen of the tests were in advance mode and sixteen were in retract mode. These tests were completed under several different conditions including:

The testing did appear to indicate that the higher than expected torques were caused by either pitch/thread depth variations from the front to the back of the screw or pre-loading on the ballnut. In addition, there was evidence of double contact with the balls on the screw thread. This double contact indicated that there was some imperfection in the screw thread profile.

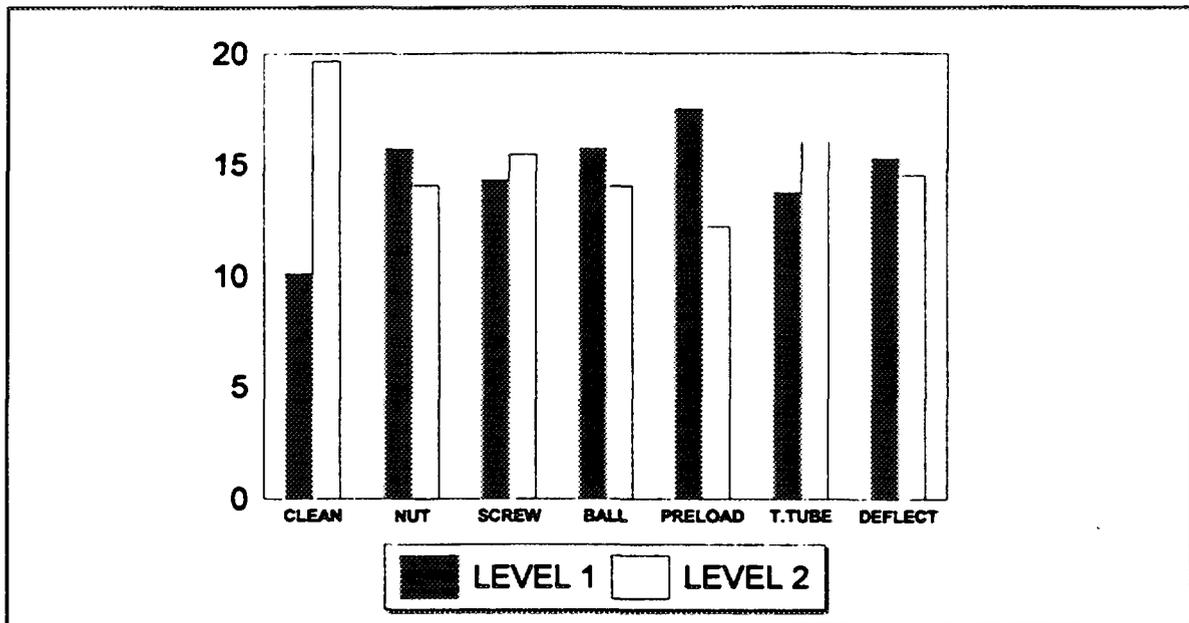
Figure 4: Result of Experiments to Determine Which Major Variable(s) Affect Ballnut/Screw Performance.

Results of this testing are shown in figure 4. Two parameters appeared to predominate, screw pre-load and rig cleanliness (crud).

Head 8 was then re-built. The pre-load on the screw was reduced from the normal level of 600lbs down to 100lbs. Efforts were undertaken to ensure that the test rig was as clean as possible. The rig was run for several days with purification flows maximized, As much crud as possible was removed from the rig.
