APPLICATION OF NON-DESTRUCTIVE TESTING AND
IN-SERVICE INSPECTIONS TO RESEARCH REACTORS AND
PREPARATION OF ISI PROGRAMME AND MANUAL FOR
WWR-C RESEARCH REACTORS

BY
MOHAMED KHATTAB

1996
INFORMATION CENTER
ATOMIC ENERGY POST OFFICE
CAIRO, A.R.E.

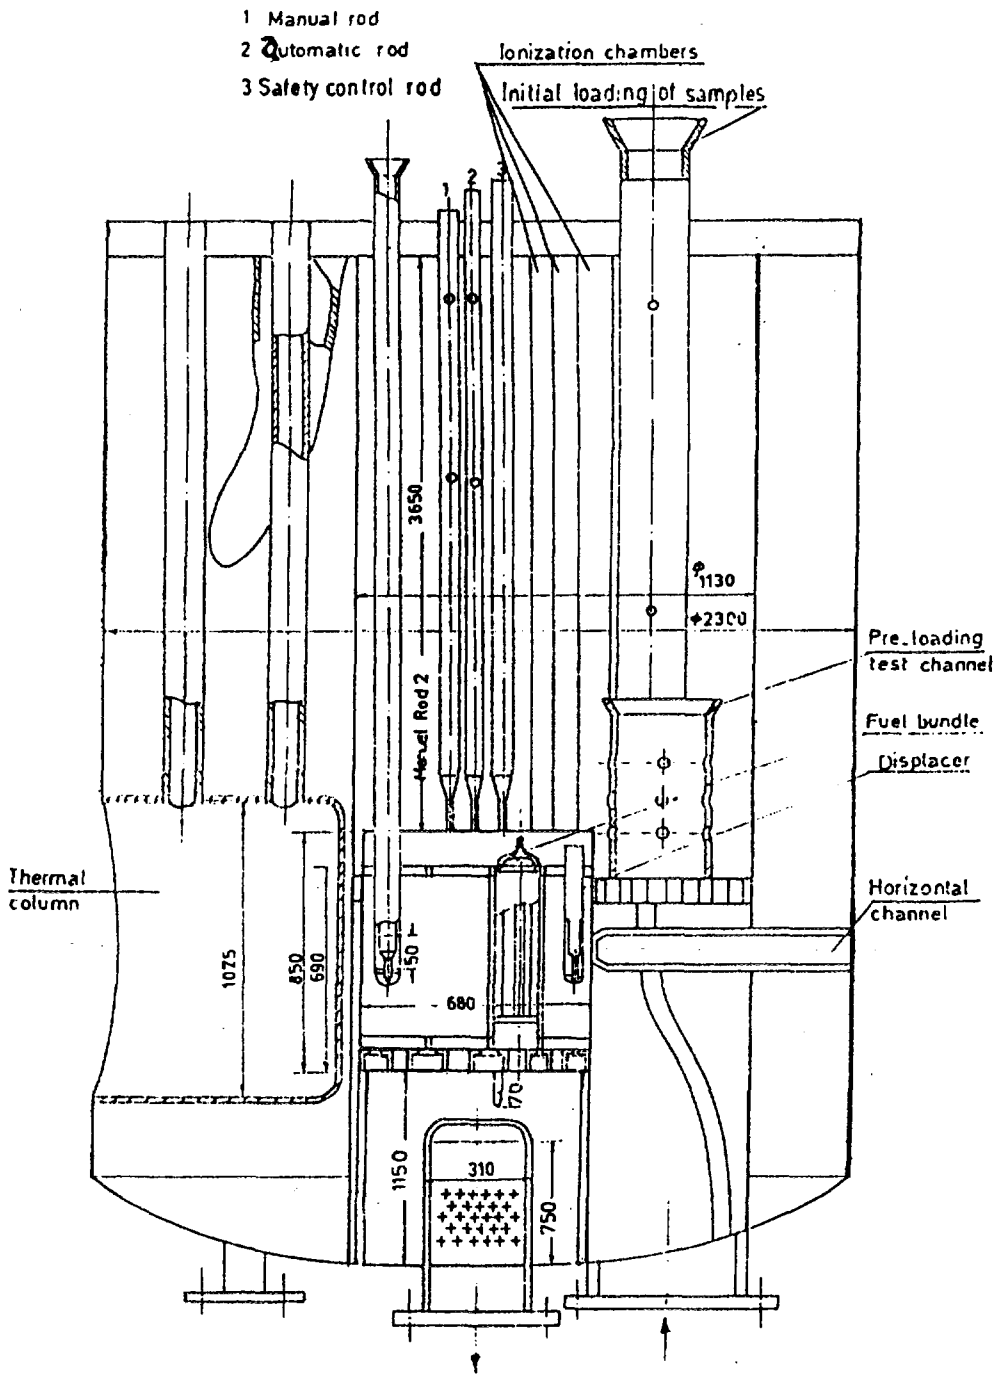
Fig.1. Reactor Construction

The most representative sites of the reactor vessel are end caps of the horizontal channels, where the fluence is the highest, and the core support grid, where mechanical stresses develop and, at the same time, irradiation affects noticeably the metal properties, Fig.1. The mechanical properties of CAB-1 suffer degradation as a result of production in the alloy of nuclear reaction products in interaction with thermal and fast neutrons, and radiation defect generation in the material. The stresses in the horizontal channel end cap are governed by thermal stresses. The high thermal conductivity of the material and small wall thickness (13 mm) provide an upper estimate for the total equivalent stress of 1 kg/mm^2 . The sudden brittle fracture cannot occur in the horizontal channel because of the low acting stresses.

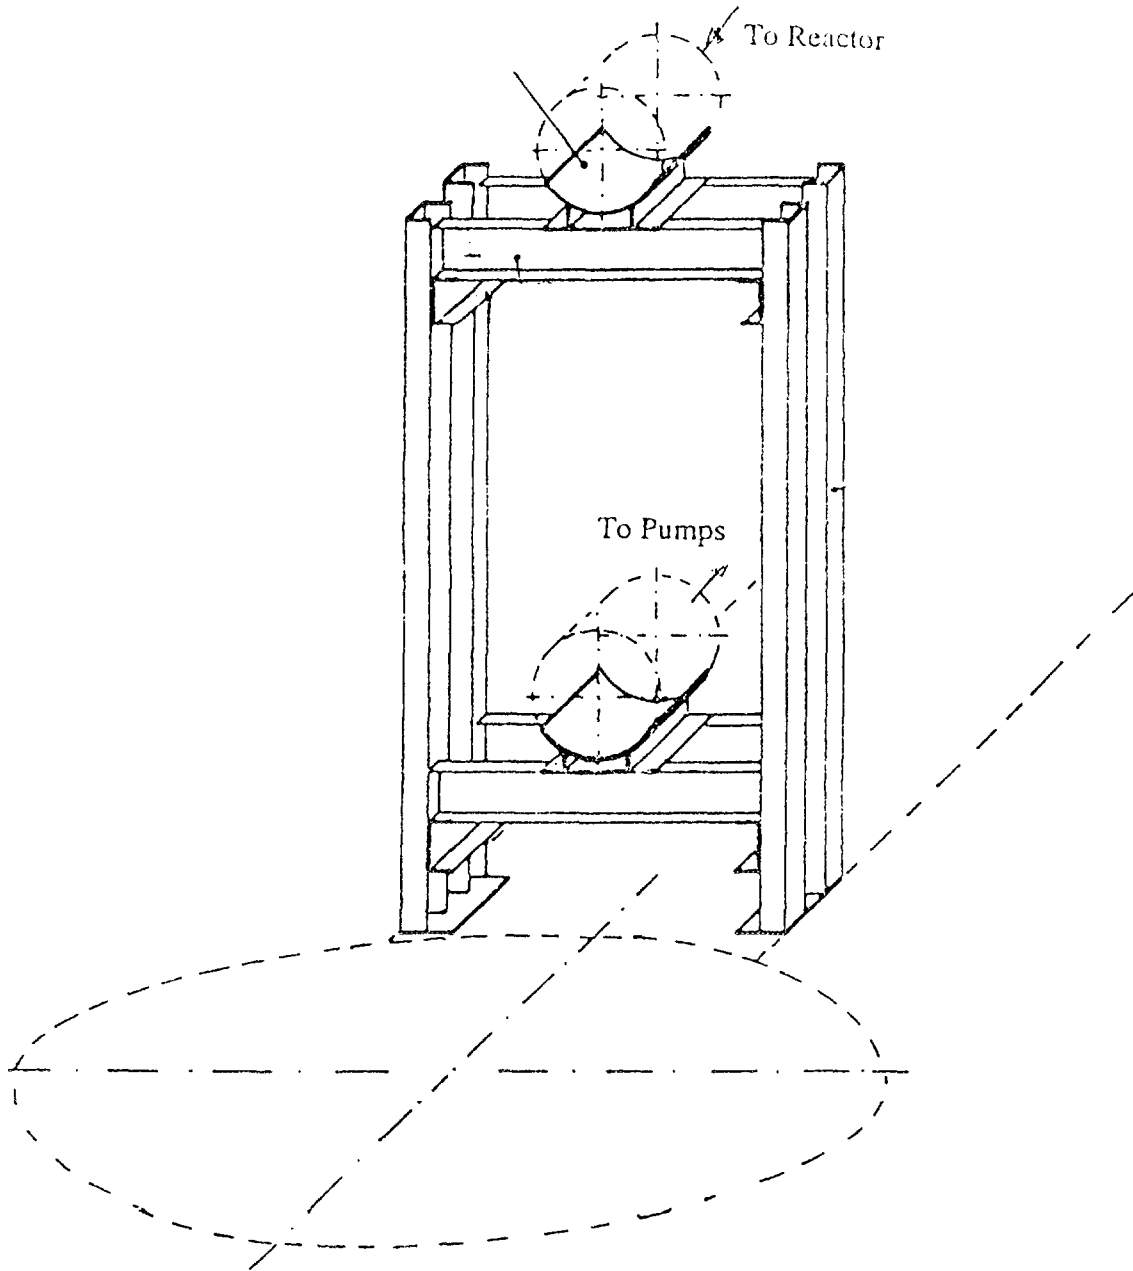
Fig.3. Emergency Support of Primary Circuit

the core. These joints are situated under the reactor, in an area which is accessible only for short periods of time due to high intensity of gamma radiation. In EWA reactor, emergency support of PCS was installed under the most critical joints to minimize the gap estrangement in case of sudden drop of the pipes connection under reactor vessel. The studies showed that beginning of fuel exposing takes about 8 seconds in the case of LOCA without the emergency support, and 400 seconds after installing it. Gap measurement probe was introduced to presage with the emergency state, Figs.(2-7). Thermal hydraulic studies were undertaken to determine the possible course of a reactor accident after break of these joints. The studies comprised analyses of heat removal from a fuel element. The upgraded reactors have provided with emergency core cooling system (ECCS). This system is controlled by electromagnetic valves supplied from emergency electric power sources. The valves would open due to spring and gravity forces whenever the electric power is lost. Two out of three monitoring system for water level and pressure measurements were installed, providing an activation signal for valves opening in case of a LOCA.[4].

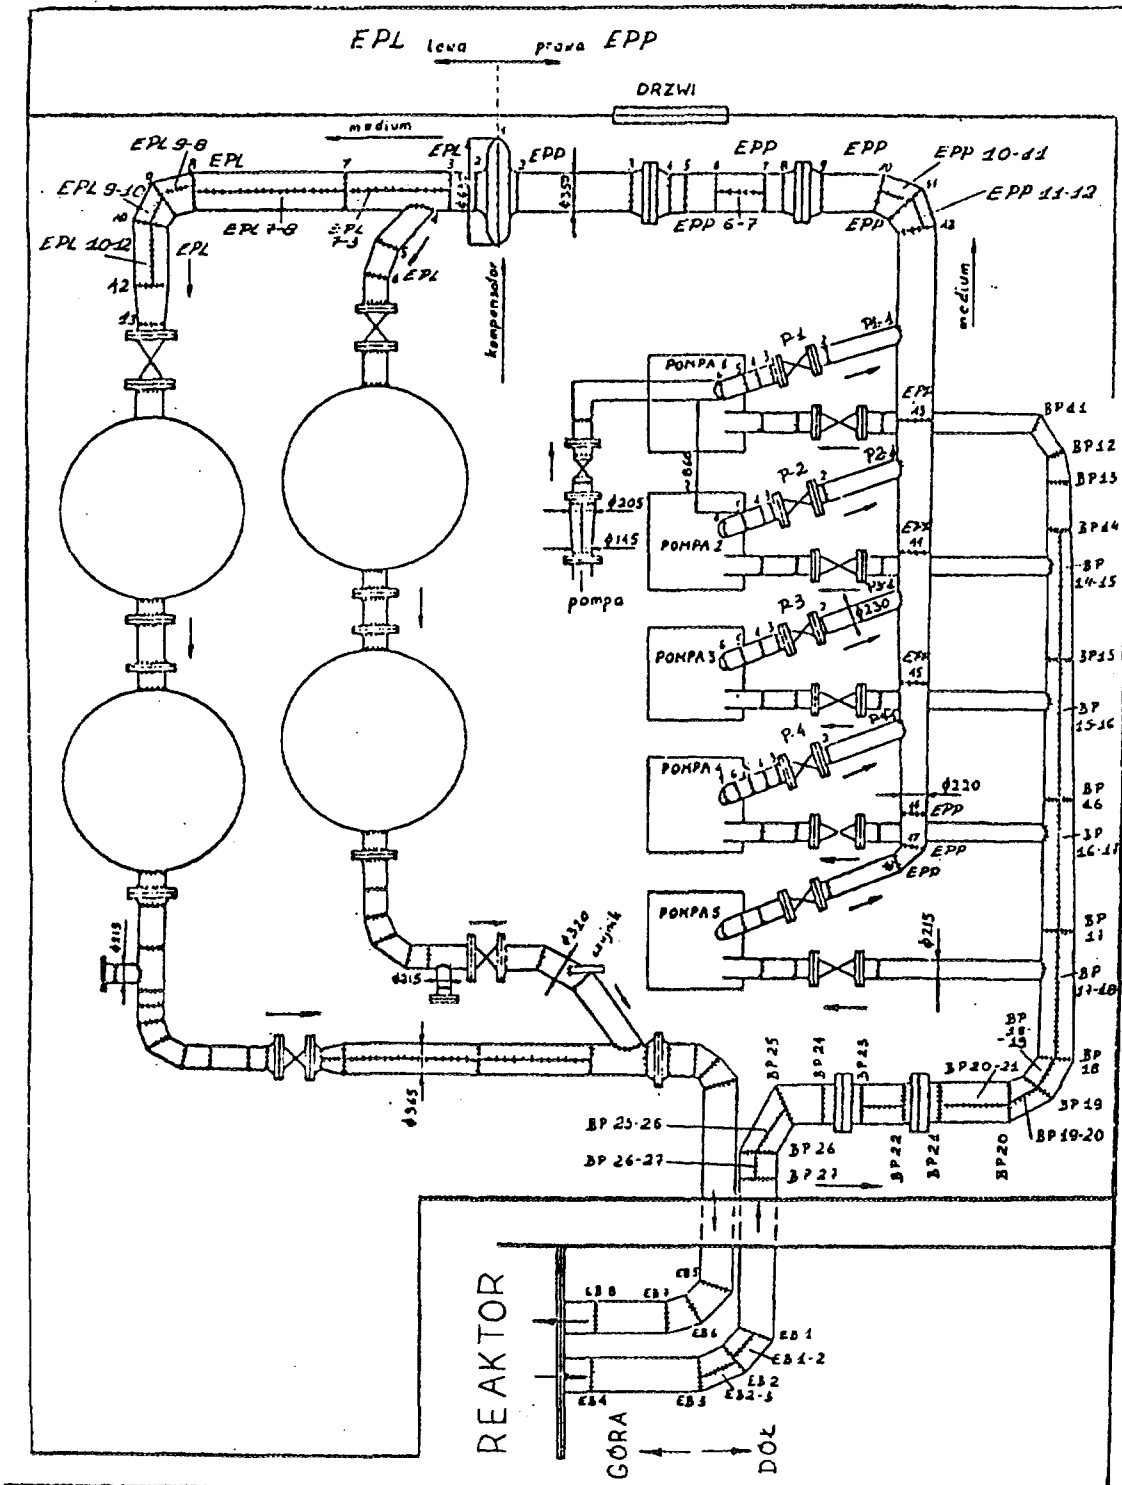
Fig.8. Welded Joints in Primary Cooling Circuit of EWA Reactor

The initial radiographic testing performed in the PCS of EWA reactor in 1975, i.e. after 17 years of reactor operation, showed poor quality of welded joints,[4]. Therefore, it was decided to undertake regular testing of all welded joints in the PCS. A summary of inservice inspections is shown in table 1. The results of PCS testing are contained in 13 reports of about 1000 pages volume. No crack propagation has been detected. The weakening of the weld area was minor, especially in view of low pressures and large wall thickness. However, the defects were too large for a responsible weld of a nuclear reactor. Subsequent controls over 12 years have not shown any crack propagation and the reactor has been safely operated throughout this time, Fig.8.
