GENTILLY 2 DIVIDER PLATE REPLACEMENT

J. Forest
Hydro Quebec

E. Kiisel/G. McClellan/W. Schneider
Babcock & Wilcox, Cambridge, Ontario

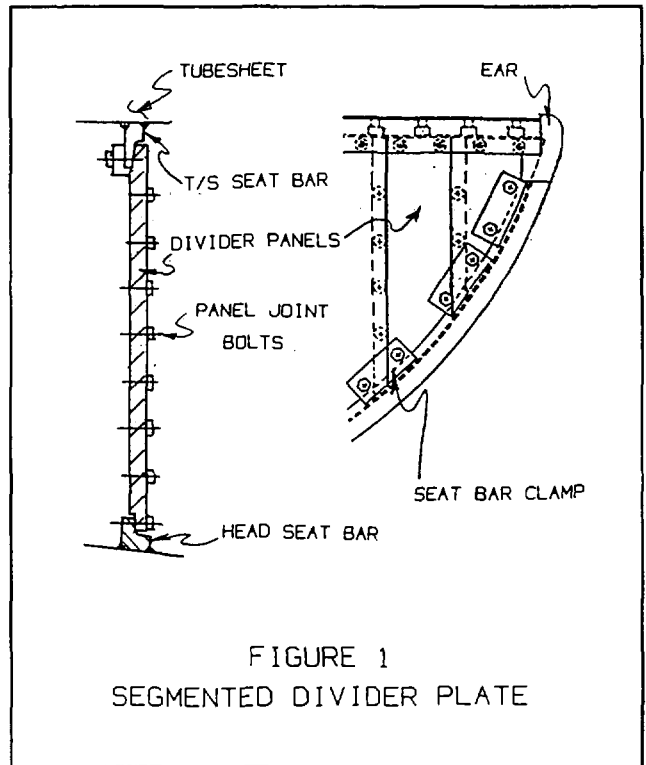
FIGURE 1
SEGMENTED DIVIDER PLATE

The original divider plate construction for the Gentilly 2 steam generators incorporated a number of 1½ inch thick vertical panels supported by peripheral seat bars as shown in Figure 1. The divider assembly was of a floating configuration in which the segmented panels rested on the seat bars at their periphery in such a way that the dilation of the pressure vessel during changes in operating temperature and pressure were accommodated by sliding of the floating divider relative to the seat bars. The divider panels were attached to each other by a lap joint secured by a number of bolts. The lower edge of the floating divider was supported by a seat bar which was partial penetration welded to the primary head. The lap joint between the divider panels and the primary head seat bar was clamped by clamping blocks. The upper edges of the divider panels were bolted to a seat bar which was bolted to the tubesheet. At the outer corners of the divider in the space bounded by the end of the tubesheet seat bar, the head seat bar and the divider panels, a space exists which is filled with filler blocks which are called "ears" because of their shape. The ears were affixed to the outer-most divider panels. The divider plates were designed as segmented panels in order to meet the specified requirement that they be removable. Their design function was to partition the steam generator primary head so that the primary flow was directed from the inlet side of the head, through the tubes to the outlet side – a process involving a pressure drop of approximately 35 psi.

During a routine inspection in September 1993, it was discovered that two of the divider panel joint bolts were missing. One was discovered lying in the

head and the second some distance down the primary piping. It appeared that the bolts which tend to be held in place by the flow had simply popped out at some time during the shutdown or during the subsequent waterjet decontamination process. Further examination showed that a number of the divider panel joint bolts had experienced erosion to the underside of the bolt head, to the shank of the bolt and even to engaged threads. The divider plate components of all four steam generators experienced this type of damage to some degree. The divider panel to tubesheet seat bar bolts experienced a similar type of damage. The clamping block and tubesheet seat bar bolts were relatively unaffected. After further inspection, it was determined that 9, 12, 20, and 7 bolts had to be replaced on SG's #1, 2, 3 and 4 respectively. On return to operation, it was noted that surprisingly the performance of the steam generators improved by a small but significant amount and that the amount of improvement happened to be consistent with the number of bolts which had been replaced in the respective steam generators – reinforcing the feeling that divider leakage may have been more significant than previously assumed.

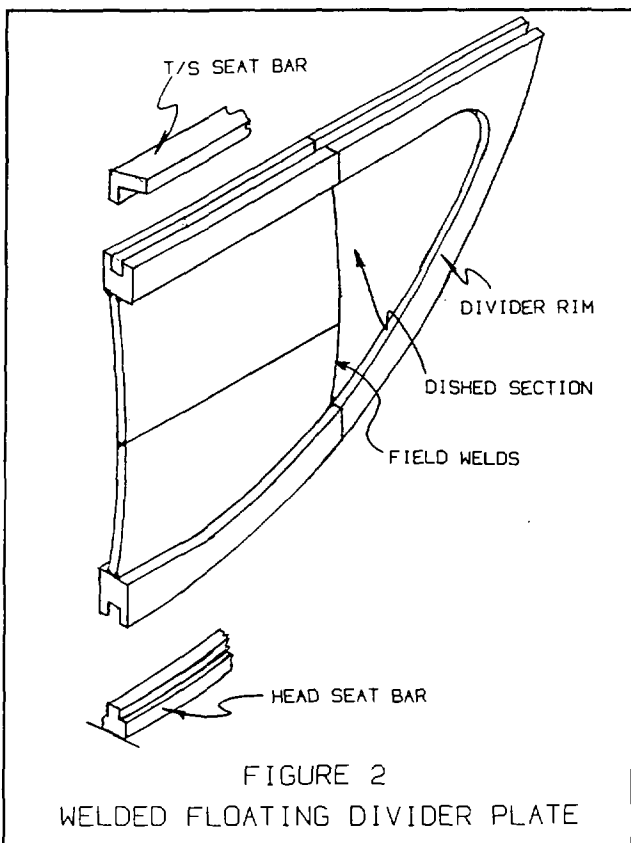
eral rim. The dish shaped section allowed for a higher load bearing capability with greatly reduced weight and field welding requirements. The features of the floating divider shown in Figure 2 include:

- A one piece floating welded divider incorporating a thin dished central section within a heavy peripheral rim.
- 3/4 inch thickness to minimize weight and welding.
- The divider is fabricated in four segments which are manipulated into the primary head for final assembly.
- The divider incorporates a continuous peripheral tongue and groove support and seal configuration.
- A new tubesheet seat bar welded to the tubesheet weld overlay.
- Ears integral with the new tubesheet seat bar which fill the corner spaces and create an essentially continuous seat bar for the entire periphery of the divider.
- Erosion resistant material for the new tubesheet seat bar, for weld buildup on the sealing faces of the divider, and for a head seat bar liner to preclude further erosion.
- Tight fitup tolerances at seal locations to minimize leakage.

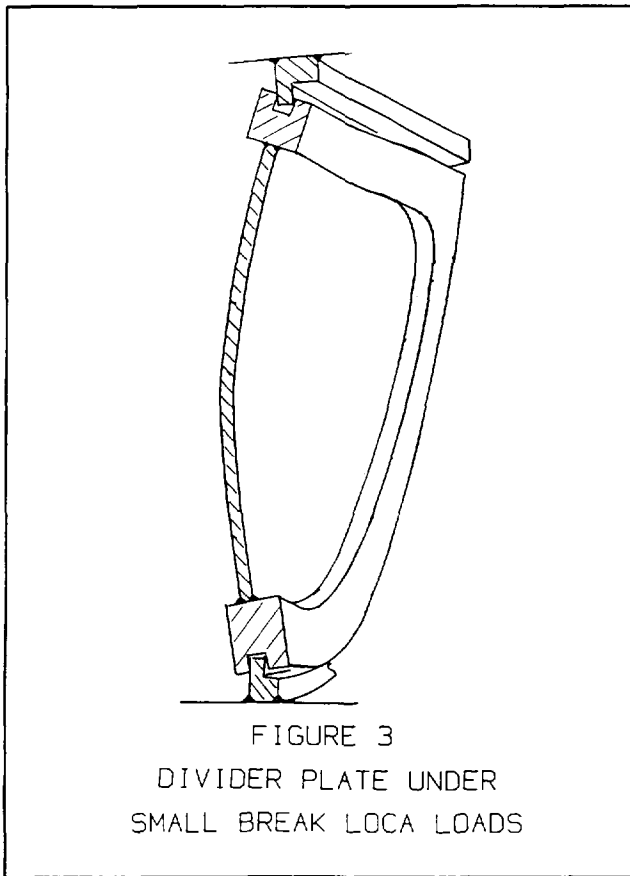
FIGURE 3
DIVIDER PLATE UNDER
SMALL BREAK LOCA LOADS

To address the LOCA loads, a large number of pipe break/divider plate condition cases were identified and modelled by Hydro Quebec. Response of the dividers to these various load cases was evaluated for B&W by Ontario Hydro using a dynamic, elastic/plastic finite element analysis. The results of the analysis have shown that the divider is able to sustain small breaks (5% and 7½% break sizes) with significant distortion but without any disengagement of the divider from the seat bar. For the purpose of modelling LOCA flow conditions, this allows the divider to be considered totally intact. The response of the divider to a small break LOCA is shown in Figure 3.

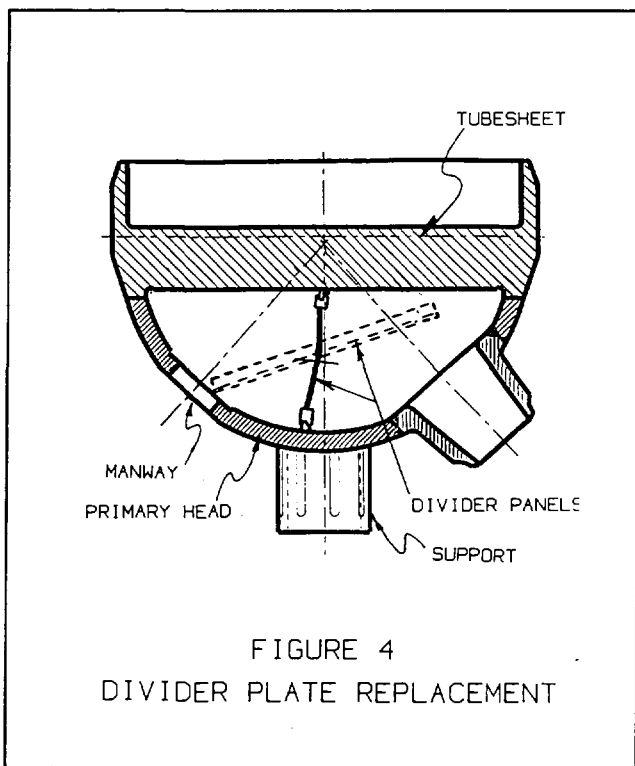
Field installation of the replacement divider plates - shown in Figure 4 - was a major operation involving installation of this first-of-a-kind design in a retrofit situation in a difficult access, high radiation environment. A major consideration in determining the fea-
