PICKERING UNIT 1 CHEMICAL CLEANING

ABSTRACT

CANDU MAINTENANCE CONFERENCE 1995

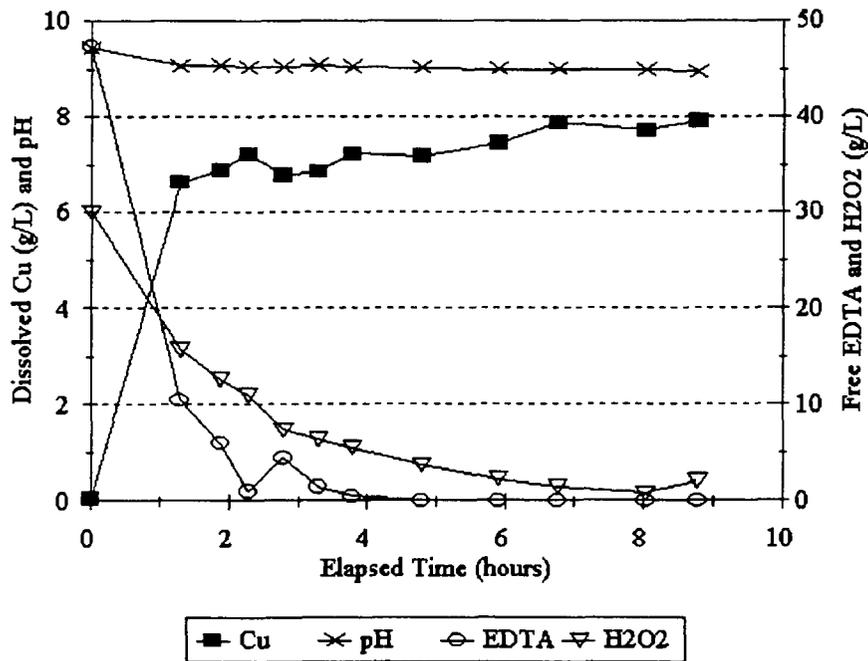
Figure 2
Chemical Parameters During Cu W-1

Copper removal steps were performed at essential ambient temperature although the temperature was allowed to rise to 100-115°F towards the end of the step to promote decomposition of residual hydrogen peroxide. Each copper step typically lasted about 10 hours. The maximum copper concentration obtained in the solvent was about 8g/L in the first copper step. The second and third copper steps had much lower concentrations. A graph of the major chemical parameters during Cu W-1 shown in Figure 2. All parameters followed the expected trends.

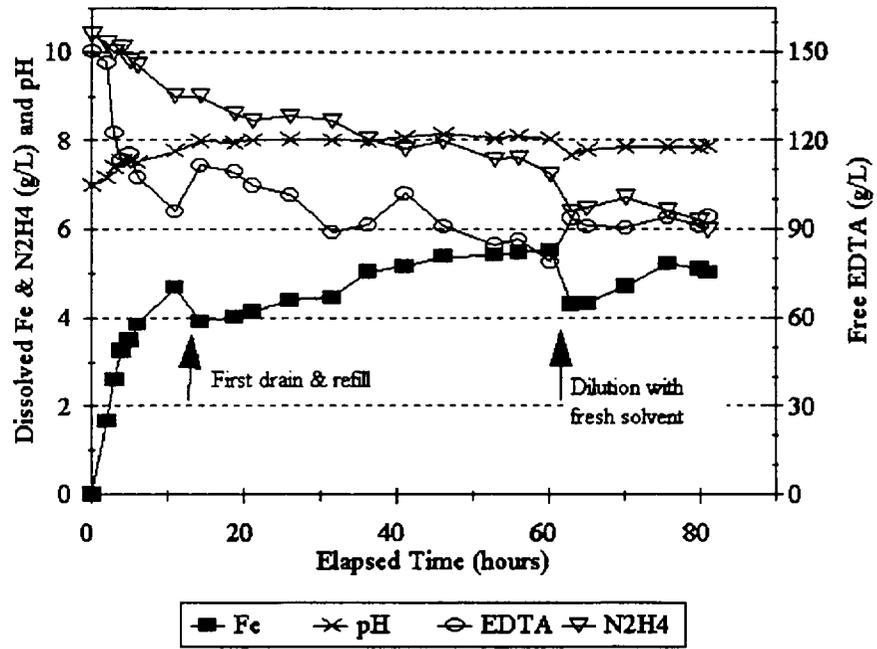
Figure 3
Chemical Parameters During Fe W-1

The iron removal step was performed at ~200°F. It lasted for approximately 80 hours. The maximum iron concentration obtained was about 6g/L. A graph of the major chemical parameters during Fe W-1 is shown in Figure 3. Again all parameters followed the expected trends.

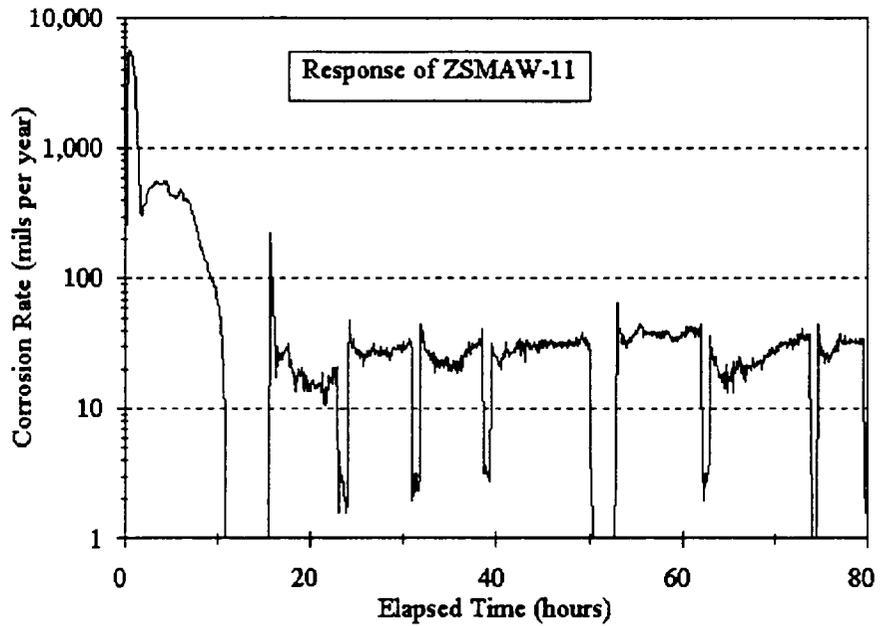
Figure 4
Typical Galvanic Corrosion Response During Fe W-1

A typical galvanic corrosion response during the magnetite dissolution step is shown in Figure 4. Note the initial peak of 6,000 mils per year (mpy) followed by a rapid drop to the steady state value of 50 mpy. The abrupt drops every 8 hours or so correspond to drain and refill operations which were performed periodically to preclude stagnant areas, or regions of localized solvent depletion within the boilers. Figure 5

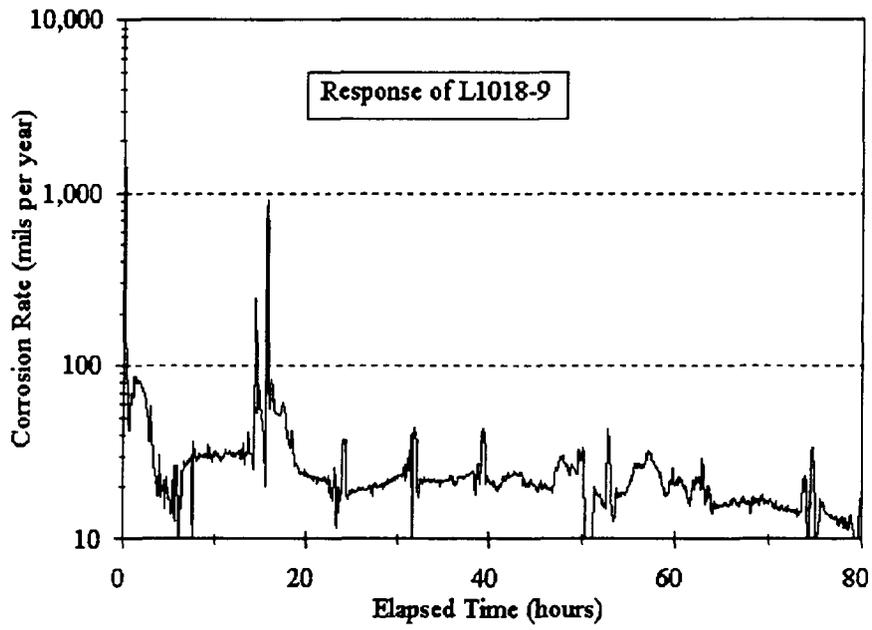
Figure 5
Typical Free Corrosion Response During Fe W-1

shows a typical free corrosion response during the magnetite step.

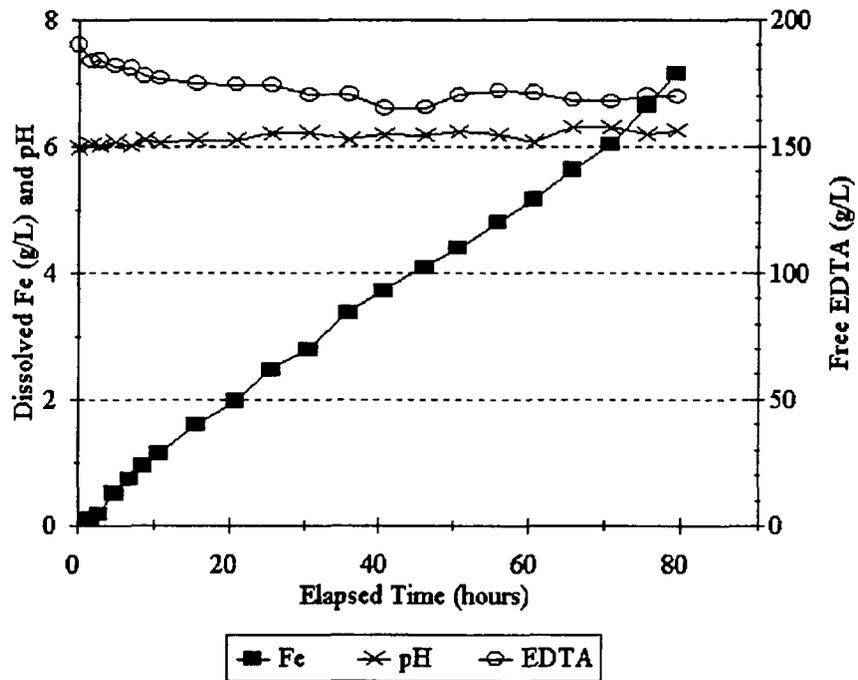
Figure 6
Chemical Parameters During Cre W-1

Following injection of the crevice solvent, the concentration of dissolved metals started to increase and the free EDTA started to decrease in a manner similar to that of the magnetite dissolution solvent. A graph of the major chemical parameters is shown in Figure 6. The apparent steep rise in dissolved iron concentration between hours 70 and 80 is mainly due to a concentration effect as a result of the ~60 gallons lost during each of the 9 vents. This effect was much less pronounced at higher elevations where the system volume was much larger. All chemical parameters remained within specification throughout the entire crevice cleaning step. No adjustments were necessary.
