UPGRADING PRIMARY HEAT TRANSPORT PUMP SEALS

CANDU MAINTENANCE CONFERENCE 1995

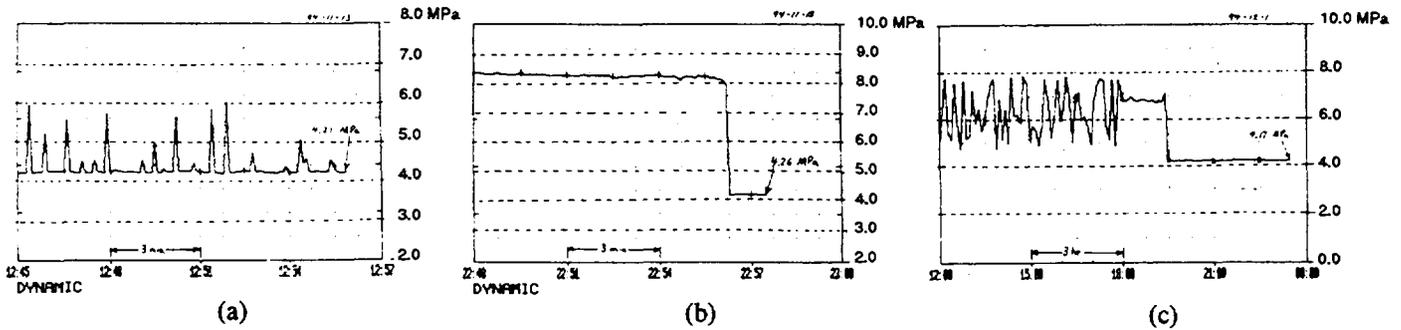
In mid-November, the CAN8 seal in Pump 2 of Unit 3 began to exhibit sporadic “spiking” in interseal pressure, accompanied by no other appreciable changes in seal operating parameters (see Fig. 2). Normal interseal pressure at the time was 4.3 MPa. During “spiking” the interseal pressure would rise suddenly, in less than 6 s, to between 5 MPa and 8.8 MPa, and remain at the higher pressure for a random period of time before returning just as rapidly to normal. The periods of high interseal pressure ranged from less than 6 s to several hours in duration. This “spiking” would disappear for several days, and in at least one case for a couple of weeks, before recurring without any discernible initiating event. Note that this behaviour is very different than the more regular pressure cycles that can occur due to high friction between the seal rings and their supporting surfaces [Refs. 1 & 2]. The seal continued in this state for an estimated 10,000 or more pressure cycles, until the unit was shut down for other reasons in mid-January 1995. The faulty seal was then removed, replaced, disassembled, and inspected by AECL and Bruce-A personnel. Excessive roughness of the sleeve coating was the suspected problem.

- For Unit 3 Pump 2, the seal faces separated in response to small downward shaft movements because the friction between the U-cup and sleeve was larger than could be consistently overcome by the spring and pressure forces acting to close the seal. As the No. 1 seal opened, the closing force due to pressure drop across the U-cup decreased because the interseal pressure increased. This left only the spring force to force

the No. 1 seal closed. Upward movement of the shaft would close these faces in a similar manner. The No. 2 seal faces meanwhile remained closed since the higher interseal pressure provided increased closing force. The reason this occurred only after several months of operation is postulated to be the loss of lubrication on the rougher surface. The other factor in this is the probability that the pump was operating near the point where the pressure forces acting on the shaft and impeller balanced the combined shaft and impeller weight.

Fig. 2: Interseal Pressure Spiking due to Sleeve Roughness: (a) Trend with "spiking," (b) Trend with step change return to normal, (c) Trend (computed) with "spiking," stabilization, and step change return to normal

The No. 1 stage internal flow modification for improved cooling and the reduced roughness chrome oxide coated shaft sleeves were installed in all four pumps in Unit 4 during the June 1995 outage. Operation of these seals and the three seals with CMF coated sleeves installed in Unit 3 has been trouble-free to date.

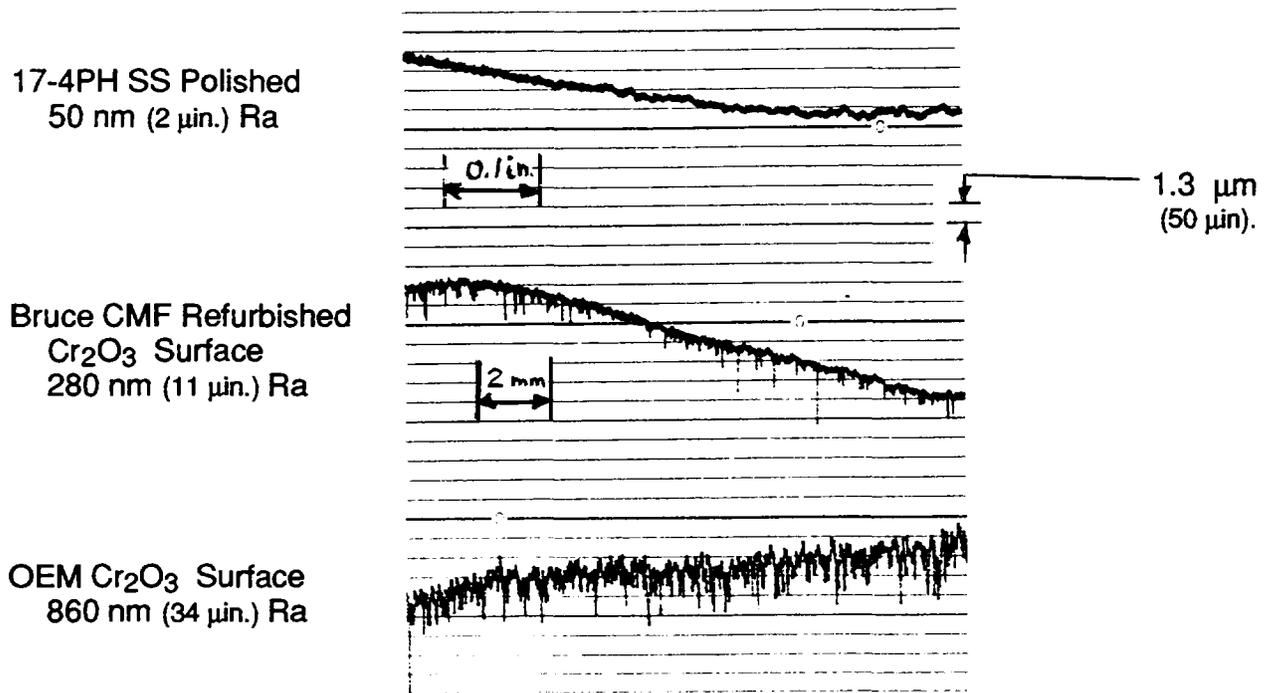
- iv) A test program to investigate the friction characteristics of U-cups on both CMF and the pump supplier's chrome oxide coatings and on polished 17-4 PH stainless steel. This program has shown that the latter's chrome oxide coatings supplied to Bruce-A are susceptible to loss of lubrication. In a lightly lubricated state, meant to simulate the conditions at the U-cup after the seal has operated for some time, the U-cup did not slide on the sleeve at pressures above 4.3 MPa during 0.05 Hz motions of 2 mm amplitude. All other sleeve preparations tested did slide under these conditions.

Fig. 3: Surface Profiles for Sleeves used in U-Cup to Sleeve Friction Tests
