Gamma Ray Scanning As Troubleshooting Tool For Unusual And Large Diameter Refinery Vacuum Columns

T.K. SARKAR, R. CHAWLA, S. BANIK, S.J. CHOPRA

Engineer's India Limited, 1, Bhikaji Cama place, New Delhi - 110 066, India

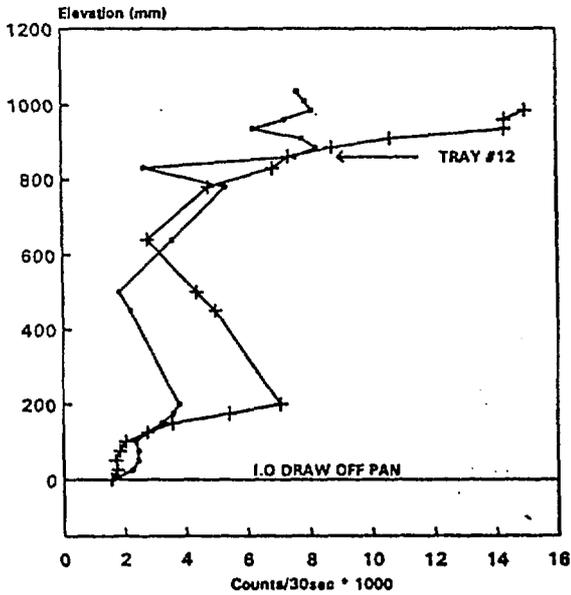
I.O. SECTION DRAW OFF PAN AND TRAY #12
FIGURE : 3

Scan was taken in two stages at normal operating condition of 60m³/hr. of mid pump around and in upset condition of 90m³/hr of pump around liquid, from the inter oil draw off pan to vapor space of tray 12. Results are shown in Figure 3.

No clear vapour space was observed upto 400 mm above tray 12 at normal operating condition. As this was not expected in normal

tray behavior, tray was suspected to be entraining or weeping. Since scan across downcomer also showed presence of two phase mixture at the same elevation as that of the tray, it appeared that only entrainment was taking place. At higher rate of pump around, liquid IO draw off rate was reduced from 28 to 18 m³/hr. Lower level of liquid in seal pan and nearly empty tray 12 deck, indicated dumping from tray 12 under upset condition.

above studies, several modifications like providing chimney tray below IO draw off, bubble cap tray for furnace recycle draw (tray 5) and heavier valves on tray decks were suggested and performance improved substantially.

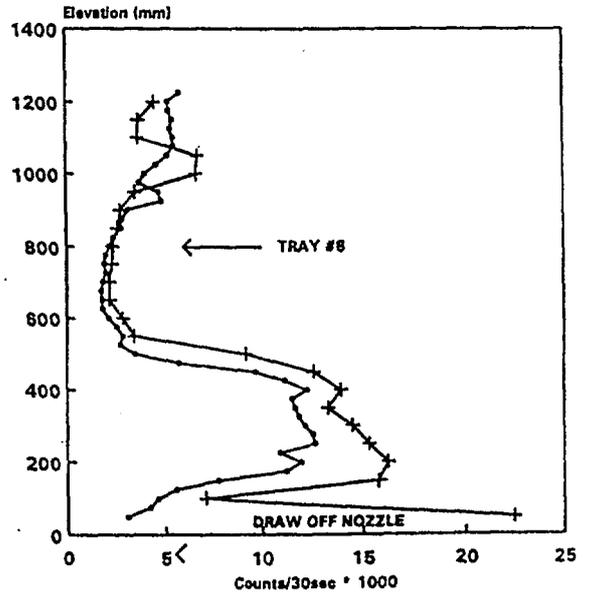
HEAVY OIL SECTION DRAW OFF
FIGURE : 4

Scan data were collected with and without steam in side-stripper. Figure - 4 indicates the scan results. Compared to scan under normal operation without steam, level of liquid in draw off box had considerably reduced when steam was charged in side-stripper. This corroborated a decrease in draw rate of HN from 17 to 10.5 m³/hr. As the frothy liquid level in the seal pan also reduced appreciably, vapour bypassing of the downcomer was suspected. However, upper part of central downcomer showed behavior similar to normal operating condition. Non-uniform behavior of tray 8 could also be observed from scan data along different chords of tray 8.

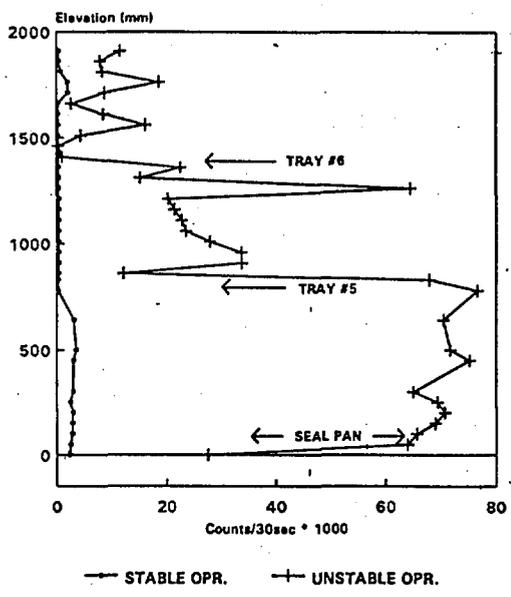
FURNACE RECYCLE SECTION
FIGURE 5

Investigation was carried out at normal and increased overflash rate in this zone. Scan results are shown in Figure 5 Presence of liquid above flash zone was observed with normal overflash rate which could have been due to either entrainment from flash zone or dumping from tray 5 or both. At increased overflash rate, radiation intensity increased steeply above the flash zone indicating clear vapour space i.e. no appreciable entrainment from flash zone. At low overflash rate there could be dumping from trays or overflowing from the draw off box. Since scan showed low level of liquid in draw off box, seal pan might not be holding sufficient liquid and thereby creating vapour bypassing through the downcomer which might have caused preferential dumping. Based on the

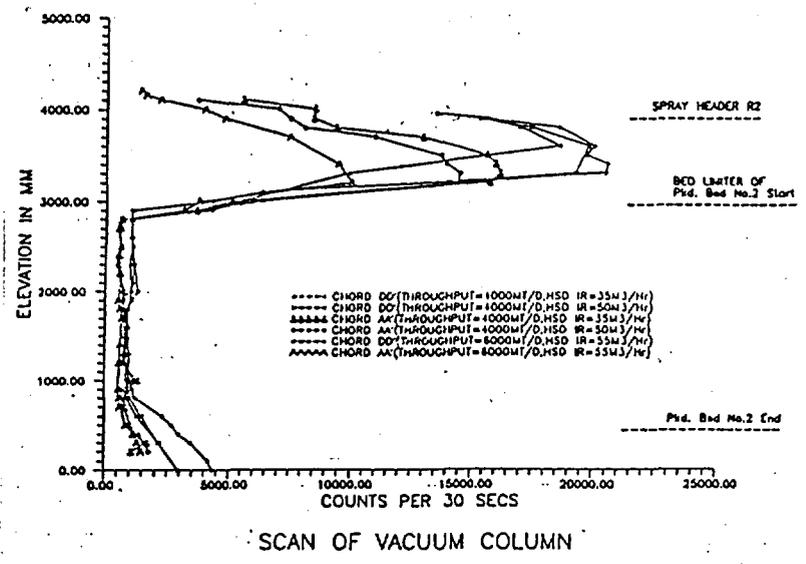
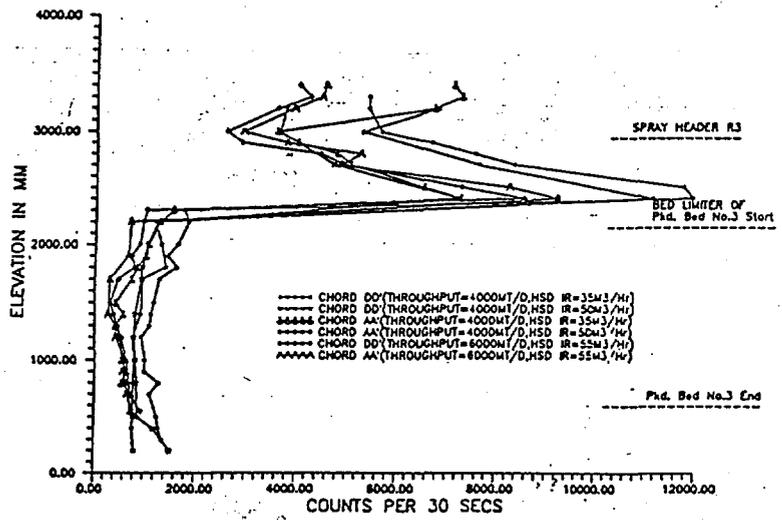
Figures 6 and 7 indicate scan results. In one bed maldistribution was indicated upto 1 meter from bed top at lower throughput but at higher throughput maldistribution decreased. Also, as the internal reflux rate was increased, hold up in the bed increased. But in the other packed bed, severe maldistribution existed as shown by the non-overlapping scan data.

Based on results of the study, the column was opened and plugged spray nozzles cleaned/replaced which improved the column performance.

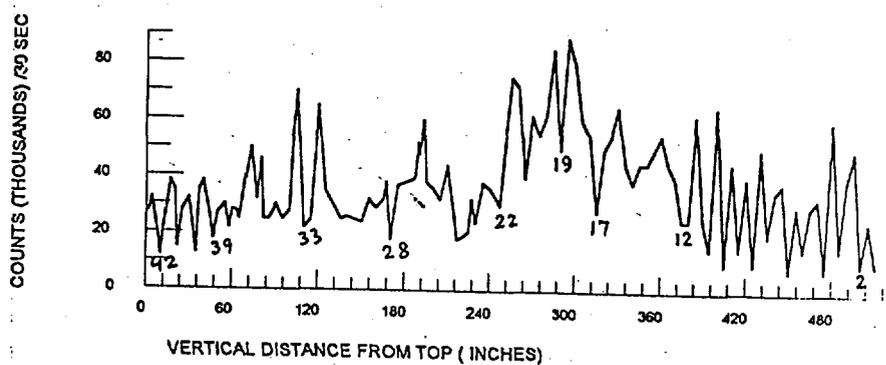
GAMMA SCAN OF AMMONIA
SEPARATOR COLUMN
FIGURE 8

These problems were minimised by using a channel support for source and detector collimators to eliminate swing and using a uniform narrow beam hole collimator instead of panoramic or conical type collimator. From the plot of the scan data shown in figure 8, the following observations were made;

- Flooding was observed between trays 4 to 10, & 39 to 42.
- Debris were found on many trays including number 12 (see below)
- Tray numbers 13, 14, 16, 18, 20, 25, 26 & 27, were observed to be missing.
- Trays 29 to 32 & 36 to 38 were found to be damaged.
