POOLSIDE FUEL ASSEMBLY INSPECTION CAMPAIGNS PERFORMED AT KERNKRAFTWERK LEIBSTADT DURING SUMMER 1997

H.U. ZWICKY, C.G. WIKTOR
Kernkraftwerk Leibstadt AG,
Leibstadt, Switzerland

D. SCHRIRE
ABB Atom AB,
Västerås, Sweden

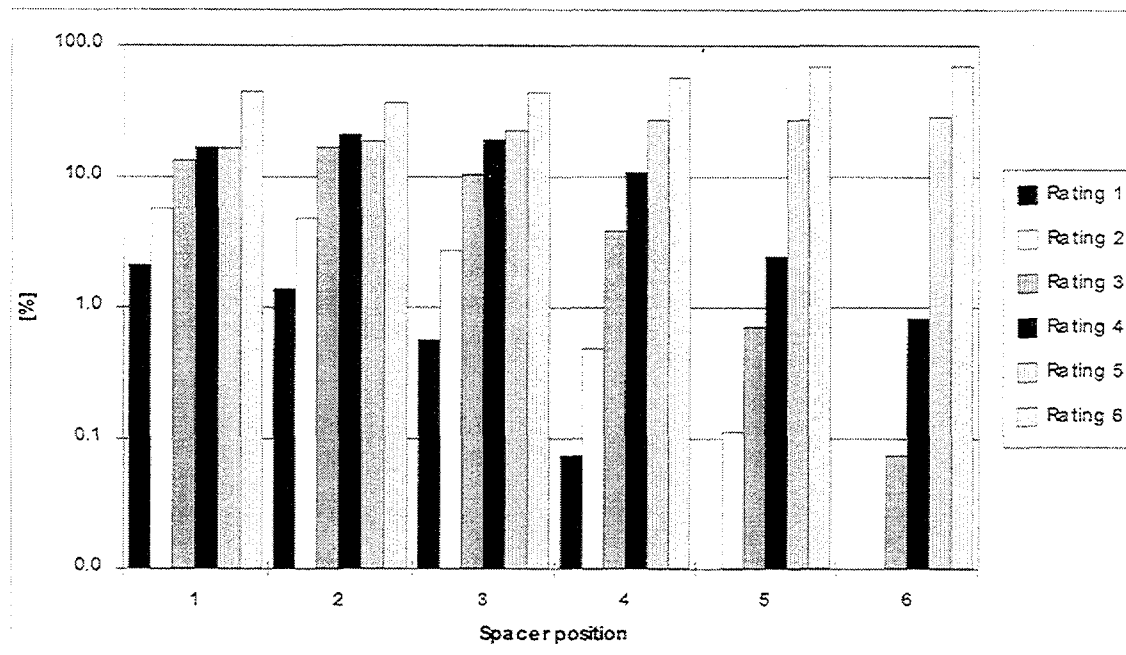
As a basis for the development of a fuel management concept for the next cycle scheduled to start at the beginning of September 1997, a broader data base was needed. It had to show whether the observations made in the hotcells were representative for all rods or for some single cases only. Within a few days, a campaign was initiated and planned for the visual inspection of all 38 discharged SVEA-96 fuel assemblies. All peripheral rods in each subassembly were inspected (60 of 96 rods). A qualitative assessment of the nature of the oxide near and under the spacer grids was made for each rod in all six spacer positions. A scale from 1 to 6 was applied (1 = extensive spalling, 3 = onset of spalling, 6 = thin oxide). The whole inspection was documented by video tape. The work was performed from June 9 to June 19, 1997. Fuel assembly transfer from storage pool positions into the fuel handling equipment and back to the storage rack was performed by operators belonging to the regular KKL staff. Subassembly handling and inspection work was done by two ABB Atom inspectors. Two shift groups worked from 6 a.m. until 10 p.m. The data were evaluated in close co-operation between KKL and ABB Atom. They are plotted in Fig. 2. The results showed that about 4% of all inspected rods were at least once rated with 1. The affected rods were more or less evenly distributed across all inspected bundles with no clear preference for certain positions, but heavy spalling was not seen in the uppermost spacer positions.

FIG. 2. Visual inspection of 5 cycle SVEA-96 fuel assemblies and qualitative assessment of nature of oxide near and under spacer grids (rating 1 = extensive spalling, 3 = onset of spalling, 6 = thin oxide). Observe logarithmic scale!

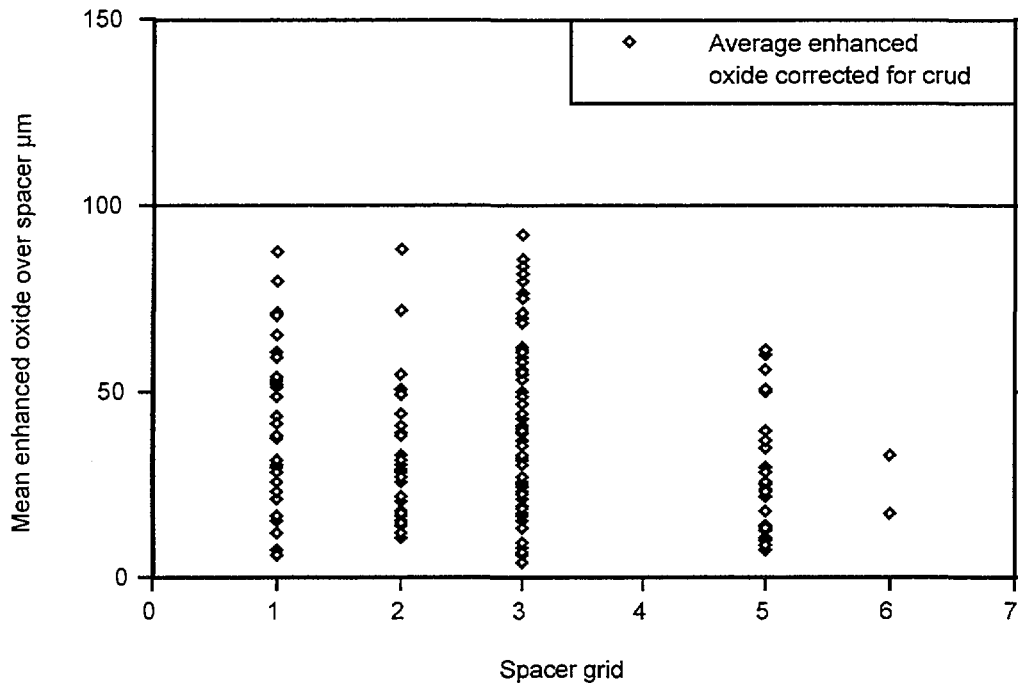
As can be seen in Fig. 3, maximum oxide layer thickness values, corrected for the crud layer and averaged over the enhanced corrosion spacer region, are smaller than 100 μm in all measured spacer grid positions for all measured 3 cycle rods. In Fig. 4, the minimum remaining wall thickness values in all measured spacer grid positions for all measured 4 cycle rods are plotted. The remaining

FIG. 3. Mean enhanced oxide layer thickness averaged over spacer region in all measured grid positions for all measured 3 cycle rods.

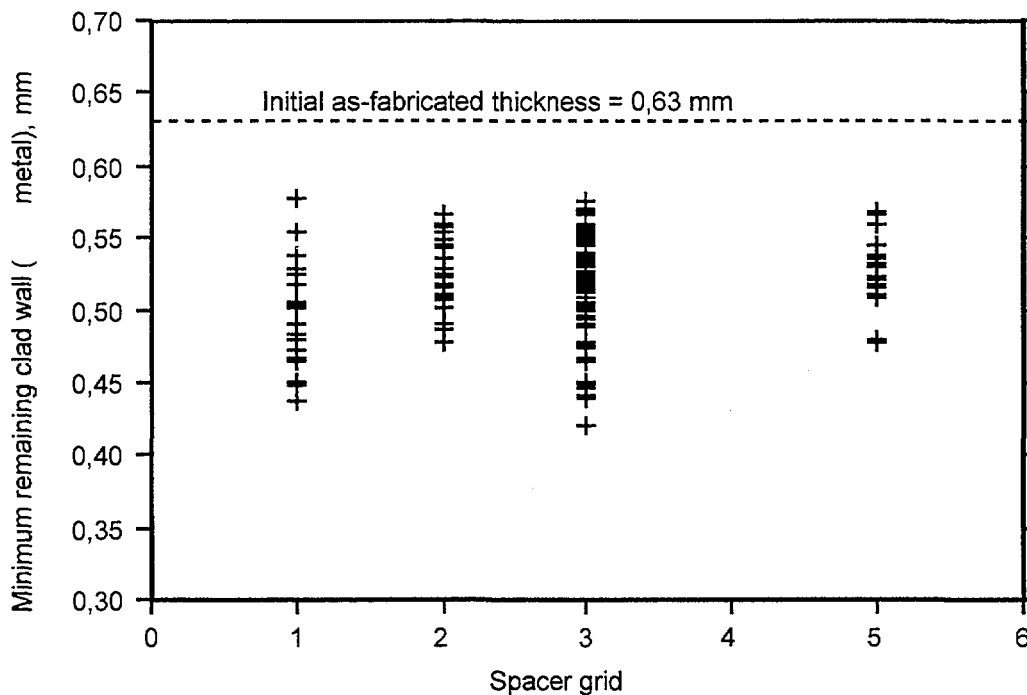
metal wall thickness is well above 50% of the as-fabricated wall thickness. Therefore, the assumptions for establishing the revised TMOL and one of the prerequisites for cycle 14 operation were fulfilled and the authority, the Swiss Federal Nuclear Safety Inspectorate HSK, was able to give their cycle operation release.

FIG. 4. Minimum remaining metal wall thickness in all spacer grid positions for all measured 4 cycle rods.
