VITRIFICATION PILOT PLANT EXPERIENCES AT FERNALD, OHIO

July 18, 1997

For presentation at Science and Technology for Disposal of
Radioactive Tank Wastes Symposium, September 1997

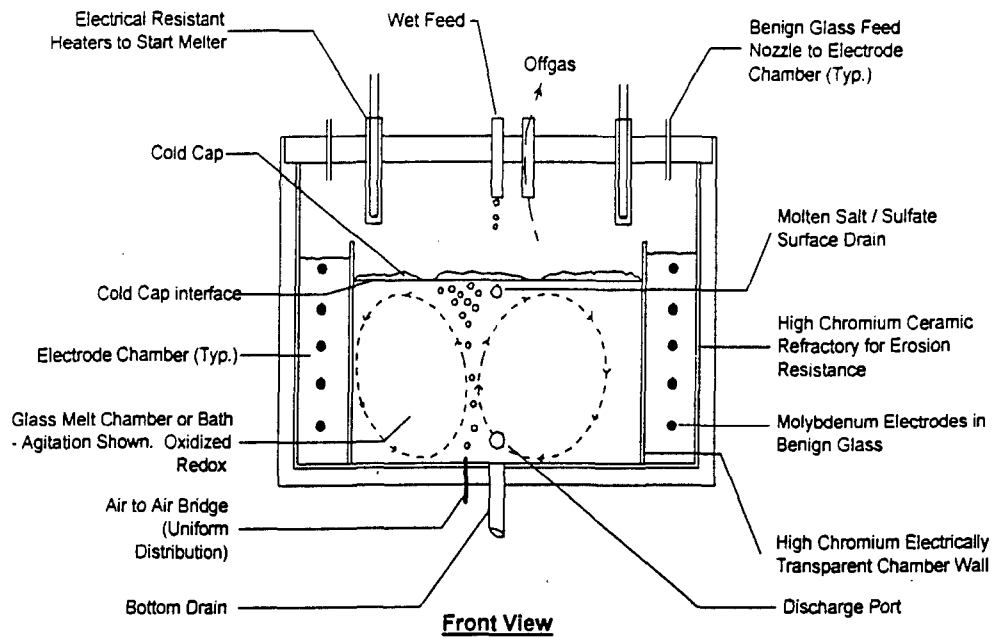
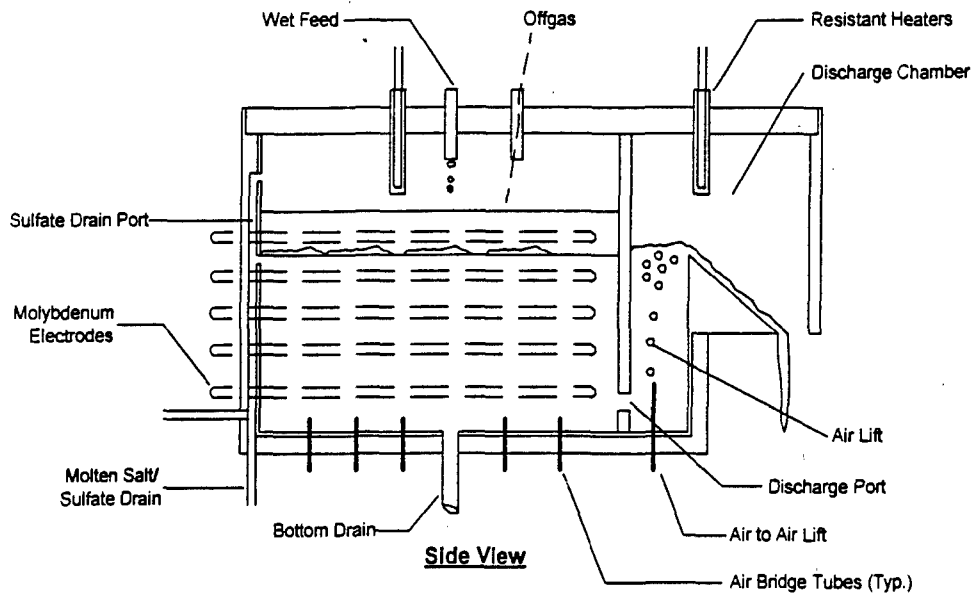
Figure 1
Schematic of the Melter

- Pluggage in the melter discharge chamber due to excess outside air being drawn up into the discharge chamber. The melter chamber was maintained at negative pressure, but the upper part of the chamber wall, as seen in side view in Figure 1, was porous. This allowed air to be drawn through the discharge chamber into the main melter chamber. This caused the molten glass to (1) waver and make it hard to cut and form into gems and/or (2) freeze and cause plugging at the discharge.
- Migration of glass through the wall between the heated Center Chamber and the heated Discharge Chamber. Normally, glass freezes in a wall and will not advance. However, this wall was heated on both sides and allowed the glass to flow. The flow occasionally caused blockage of the discharge port. Cooling was later used to limit the flow.

- Cracks in the partition wall between the Main Chamber and each Electrode Chamber appear to have formed or opened during the melter Acceptance Test during Campaign 1. The Acceptance Test was overseen by the melter vendor's personnel around the clock. The partition wall was made from high-chromium blocks. Cracks in the walls allowed the lead and sulfate-bearing Main Chamber molten glass to enter the Electrode Chambers. The Electrode Chamber molten glass was to be maintained in a reduced state because of the presence of the molybdenum metal electrodes. The reduced glass condition aids in the destruction of the sulfates, forming SO₂ gas as bubbles or foam. Also, reboil of the molten glass as it passes through the wall cracks, aids in the destruction of the sulfates. In defense of the situation, the vendor's scientists responded stating that the minimelter (the predecessor to the VITPP melter) during earlier stages of the development program, also developed a large hole in the partition walls. Similarly, foaming developed, but the minimelter electrodes appeared to be protected. And while the foaming in the pilot plant melter was an operational hindrance, it would not be destructive to the melter electrodes. However, FDF in an effort to control the situation responded with (1) flushing the Electrode Chambers with new benign glass and (2) replacing the Electrode Chamber glass with a denser glass formula to try to reverse the molten glass flow into the Main Chamber. Unfortunately, the cracks were too large and the efforts were to no avail.
