POTENTIAL IMPACTS OF CRUD DEPOSITS ON FUEL ROD BEHAVIOR ON HIGH POWERED PWR FUEL RODS

W. WILSON, R.J. COMSTOCK
Westinghouse Electric Company,
Commercial Nuclear Fuel Division,
Columbia, South Carolina,
United States of America

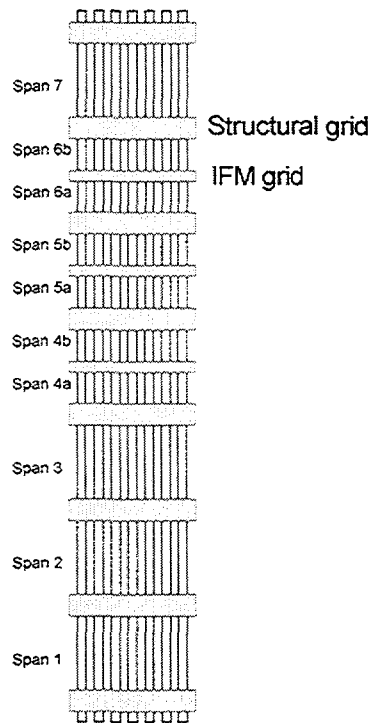
Figure 1: Schematic drawing of a Westinghouse PWR fuel assembly. Crud deposits are typically observed in spans 4 through 7.

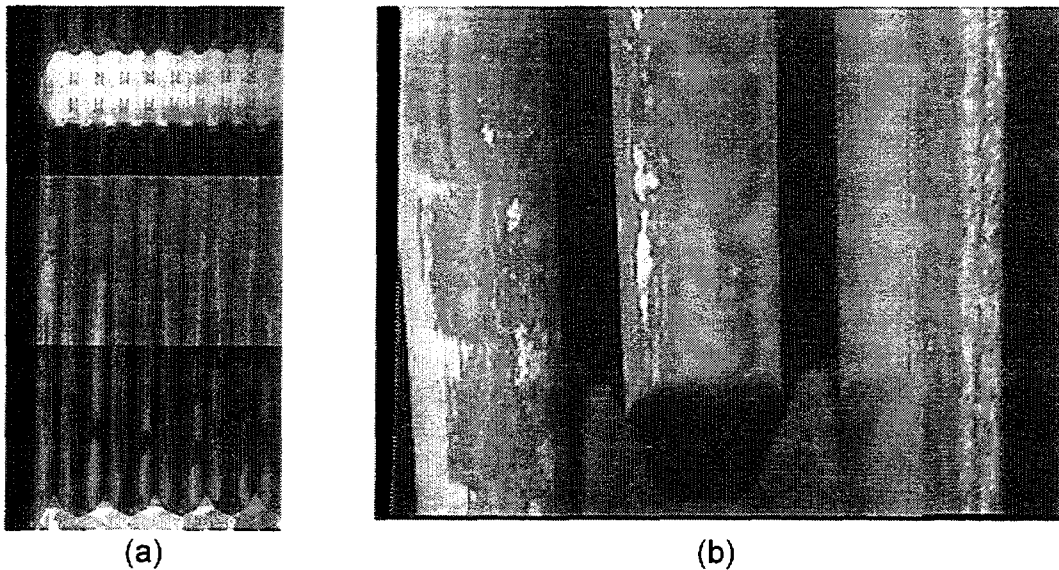
Video images of crud deposits on PWR fuel rods are shown in Fig. 2. The lower magnification image in Fig. 2a shows the presence of crud in Span 6a of a fuel assembly. The higher

Figure 2: Video images of crud deposits in span 6a of PWR fuel.

magnification image in Fig. 2b shows the preferential deposition of crud associated with the fuel pellet height.

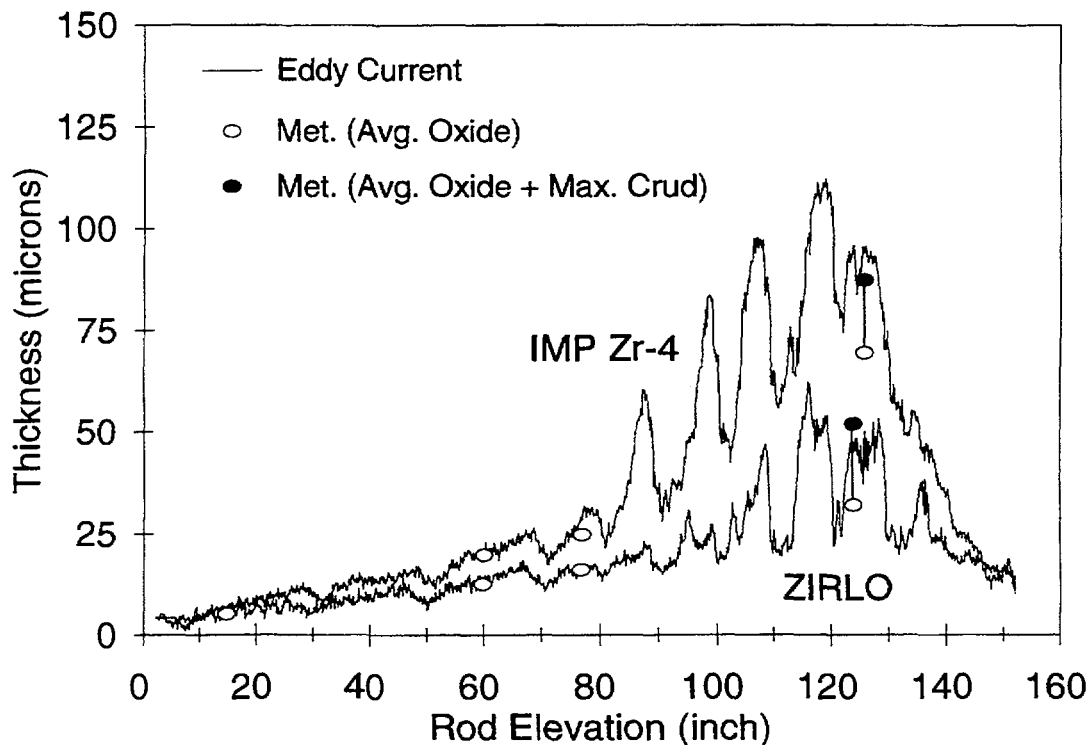
To provide a more quantitative measure of crud thickness, eddy current measurements were performed on an improved Zircaloy-4 and ZIRLO™ fuel rod with burnups of about 45 GWD/MTU. The eddy current measurements performed along the full length of the rod are plotted in the Fig. 3. Significant increases in thickness were observed at rod elevations above 80 inches where crud was visually observed. The rods were then sectioned and four metallographic mounts were prepared from each rod corresponding to axial locations of about 15 inches, 60 inches, 77 inches and 125 inches from the bottom of the rod.

Oxide thickness measurements were made around the tube circumference along with maximum crud thickness. These data are plotted in Fig. 3. At axial elevations below 80 inches where no crud was present, there was good agreement between the eddy current measurement and metallographic measurement. In Span 6b (~125 inches), the oxide thickness from metallography was significantly lower than the eddy current measurement. A one-to-one comparison between the two techniques was not possible since the rod azimuthal orientation was not maintained during sectioning. However, reasonable agreement was obtained when comparing the eddy current data with the sum of the average oxide thickness and maximum crud thickness. Micrographs of the oxide and crud deposit are shown in Fig. 4. Apparent in the micrographs are crud deposits approximately 20 microns thick.

Figure 3: Eddy current and metallographic thickness measurements on improved Zircaloy-4 and ZIRLO fuel rods.

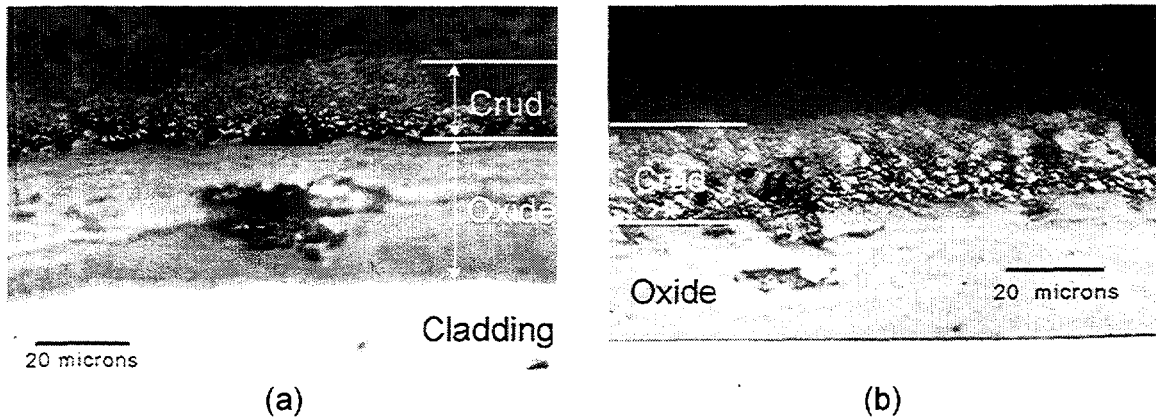
Figure 4: Metallographic cross-sections of fuel rods in crud-affected regions. (a) ZIRLO rod at axial elevation of 124 inch with 18 microns of crud and 32 micron of oxide, and (b) Zircaloy-4 rod at axial elevation of 125 inches with 20 microns of crud and 69 microns of oxide.

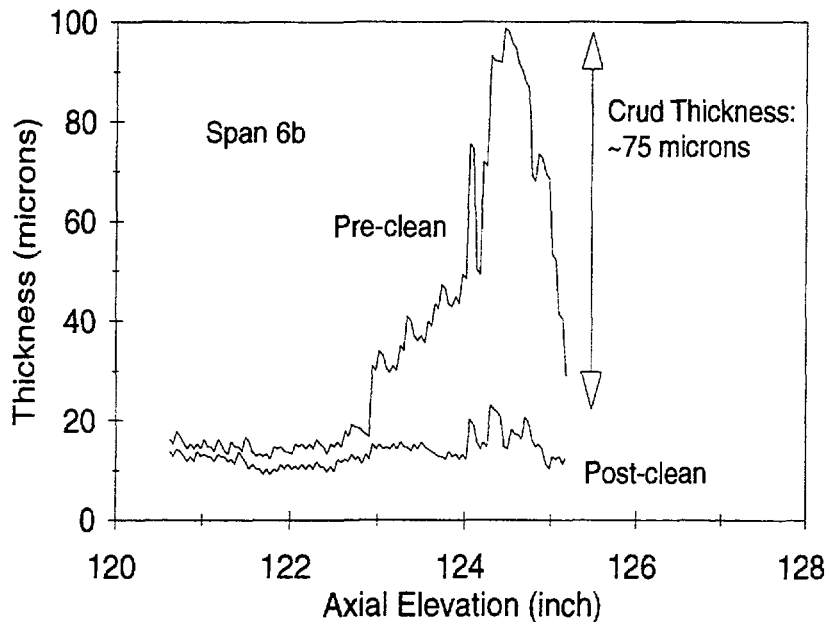
Another example of eddy current measurements being impacted by crud deposits is shown in Fig. 5. Axial traces were performed on a peripheral fuel rod following one cycle of irradiation with the results from Span 6b provided in the figure. The measurements were performed both before and after cleaning the fuel rod. The pre-cleaning measurements revealed a sharp increase in thickness from less than 20 microns to a maximum thickness of about 100 microns. The abrupt increase in thickness suggested the presence of crud which was confirmed by visual inspection of the rod (Fig. 6a). The eddy current measurement was repeated following mechanical cleaning and removal of the crud (Fig. 6b). The thickness measurements were about the same in the crud-free region and significantly reduced in the region previously covered by crud. The difference between the

Figure 5: Eddy current probe measurement of oxide thickness in span 6b of a fuel rod before and after removal of crud deposits.

measurements before and after cleaning suggested a crud thickness as high as 75 microns. Despite the thick crud, average oxide thickness beneath the crud and in crud-free zones was similar.

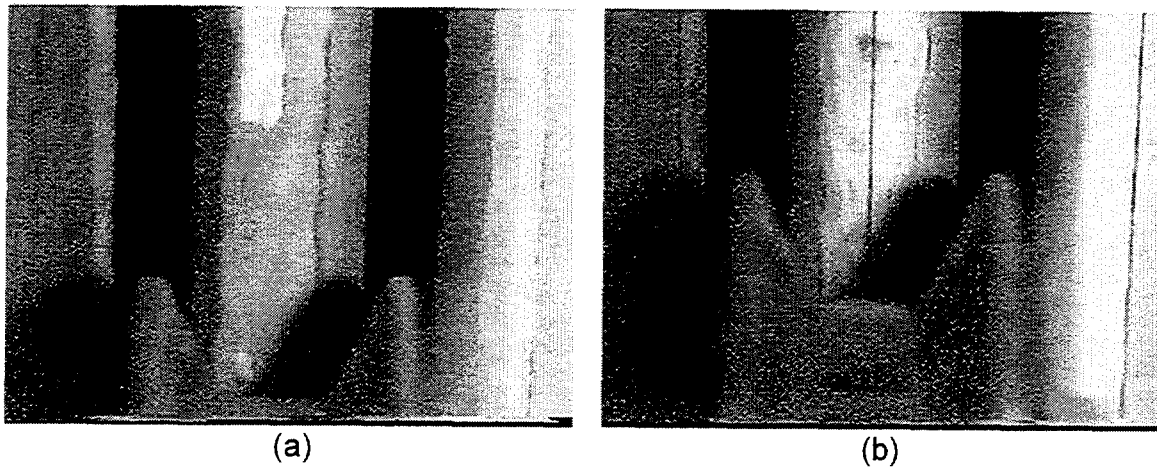
Figure 6: High magnification video image of fuel rod. (a) before removal of crud deposits and (b) after removal of crud deposit.

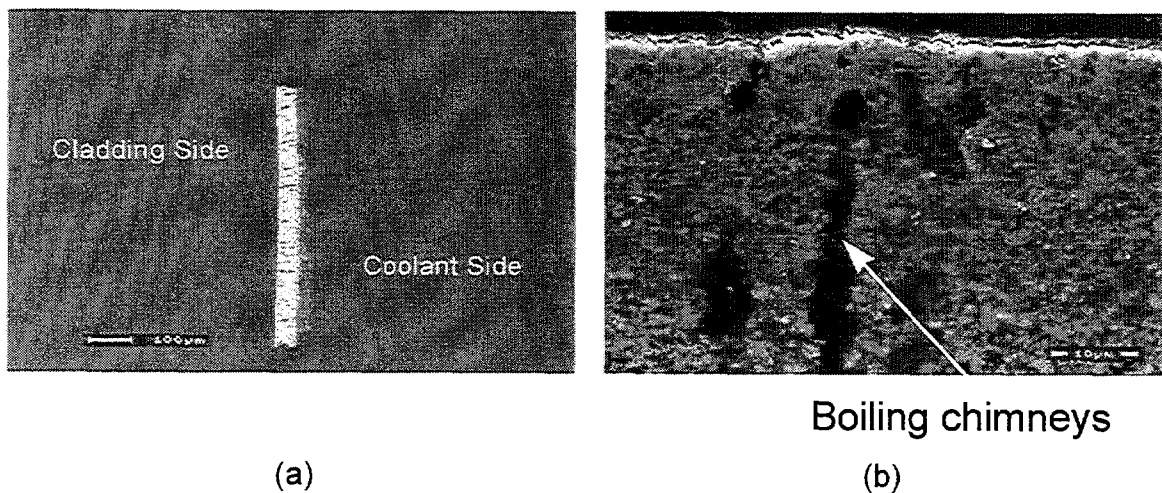
This indirect measure of crud thickness was confirmed by examination of a crud flake collected during the cleaning operation. A scanning electron micrograph (SEM) of the cross-section is shown in Figure 7a where the crud thickness measured between 72 and 79 microns which was consistent with the estimated thickness from the pre- and post-cleaning eddy current measurements. Higher magnification examination of the crud flake showed the presence of boiling chimneys within the crud.

Figure 7: SEM micrograph of crud flake cross-section.
