**EDDY CURRENT AND ULTRASONIC FUEL
CHANNEL INSPECTION AT
KARACHI NUCLEAR POWER PLANT**

W. R. Mayo

Atomic Energy of Canada Limited
Chalk River Laboratories
Chalk River, ON K0J 1J0

Muhammad Mansur Alam (PAEC)

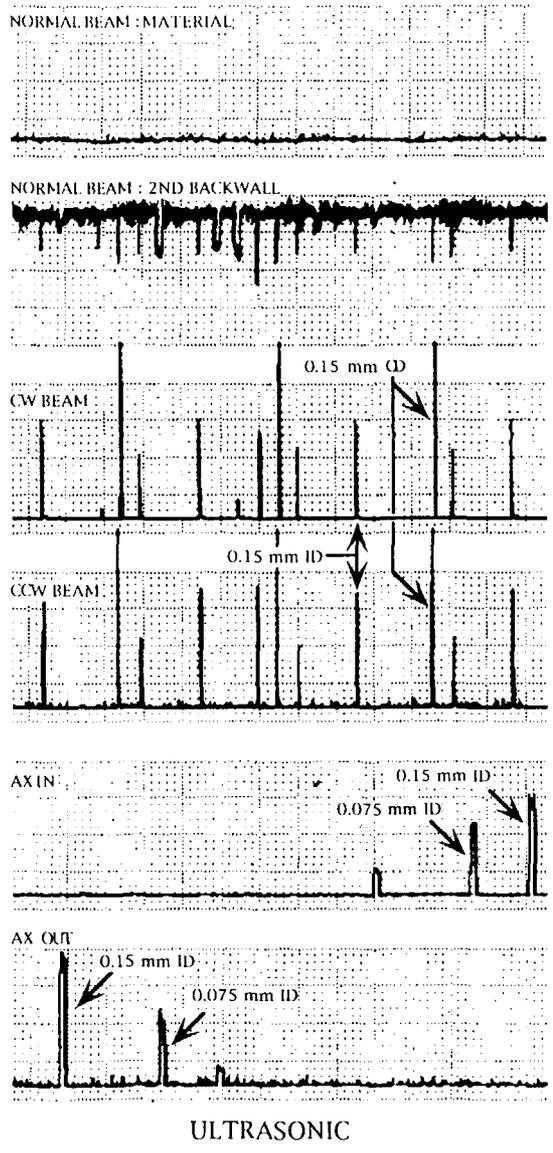
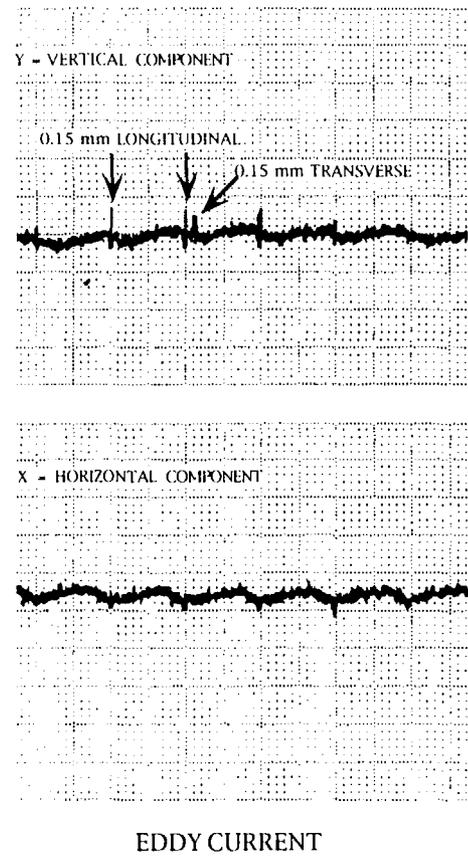
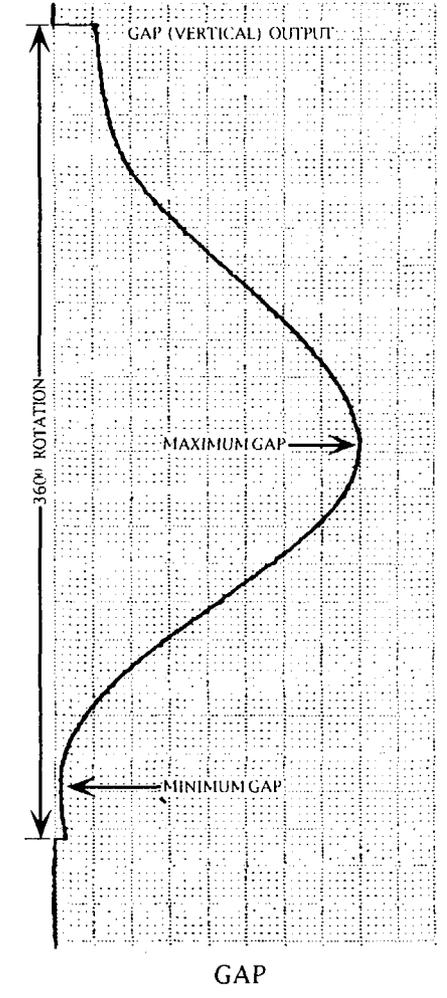
FIGURE 3 : Ultrasonic, Eddy Current, and Gap Calibration Signals

Ultrasonic signal-to-noise was judged satisfactory. This can be seen in the signals from the calibration notches and was evident in the data during scanning (Fig. 3). A strip chart display of the digitized data was generated as scanning took place. After scanning of a channel was complete, an "off-line" C-scan of the data could be generated (Fig. 4). This tended to greatly aid the detection of low level signals that might be lost in the noise of the compacted strip-chart, and allowed inspectors to verify whether echoes detected on successive rotations represented a flaw of axial extent or were simply the result of random reflections. The presence of serious flaws is not therefore expected to have gone undetected.

The eddy current equipment was quite satisfactory, and the STEM units worked very well with the eddy current flaw detection system. Reference signals from 0.15 mm deep (typ.) EDM reference notches generally showed a signal-to-noise ratio of about 3 (Fig. 3). As with ultrasonics, data could be displayed in an off-line C-scan format, which aids detection and characterization. An X-Y (impedance plane) re-display capability also enhanced the ability to characterize indications from the eddy current data (Fig. 4).

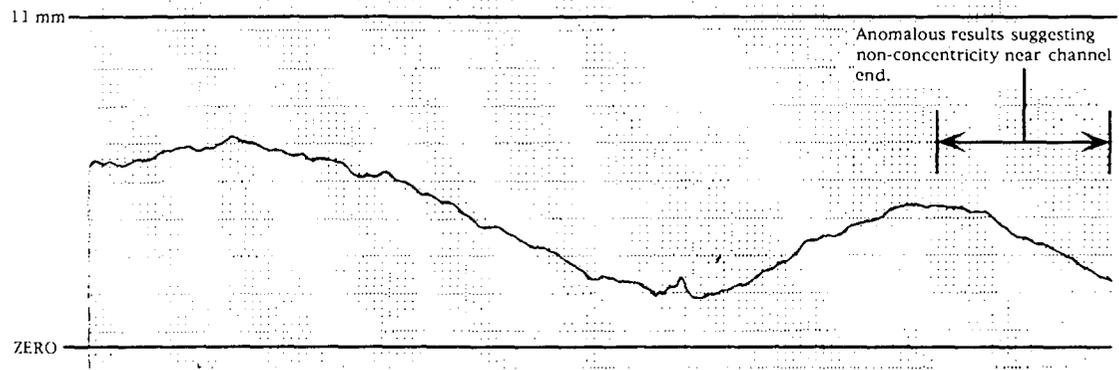
CHANNEL G12 BOTTOM-OF-CHANNEL AXIAL PROFILE

Equipment for gap measurement functioned near flawlessly, and data display was satisfied by the simple generation of strip charts for axial and circumferential scans. The greatest issue in gap measurement performance involved the discovery of

anomalies in the data. Examples are shown in Fig. 5.

These were areas where the gap measurement data could not be reconciled with expected results based on other sources of information.

FIGURE 5 : Gap Data Anomaly Examples

1. The delivery system requires improvement to cope with abnormal channel sag, and an automated couplant collection system is necessary.
2. The accuracy of the gap measurement system may be increased by compensating the effects of wall thickness variation. This is based upon Ontario Hydro's SLAR and CIGAR experience, where a dramatic effect on eddy current signal is seen as a result of wall thickness variation, to the extent of 50% gap equivalent [2]. (Note however that the KANUPP 93 gap probe is different than those used on SLAR and CIGAR, and the effects of wall thickness are not expected to be as dramatic.)

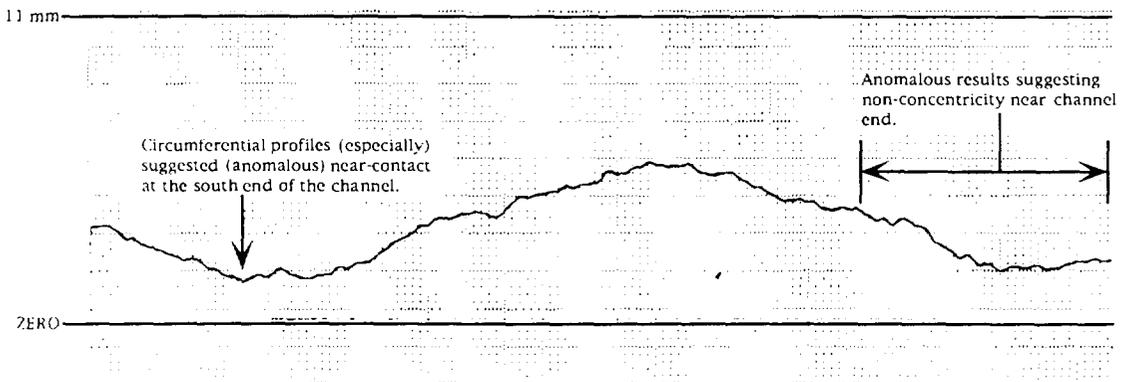
CHANNEL 110 BOTTOM-OF-CHANNEL AXIAL PROFILE

2. The gap measurement using eddy current gave anomalous results. For example, in J10 the measurement suggested the pressure tube might be near contact with the calandria tube, in the south channel end, which was not supported by ultrasonic inspection. Again, in the same channel the gap was measured to be highly nonuniform at a distance of 300 mm from the end fitting, which is difficult to accept since the tubes are expected to be concentric at this location.
