OPERATION OF FINNISH NUCLEAR POWER PLANTS

Quarterly report, 2nd quarter 1999

Kirsti Tossavainen (ed.)

TOSSAVAINEN, Kirsti. *Operation of Finnish nuclear power plants. Quarterly report, 2nd quarter 1999. STUK-B-YTO 196. Helsinki 1999. 21 pp. + Appendices 2 pp.*

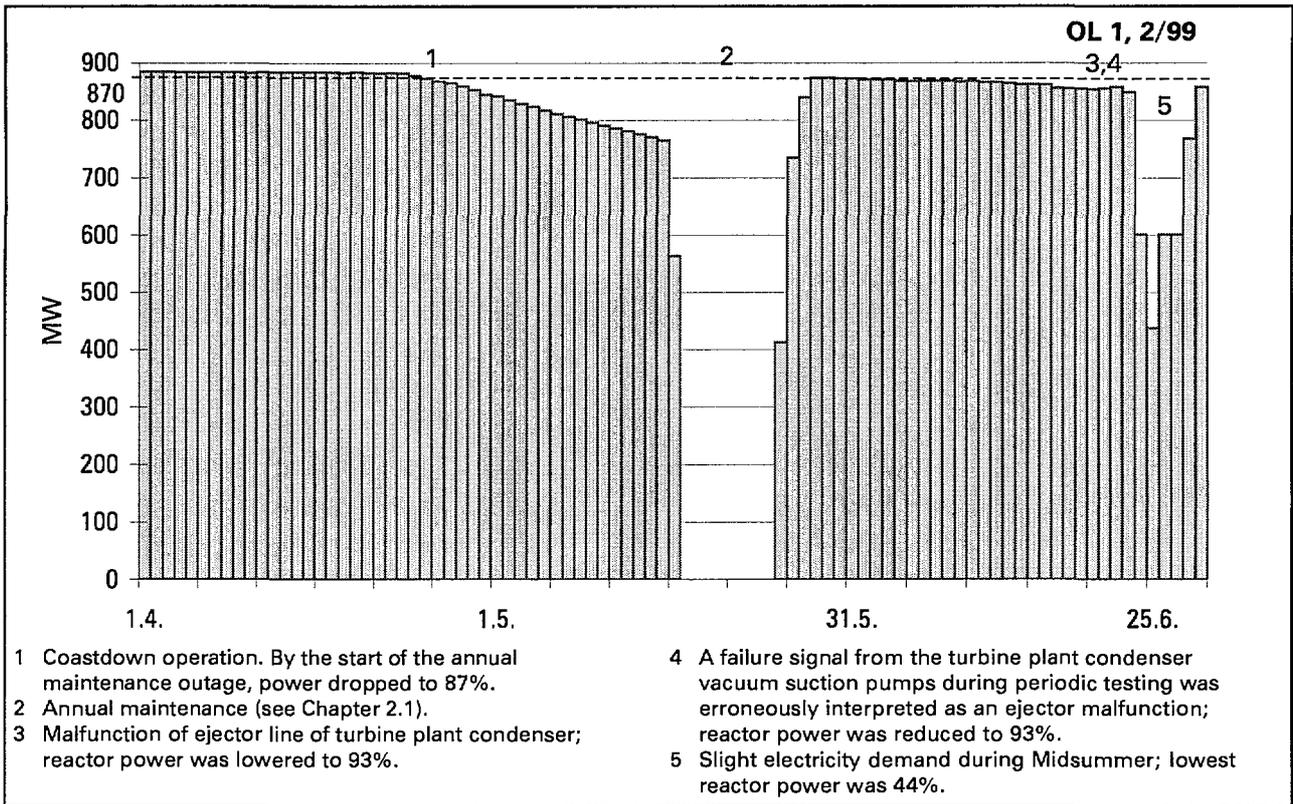
Fig 3. Daily average gross power of Olkiluoto 1 in April-June 1999.

The 20th refuelling and maintenance outage of Olkiluoto 1 was from 16 to 25 May 1999. The plant unit was off the grid for about nine days.

During the plant unit's shutdown phase on 16 May 1999, operation of the isolation valves of the reactor's main steam lines was tested. The valves are located inside the reactor containment and since they are part of the containment isolation function they must close tightly in case of various transient and accident situations. The valves close automatically if necessary. The test was meant to demonstrate that the valves operate reliably also at the uprated 2500 MW power. In post-testing valve tightness tests, one untight valve was found. Nothing out of the ordinary was found in its structure and the valve's untightness was attributed to particles, which had loosened into the piping during testing. According to STUK the reliable operation of the valves had not been demonstrated well enough. STUK therefore re-

Cracked sections of the emergency cooling system piping located inside the reactor pressure vessel were repaired during the outage. The system comprises four redundant pipelines and, in the event of an accident, cooling water is directed to the reactor upper plenum by means of the piping sections located inside the reactor pressure vessel. During periodic inspections in the 1998 annual maintenance outage, cracks had been detected in these pipes, which were temporarily repaired (STUK-B-YTO 184, 1999). In the inspections now conducted, new cracks were observed in three of the system's pipelines. The largest one was a branching crack, assessed at ca. 24 cm in length. One of the cracks, temporarily repaired in 1998, had grown. The cracked piping sections were removed and replaced with new piping segments that had thermal protection. The uncracked pipe was equipped with a thermal shield. The thermal shield is made of material that has better thermal fatigue resistance than the piping and

has no stress concentrations caused by discontinuities. In addition, the fourth uncracked pipeline was fitted with a thermal shield to prevent cracking. For the time being, owing to the risk of loose parts and thermal fatigue, the repaired piping sections are inspected every year.

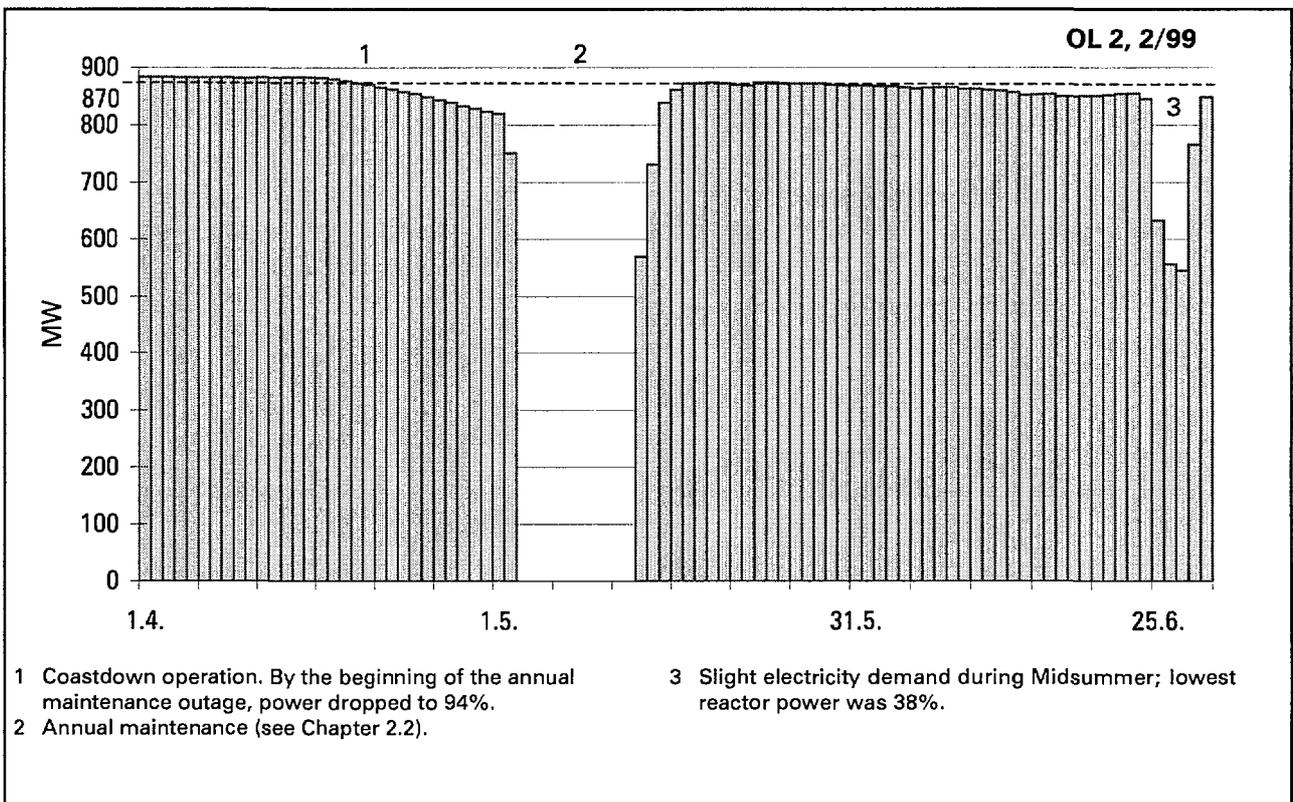
Fig 4. Daily average gross power of Olkiluoto 2 in April-June 1999.

The 18th refuelling and maintenance outage of Olkiluoto 2 was from 2 to 12 May 1999. The plant unit was off the grid for ten days.

In the final phase of the reactor shutdown on 3 May 1999, the reactor scram function actuated. All control rods were inserted into the core and the reactor was near atmospheric pressure. The plant unit was not generating electricity. The event was due to instantaneous high reactor water level values yielded by two level measurement channels simultaneously. The values can be instantaneously high for example owing to uncondensed gases that are released within the level measurement equipment during a reactor pressure reduction. The scram function always actuates if two channels send a measurement signal

In connection with the replacement of the safety switches of relay cubicles on 4 May 1999, i.a. one pump of the core spray system and one pump of the auxiliary feed water system began to inject water into the reactor and the reactor pool. The pumps started when a mounter's hand accidentally contacted the switch of a nearby unit and changed its position. The switch was immediately turned to the right position but this did not stop the pumps. The level transmitters of the overflow channel of the reactor pool sent an alarm signal to the control room and the pumps were stopped. Water spilled over the upper edge of the channels but not over the edge of the reactor pool and to the reactor hall floor.

Cracked piping sections of the core spray system were repaired at Olkiluoto 2 as well. A branching crack, ca. 50 cm in length, was detected in inspections made during the outage. In the same piping section was a crack detected in 1998. In addition, three cracks were found in other pipes. The cracked piping sections were removed and replaced with new pipe segments having thermal shields. Pipes that had no cracks in them were provided with thermal protection only. For the time being, owing to the risk of loose parts and thermal fatigue, the repaired piping sections are inspected every year also at Olkiluoto 2.
