# **ANALYSIS OF FUEL OPERATIONAL RELIABILITY AND FUEL FAILURES**

**Ivan Smieško  
SLOVAK ELECTRIC  
NPP JASLOVSKÉ BOHUNICE**

**Prepared for IAEA Regional Training Course  
„WWER Fuel Design, Fabrication, Performance and Back End“  
Bratislava , June 1999**

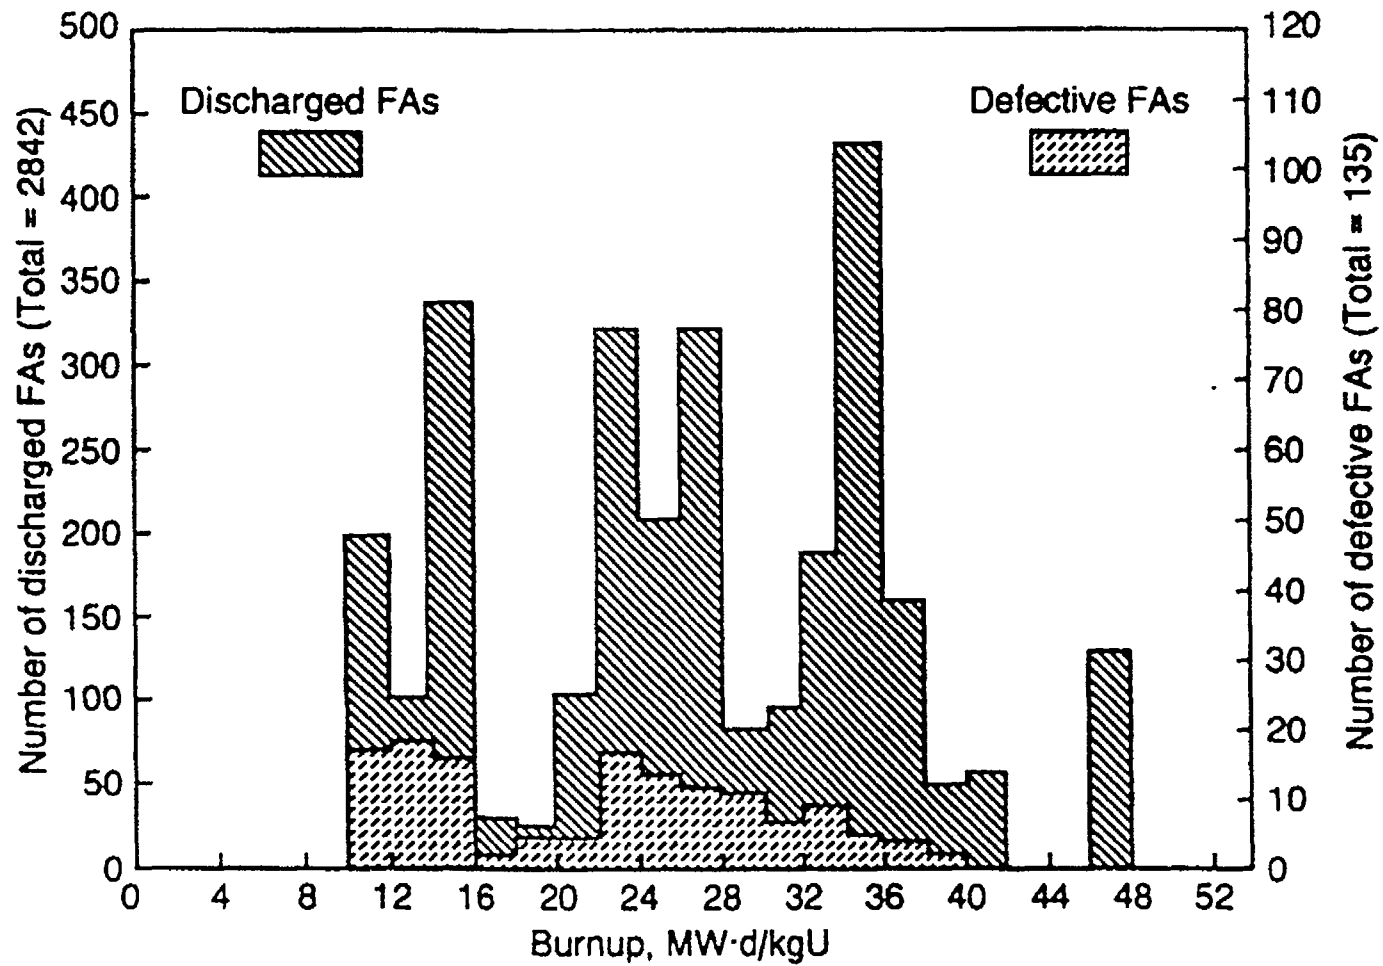
FIG. 21. Burnup distribution of discharged (including defective) WWER-1000 FAs [10].

- closure of gap between pellet and cladding
- iodine induced IGA SCC (axial cracking)
  - slow growth to 60 um depth then acceleration
  - whole process may take only minutes
  - next power ramp may lead to leak
- WWER fuel - excellent resistance
- very low failure occurrence at high burnups
- occurred only at
  - violation of operating rules (power ramps)
  - loop reconnection
- WWER - 1000 - improvement after reduction of permissible cladding defects from 60 to 35 um
