Feedback from Practical Experience with Large sodium Fire Accidents

V.P. Luster, K.F. Freudenstein (Siemens AG KWU)

1 SODIUM FIRE ACCIDENT IN THE ALMERIA SOLAR PLANT

2 SODIUM FIRE ACCIDENT IN THE ILONA TEST FACILITY AT BENSBERG

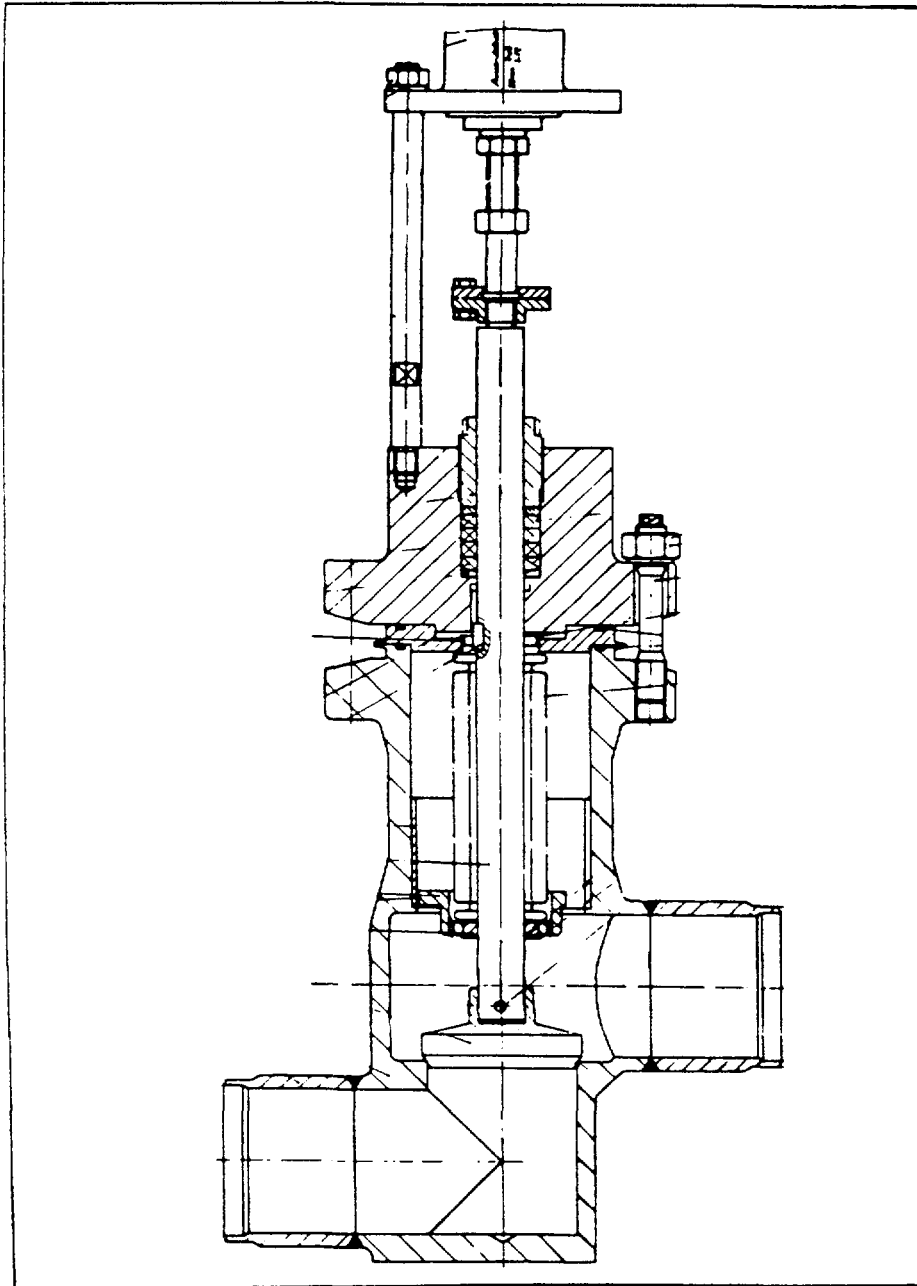
Figure 2 ALMERIA :: Cross Section of the Damaged Valve LK01 AA06

The plant was on cold shut down for repair of a sodium valve DN80. Several days before, a small leak on the gland of the valve was visually detected (figure 2 shows a cross section of the concerned standard valve DN80).

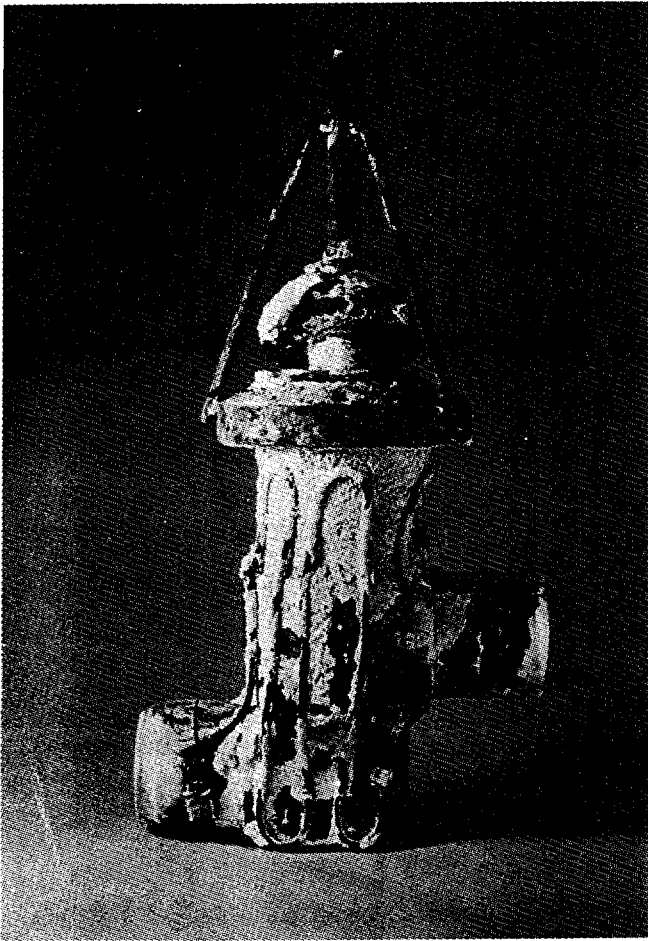
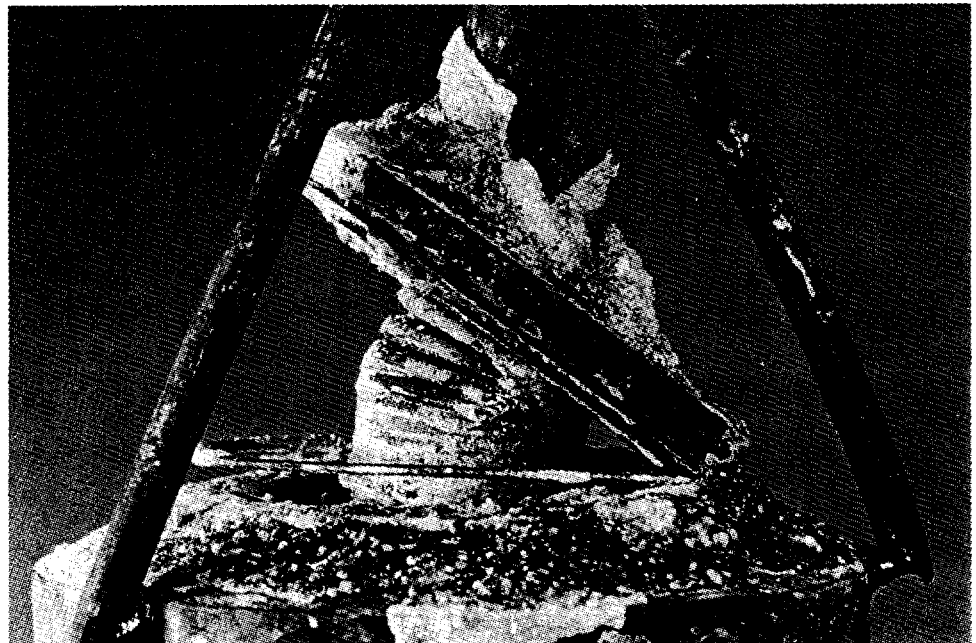
Figure 3 ALMERIA : Photographs of the Damaged Valve LK01 AA06

- During the first period of grinding the seal weld the leak tightness was maintained by an auxiliary helicoflex seal. When about 2/3 of the seal weld perimeter were cut the helicoflex seal gave way. By this the flange was suddenly lifted up. Several gulps of gas with sodium aerosols were expelled, followed after a few seconds by a strong sodium jet. This was the begin of a violent sodium spray fire.

The valve was located in a horizontal section of the line which was in parallel to the a wall of the building at one meter below the + 4 m level floor. The opening of the flange was limited by the spindle to an angle of 40° and oriented to the middle to the room. Figure 3.

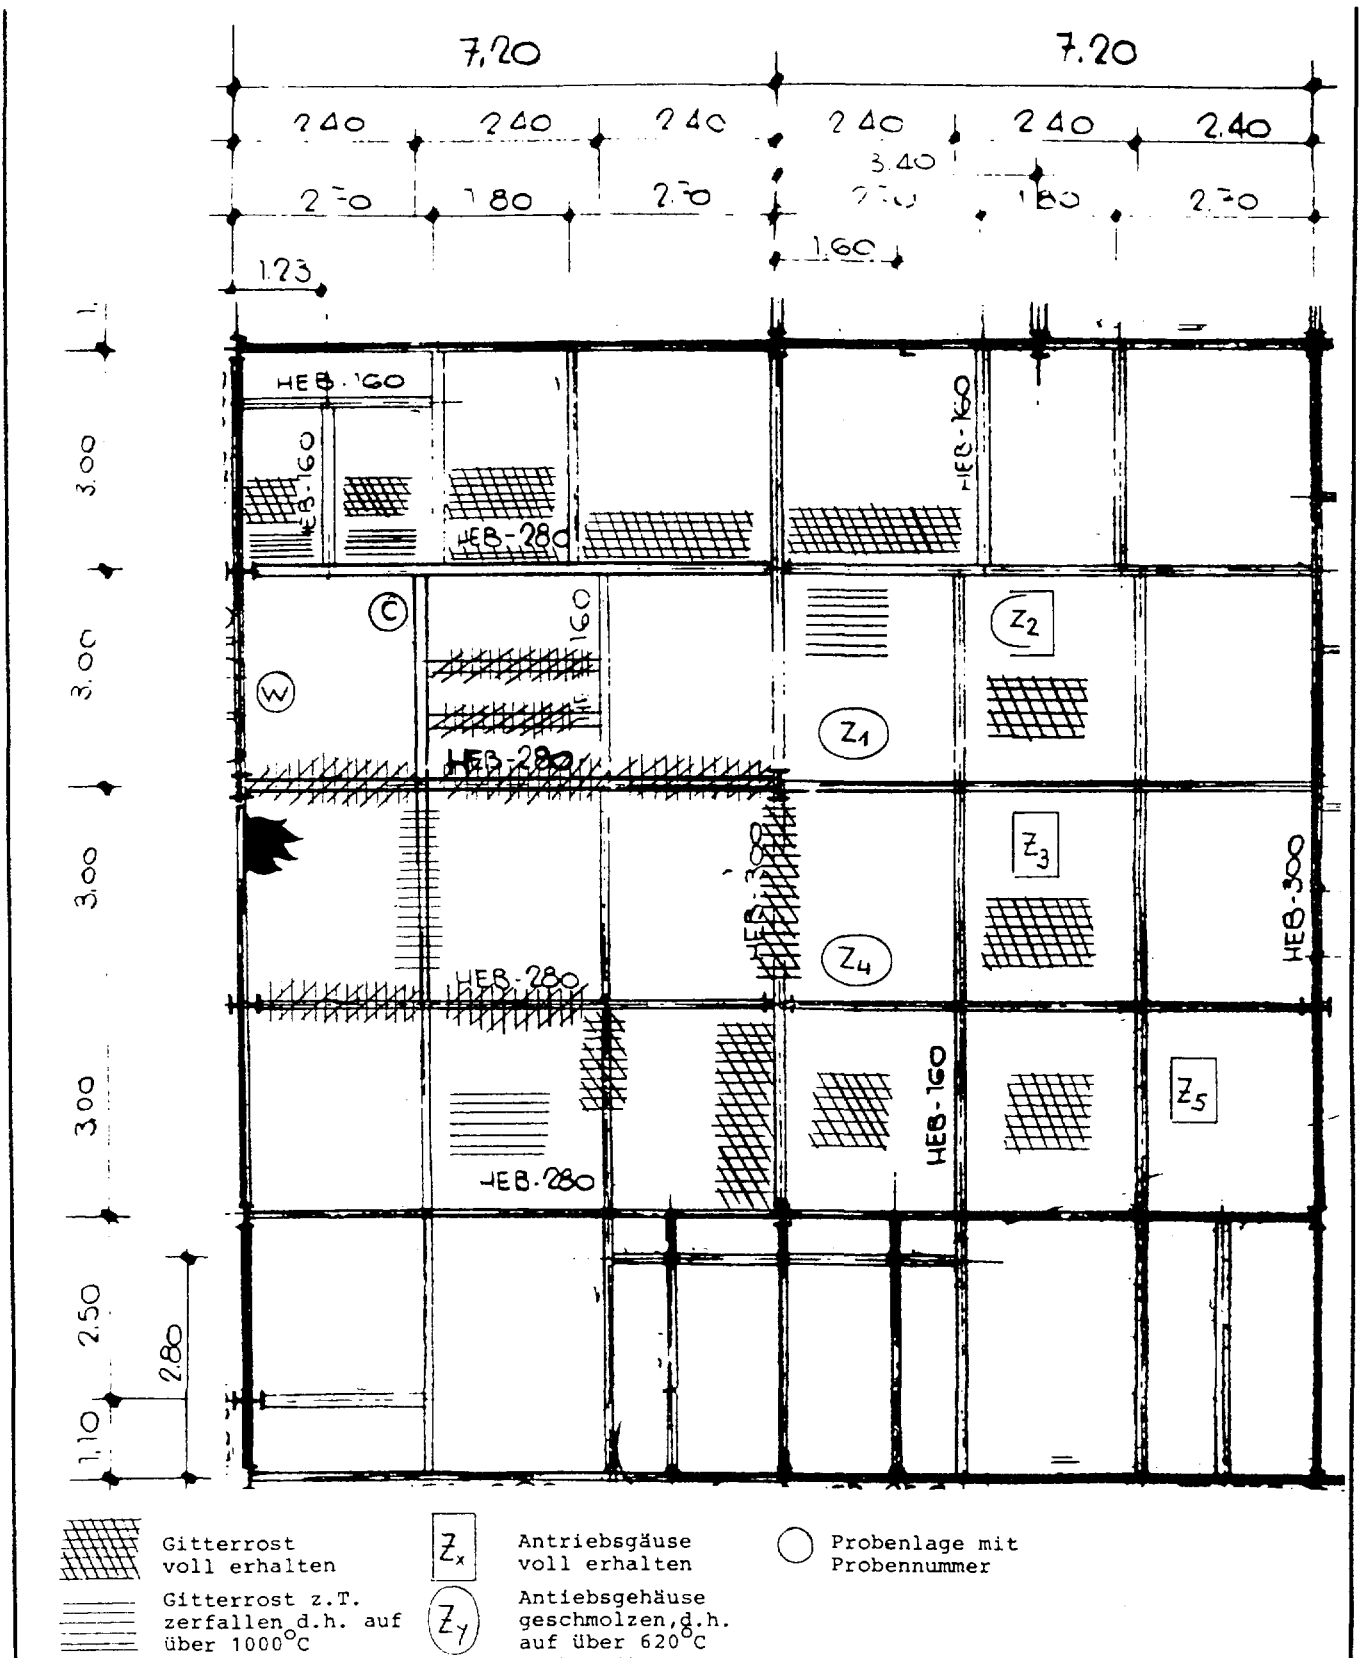
Figure 4 ALMERIA : The 4,00 m grating with positions of material samples

Material samples were taken in order to determine temperatures and gradients by metallographic analysis and to get feedback from material behaviour. Figure 4 shows a plan of the 4,00 m grating and indicates the location of the samples.

localisation	material	material temperature	type of damage
center of spray fire, 1...3 m from spray origin in spray	Na-pipework austenitic steel, wall thickness 3 mm	1450 °C at the rupture surface (nearly melting temperature)	total rupture of 1 sodium tube and one sodium nozzle DN 80, due to failure of ferritic support beams 10 mm Ø
direction	Na-pipework austenitic steel, wall thickness 3 mm	1200 °C within the material	
	ferritic steel I-profile, 115 mm, 4,00 m grating		deformation and weakness of the material
surroundings of the spray fire center	galvanised iron gratings	1100 °C	destruction
	support beams	1100 °C	rupture of support beams 10 mm Ø
boundary of the spray fire region	casing of a valve drive motor, aluminium	620 °C, melting temperature of Al	partial melting of casings

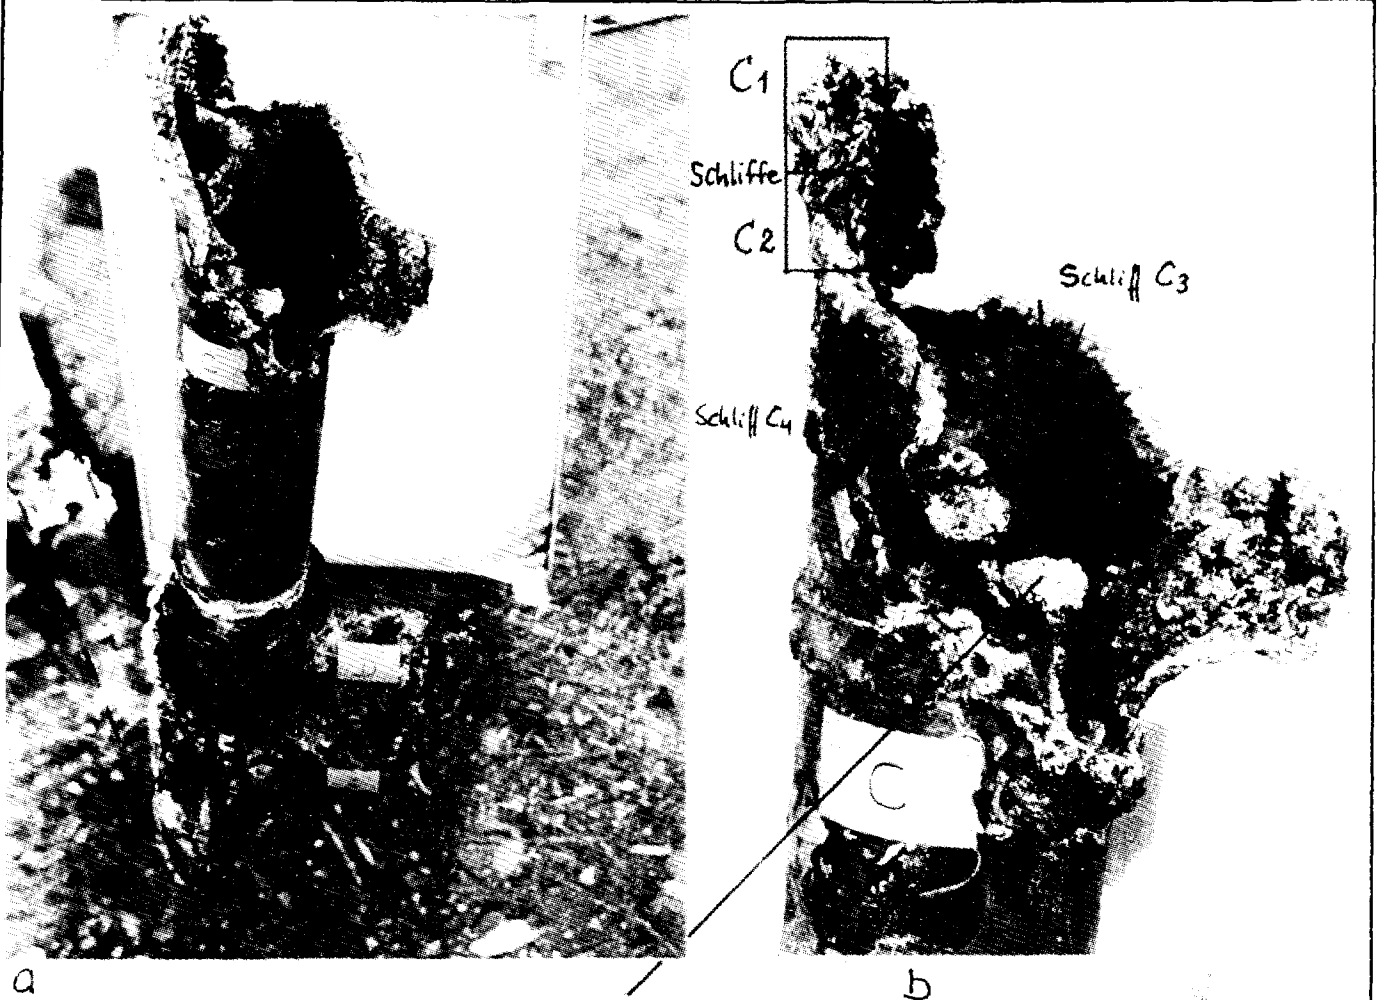
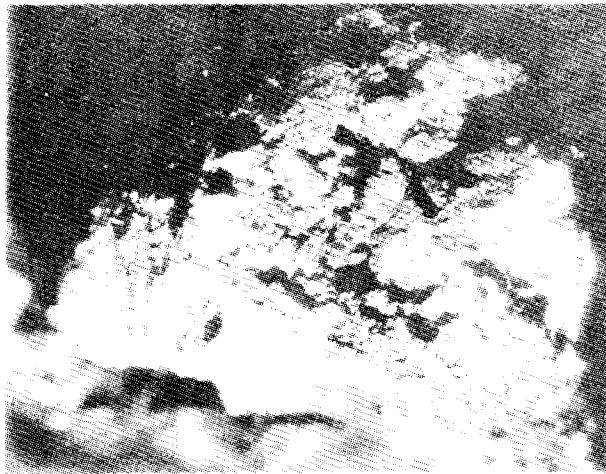
Figure 5 ALMERIA : Photograph of a Broken Stainless Steel Tube

As an example of the failed material a broken austenitic tube is shown by figure 5. The following table 1 gives a summary of the material analysis results.

Bild-Nr.	Vergrößerung	Vermerk	Archiv-Nr.
a, b	< 1 : 1	Abgerissenes Rohr und Rohrschelle (Gegenstück zu Pv. K)	
c	≈ 10 : 1	Oxidkrust mit Metallrest für den Wiederaufschmelzversuch

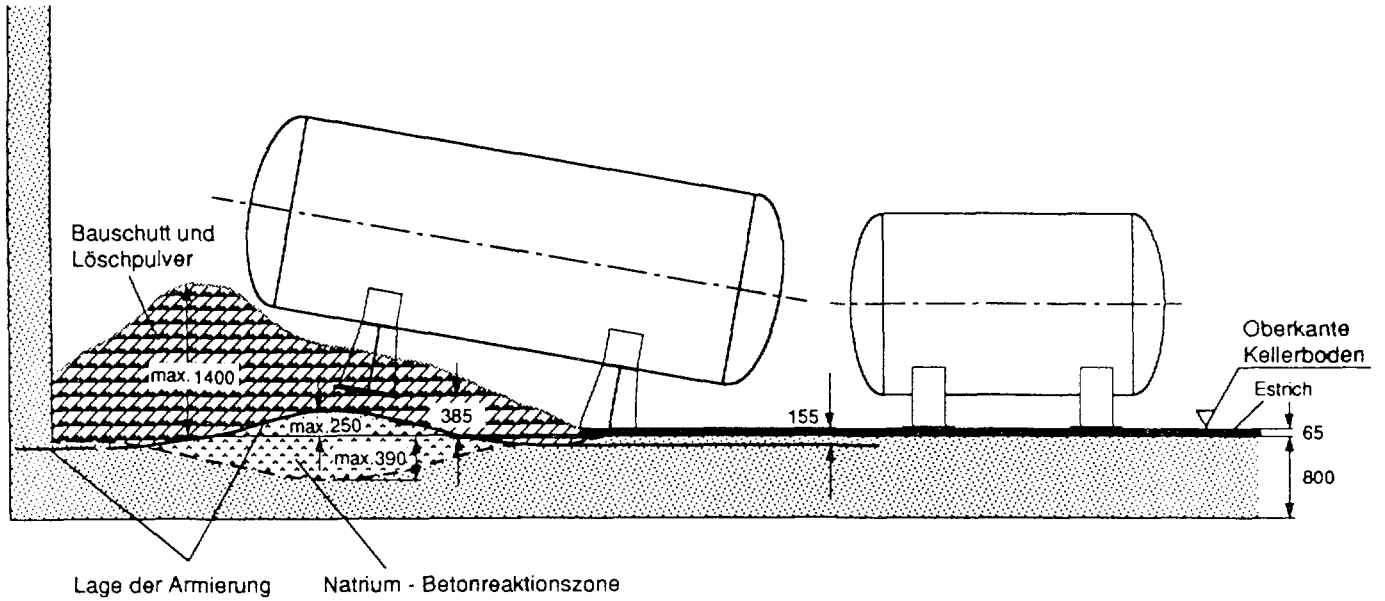
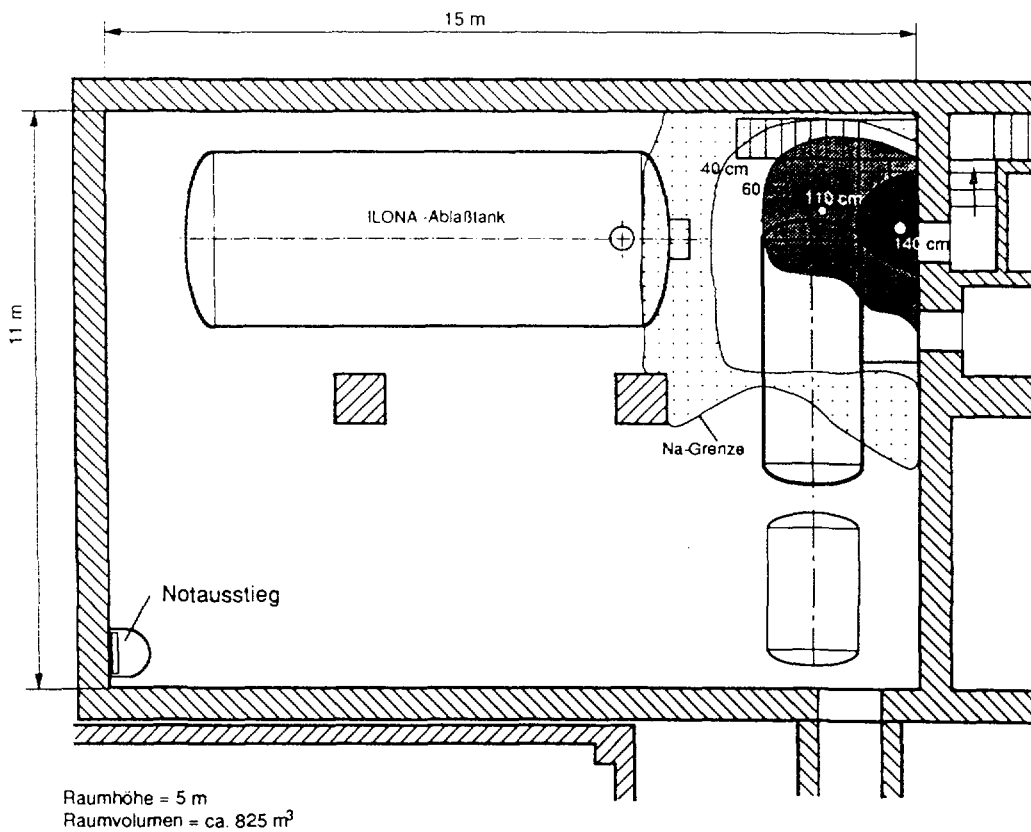
Figure 8 ILONA : Cross Section of the Sodium - Concrete Reaction Zone

The same phenomenon lifted the vessel at one end as well. By inclination of the vessel the entrance to the dip tube of the vessel became uncovered and this stopped the leakage.

The concerned area was situated under the vessel, more precisely below the part of the vessel where the dip pipe delivered the leakage flow. The concerned floor surface was about 20 m².

There the sodium attacked the concrete to a depth of 390 mm. The reaction products increase the concrete volume. This was one of the effects which lifted the vessel and stopped finally the leak. The other was thermal dilatation of reinforcement steel. Exhaustive post accident analyses were made of the concrete damage. Figure 8 shows a cross section and horizontal extent of the sodium - concrete reaction zone.

As maximum concrete temperatures 900 °C were found. In total 2 m³ of concrete reacted with sodium. The reaction produced hydrogen. The hydrogen combustion increased the surface temperature of the vessel. This was confirmed by lacquer replica technique.

Schiefelage des 5MW-Sammelbehälters nach dem Brand

Brandzone mit Schuttauflage

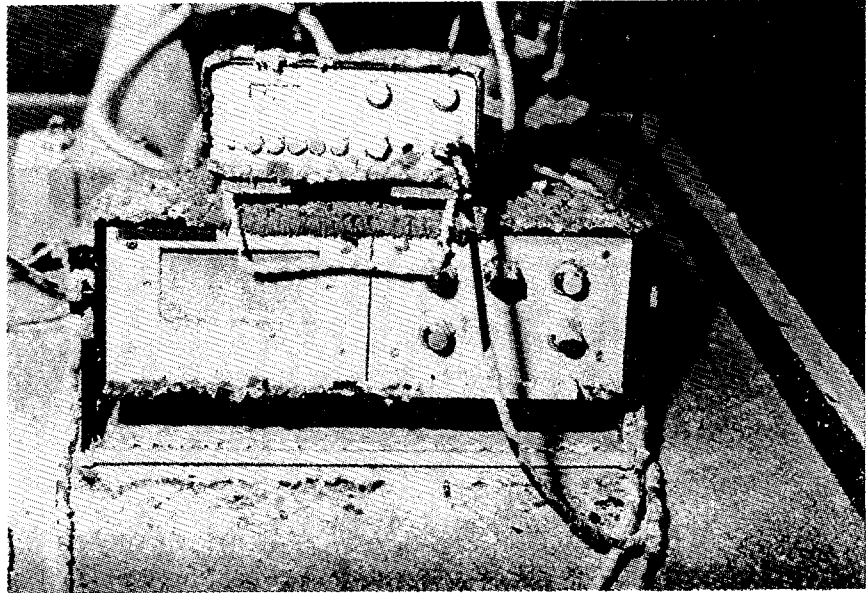
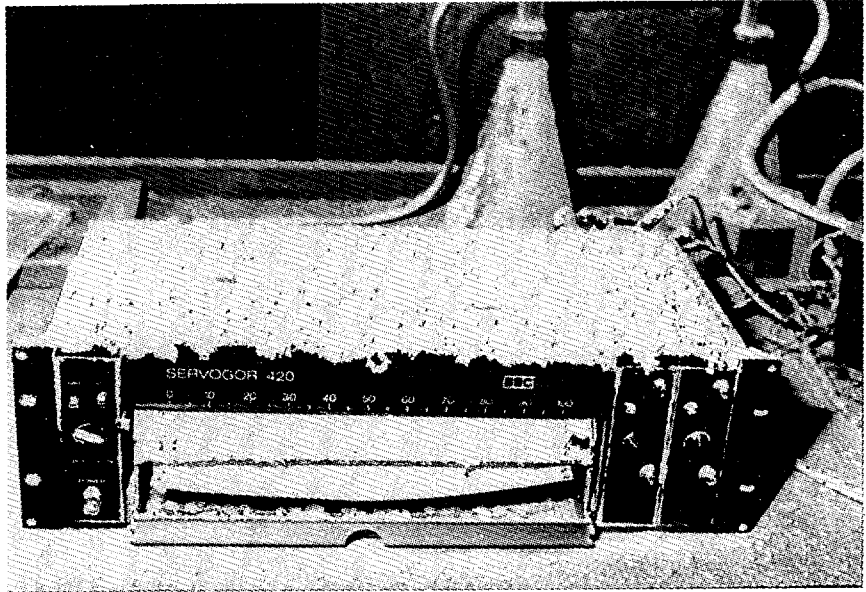
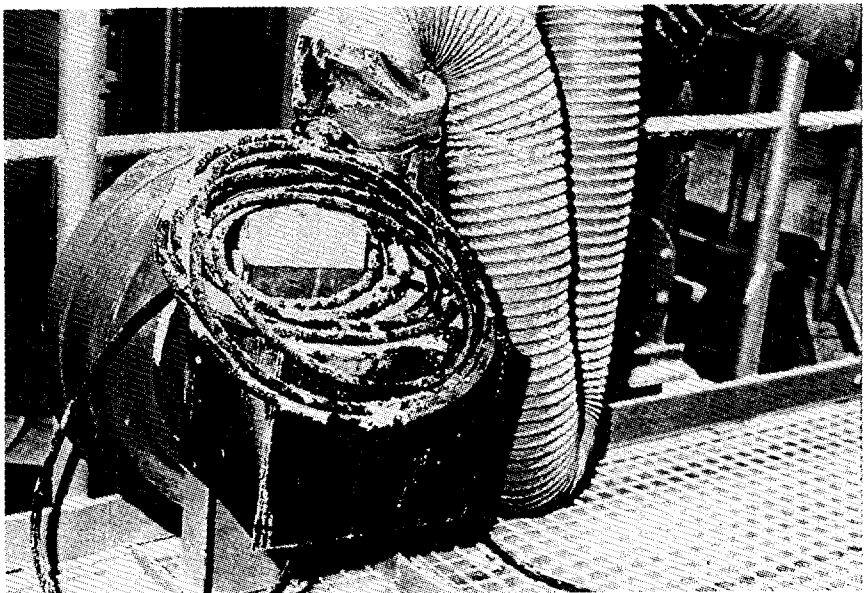
Aerosolbelegung in der Anlage

In opposition to local damage of concrete aerosol deposits were found in the whole building.

burnt sodium	3000 kg
sodium transformed in aerosols	2500 kg
deposits in the building	1500 kg
release to environment	1000 kg

Several months after the accident the ILONA building was cleaned. The cleaning was accompanied by continuous chemical and material survey. After repair of the concrete damage the building was ready for another use.
