| K.2. Leakage Experiences with 1 MW Steam Generator | A. Kanamori M. Kawara A. Sano | Japan |

K.3. KNK-Steam Generator Leak- K. Dumm Fed.Rep.Germany
age, Evaluations and W. Ratzel
Improvements

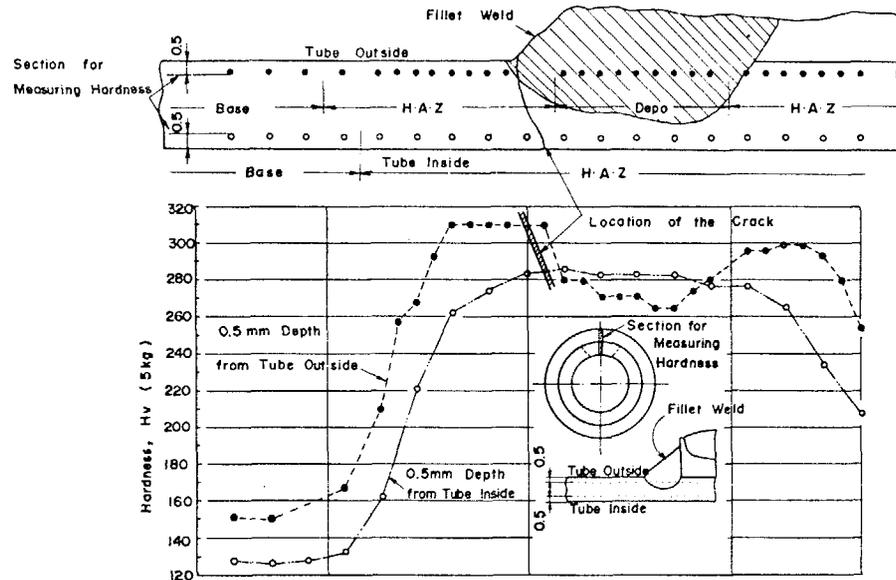
Liquid penetrant examination showed 12.4 mm of cracking on the outer surface and slightly less than 5 mm on the inner surface. Hardness was checked along axial direction which resulted in two or three times harder on the heat affected zone, as shown in Fig. 4.

FIG. 4. Hardness of the Tube at the Crack-originated Region

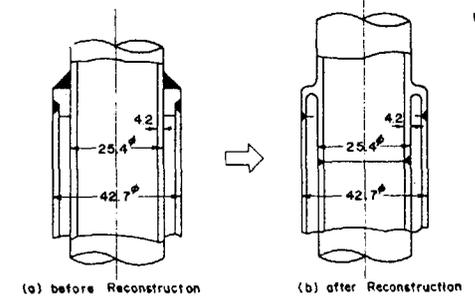
FIG. 6.

Comparison of Tube-to-Thermal Insulation Pipe

The repair was made with using so called "fluid head" which is presented in Fig. 6. It was purposed to adopt a butt-welding instead of a fillet welding and a postweld heat treatment was added to eliminate the residual stress due to the welding. Investigation of the causes, repair works, clean up operation of sodium in the system and washing off caustic products on the surface in the steam generator, which was formed with air during repair works, required so many days until the end of September.
