SECOND LEAKAGE EXPERIENCE

K.3. KNK-Steam Generator Leak- K. Dumm Fed.Rep.Germany
age, Evaluations and W. Ratzel
Improvements

K.4. Post-failure Metallurgical Investigation of KNK Steam Generator Tube Damage	H. Lorenz G. Herberg (presented by E.D.Grosser)	Fed. Rep. Germany
--	--	-------------------

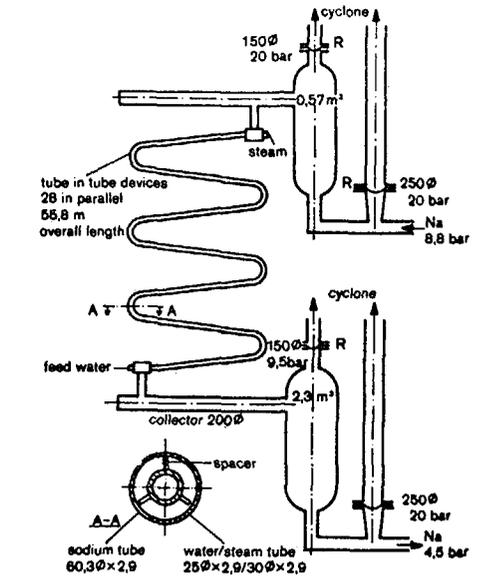
KNK STEAM GENERATOR 28 MWth Figure 2

Fig. 1 shows the geometrical arrangement of the secondary sodium loop with its main components. As explained later the event was partly influenced by this geometrical arrangement. The steam generator with the connected pressure relief system is illustrated in Fig. 2. Steam is produced in 28 parallel tube-in-tube units which are connected to headers. Three additional units are available as spare parts; they are not connected to the headers. Each sodium outlet is equipped with an inductive bubble indicator by which hydrogen bubbles originating from a sodium-water reaction can be detected. At the time when the leak occurred each sodium outlet was additionally equipped with a thermocouple for low load stability measurements. In the case of large sodium-water reaction fast pressure relief is achieved by 4 rupture discs. Previously to the steam generator failure described here all rupture discs were designed having an actuating pressure of 20 bar.

Contrary to the design case during the described incident the whole secondary system was uniformly pressurized. Therefore in order to avoid overloading the main components such as pump, expansion tank and IHX in the case of a simialr event, the relief pressure of one of the rupture discs was reduced to 9,5 bar as already shown in Fig. 2.

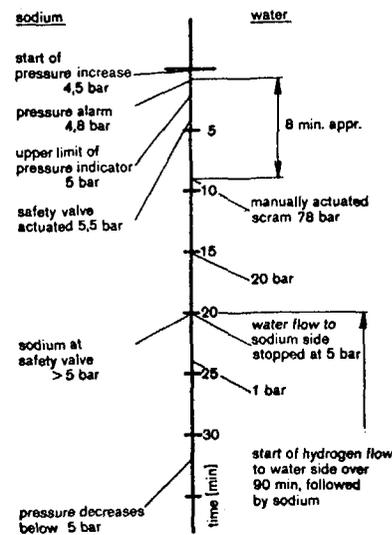
KNK EVALUATION OF STEAM GENERATOR FAILURE Figure 3

After an instrumentation check was carried out by the operator, the reactor was manually shut down. The water/steam side was isolated and depressurized. During the depressurization period the water leakage continued until pressure equilibrium with the sodium side was reached. Therefore pressure and level in the expansion tank increased further; the safety valve starts to blow at 5,5 bar (diff.) and finally the expansion tank was completely filled with sodium up to the safety valve where the sodium solidified. By chance at this point the equilibrium between sodium and steam pressure was attained thereby preventing further pressure build up. As the steam blow down continued hydrogen from the sodium side passed back through the leak and entered the water side. During the incident a part of the air cooler (see Fig. 1) was also filled with hydrogen. By expansion of this hydrogen the steam generator was refilled with sodium and 65 kg of sodium passed through the leak to the water side. This summary of the event is given in Fig. 3.

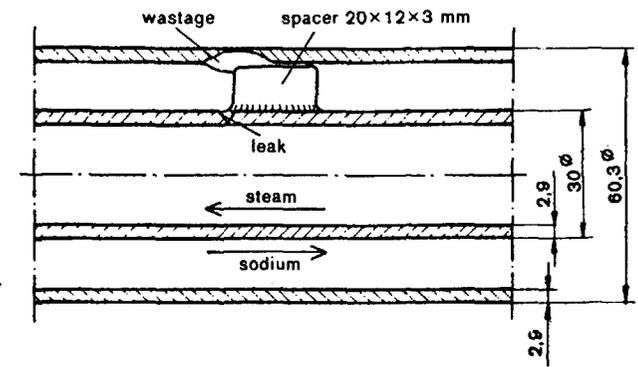
KNK STEAM GENERATOR LEAK ZONE Figure 4

the water side of the steam generator was pressurized with nitrogen and the water/steam tubes near the feed water and steam headers were controlled by an ultrasonic microphone. The nitrogen pressure was increased up to 5 bar. At this pressure the sound emission from tube no. 39 increased to a level 6-10 times higher than from the other tubes. Having two independent indications tube no. 39 was assumed to be the leaking unit. After dismantling this tube unit the leak was located in the lower superheater region. Fig. 4 shows schematically the leak region. The leak is of a circular shape. At the steam side it has a diameter of approx. 1,3 mm which enlarges conically to the sodium side up to about 4,5 mm. It is positioned in the neighbourhood of a spacer. There was a wastage area of about 18 mm in diameter at the inner surface of the outer tube. The remaining wall thickness of the 2,9 mm thick tube was 0,8 mm in the affected region. The cause of the leak is presented in literature [17].

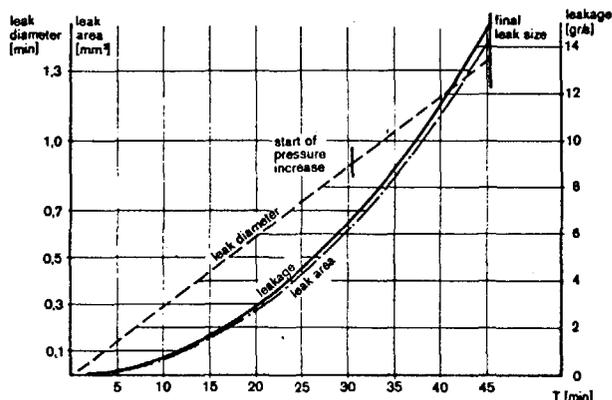
KNK DEVELOPMENT OF STEAM GENERATOR LEAKAGE

Due to results from wastage tests a linear enlargement of the leak diameter in time was assumed. Based on this it was estimated that the leak started at least 30 minutes prior to detection (see Fig. 5). This has to be understood as a minimum time. Much longer times of leak development are possible.
