## DESIGN, CONSTRUCTION AND OPERATING EXPERIENCE OF BOILERS AT WYLFA POWER STATION

R.N. RAZZELL

Wylfa Power Station,  
Central Electricity Generating Board,  
Gwynedd, United Kingdom

### Abstract

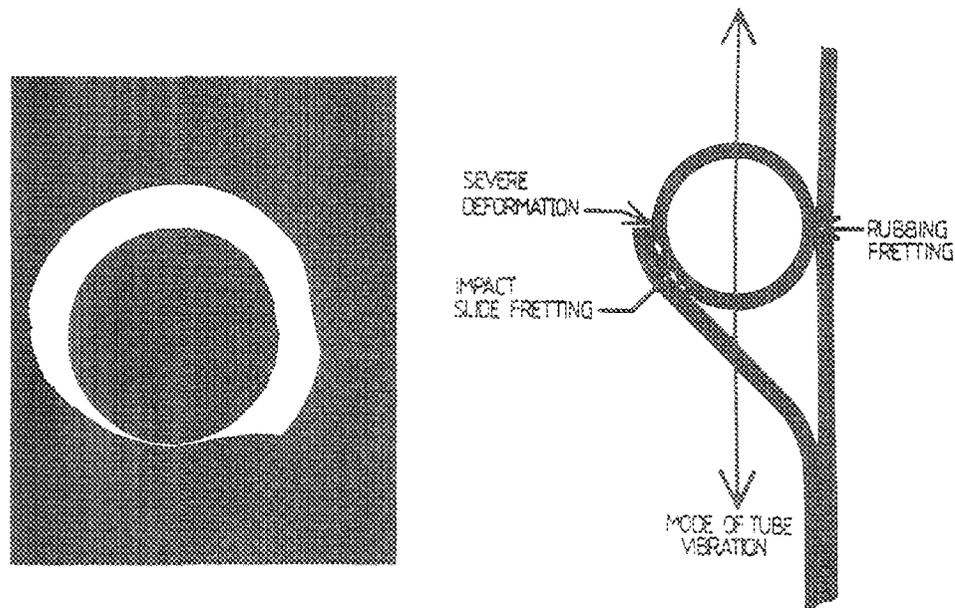
Firstly the height of the leak in the boiler had to be determined and this was done by manometric means. Stress calculations were carried out and showed that it was acceptable to cut a large enough hole in the support tank to enable a failed tube to be removed. The operation was carried out and a failed tube located. Inspection of this showed that failure was due to fretting between the unlined section of the tube and its securing clip at the platten end channel. An extensive operation followed whereby all of this type of clip were inspected by means of fibre optics. This indicated that fretting damage had occurred only on end of packet plattens in the economiser region of the boiler. Further investigations revealed that the whole of the boiler sections had become displaced resulting in comparatively large gaps between packets, i.e. up to about 1 inch.

The reason for tube failure had now been identified but it was still necessary to determine the cause of the vibration. To do this the boilers were extensively fitted with instrumentation and a series of cold runs at various gas circulator conditions carried out. The results from these runs were analysed and indicated that the fretting was due to resonant vibration of the tubes, mainly in the vertical plane. See Figs. 7 and 8.

FIG.7. Fretted tube.

FIG.8. Most probable mode of tube vibration. Clip-to-tube arrangement and location of fretting damage.

Various solutions to the problem were considered and the final outcome was a two part course of action. Firstly, the tubes in the economiser section of the boiler would have to be restrained to 'stiffen' them up. Secondly the boiler packets would have to be repositioned to reduce and equalise the interpacket gaps.

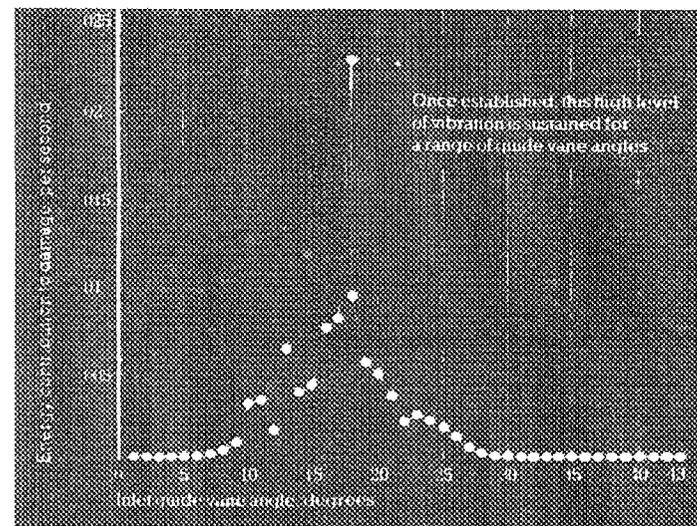
The cold runs showed that the excitation frequency within a boiler packet is of the order of 30HZ in the horizontal plane and 66HZ in the vertical plane. With a 1 inch interpacket these figures are 45HZ and 90HZ respectively. The natural frequency of the tube varies depending on the state of the tube clips but most are in the range 30HZ to 50HZ for their first critical and 80HZ to 120HZ for their second critical. This shows that the excitation frequency and natural frequency ranges overlap and are coincident at certain gas velocities giving rise to resonant vibration. Fig. 9 shows a typical vibration graph from the cold run tests.

FIG.9. Gas-mass-flow dependent resonance peak, showing the vibration energy of one of the tubes against guide vane angle with four circulators operating. The critical guide vane angle is different for each tube.

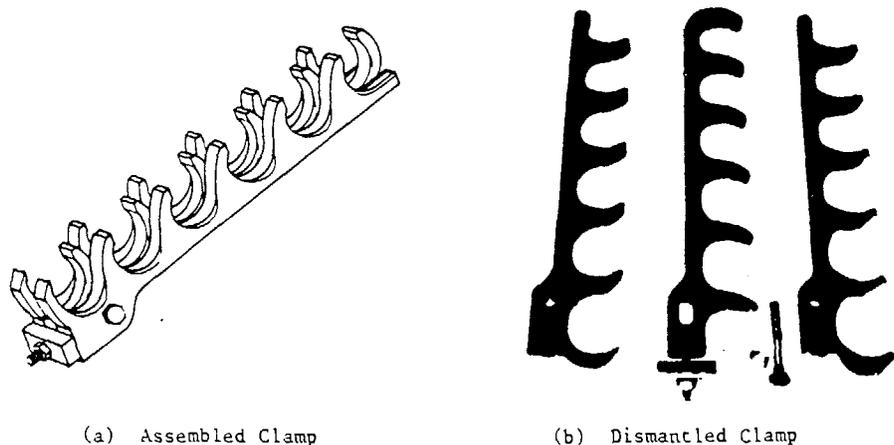
FIG.10. 'Short' boiler tube clamp.

To restrain the tubes a scissor type clamp was designed which was capable of clamping the bottom 18 tubes of the economiser together, see Fig. 10. Because of the limited space between the packets it had to be fitted in three separate sections and brought together and tightened in position. Two of these clamps were fitted at the outer end of each of the end of packet plattens, a total of 248 clamps.

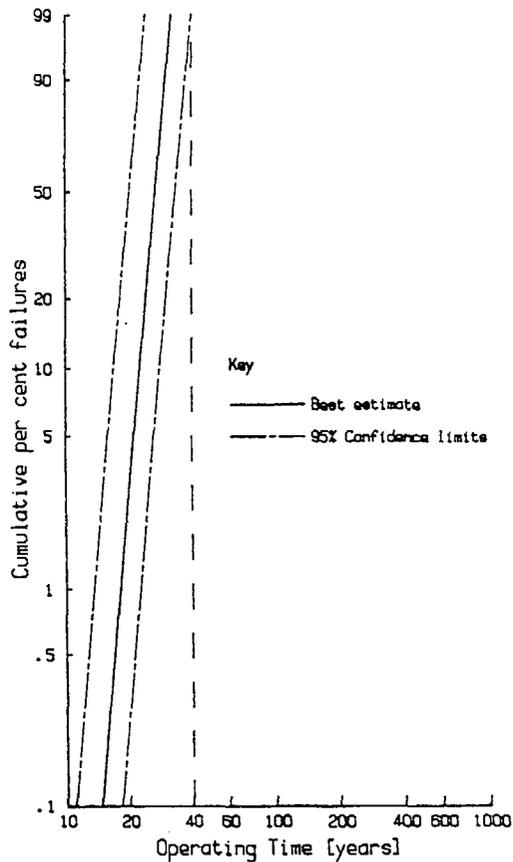
FIG. 11.

Failure predictions for 1ppm ammonia.

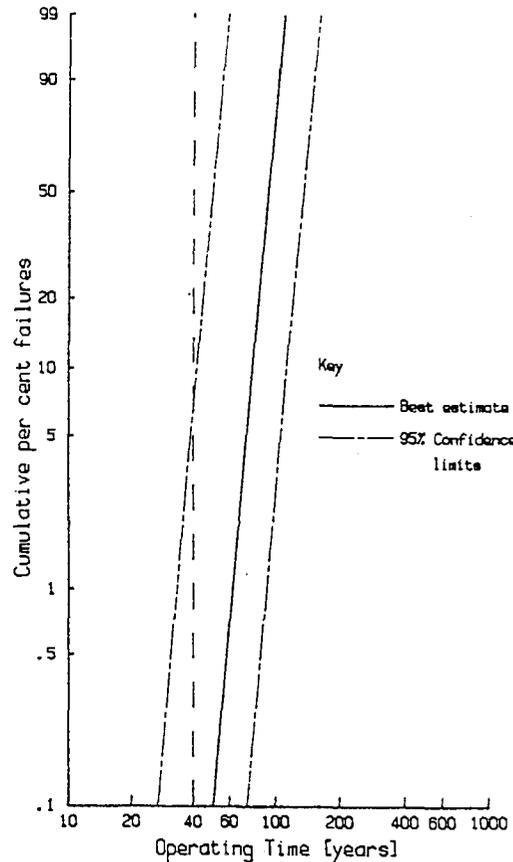
FIG. 12.

Failure predictions for 10ppm AMP.

The amine was brought into use in the Autumn of 1983 and is currently added to the feedwater at a concentration of 10 ppm producing a pH(25°C) of 9.75. The current assessment of the beneficial effects are favourable but as yet, from a practical standpoint of tube failure, it is too early to be overconfident. The histogram, Table 1, of tube failure shows the failure rate due to vibration and the reduced failure rate when ferrules were installed as well as the effect of introducing AMP.

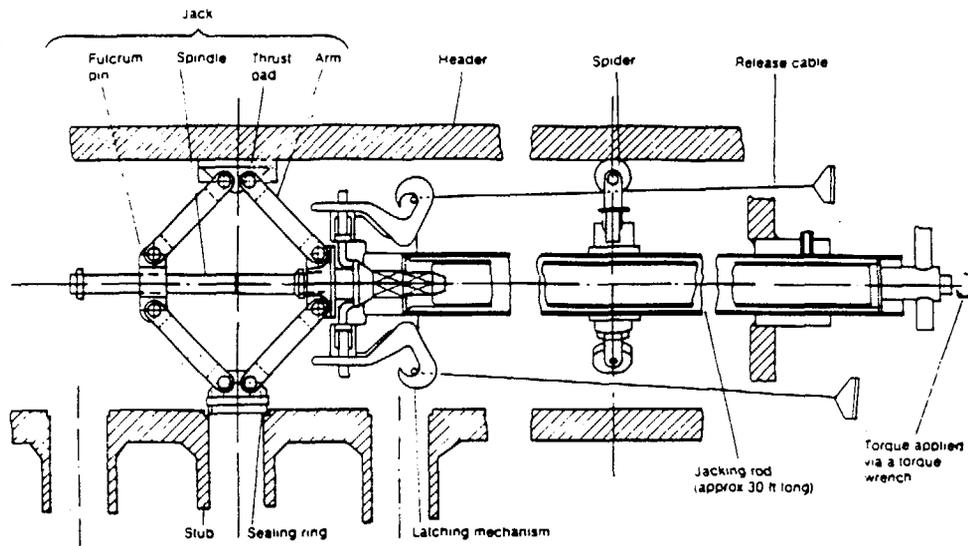
FIG.13. Original design of jack and insertion tool.

With the large number of tube leaks being experienced in 1973 it was decided that a quicker method of sealing the leaks should be sought and consequently various alternatives were investigated. By far the most promising idea was that of plugging off the superheater tube with a plug held in position by a jack acting across the header bore.

This idea was developed and the result was a car type scissor jack with an integral plug which was inserted by a remote handling tool. (See Fig. 13).

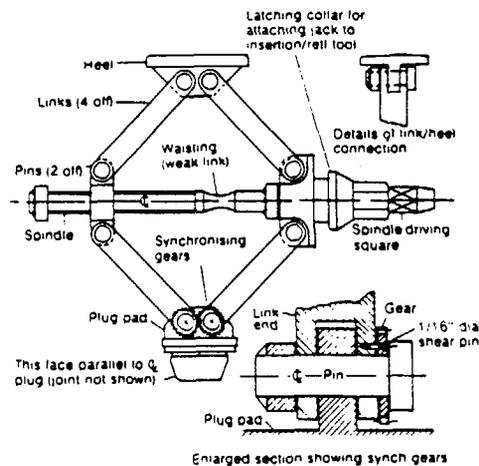
FIG.14. Later design of jack.

Although some difficulties were experienced with the early design the method proved a great success. Through operating experience, the jack and tool have been developed until it is now a relatively straight/forward operation to fit one. The main improvements have been a redesigned plug giving a better lead into the tube to be sealed and synchronising gears to prevent the plug being diverted by escaping gas during fitting. (See Fig. 14).
